NERC Lessons Learned

Moisture Intrusion in Hermetically Sealed Metering Current Transformers

SERC Reliability Corporation

December 17, 2019

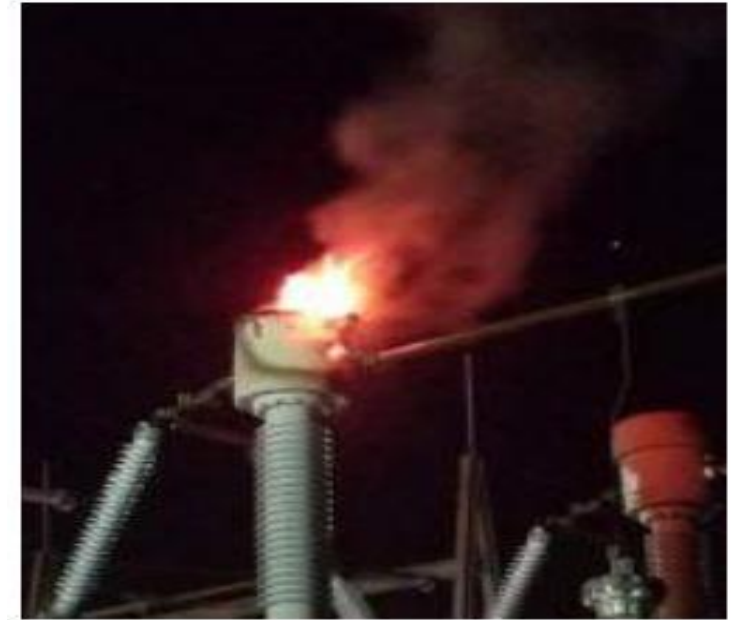
- The initial oil and lab inspection revealed no concerns except for a higher moisture content above acceptable levels
- The root cause from the lab reports was analyzed to be the seal design that allowed moisture to enter the metering CT
- The design allowed moisture at the rim of the two sections of the tank to be pulled in by internal pressure changes caused by the daily cycling of temperature
- Over time, the atmospheric moisture contaminated the CT's kraft paper insulation
- The corrective measures included the design with a bolted gasket system and purchase of spare parts stored in a climate-controlled dry, indoor environment

Figure 2: C-phase CT failure [1]

- CTs may fail without warning and spare units must be on hand
- Spare units must be stored in temp/humidity controlled environment
- Moisture sampling is recommended prior to use - if advised against by the manufactures, contact them and ship back if needed
- Normal hi-pot testing in the field may not indicate a high moisture content
- A Doble test (insulation power factor) may provide a better indication of moisture if an original baseline test was performed for comparison later
- Perfect-looking metering data provided no early warning signs or guarantee of avoidance of catastrophic failure

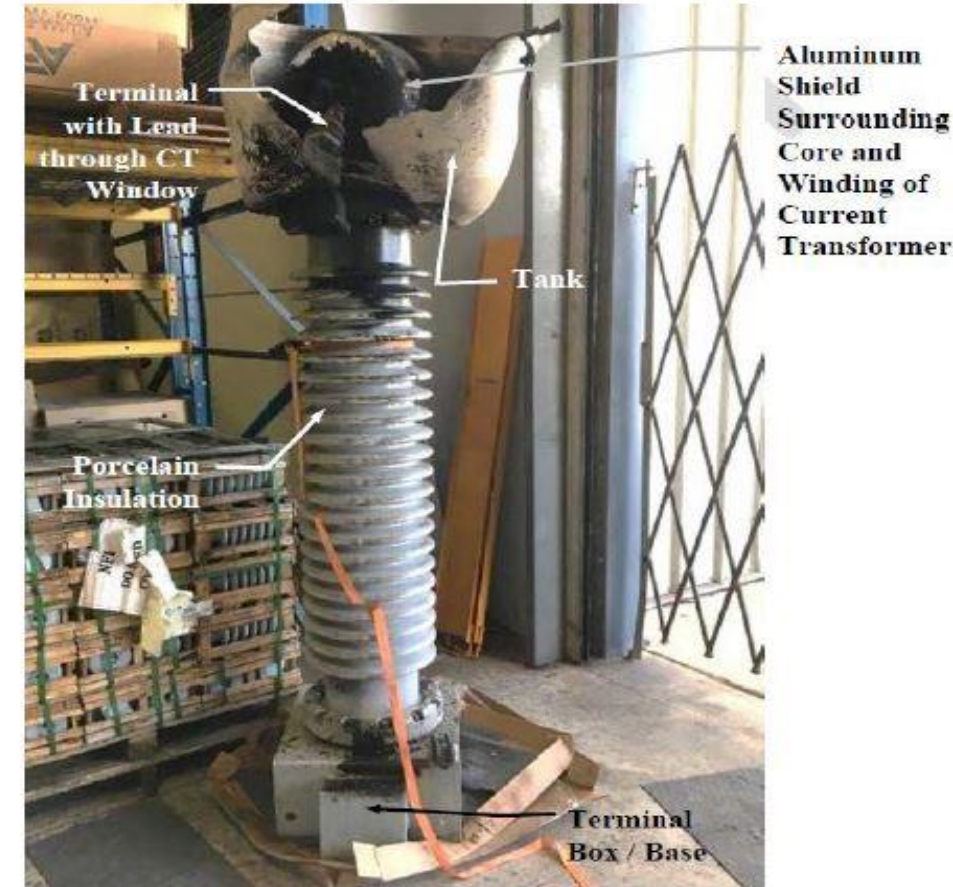
Figure 3: A labelled diagram of a failed CT [1]
