NERC Lessons Learned

Transient Induced Misoperation:
Approach I

Control Circuit Transient
Misoperation of Microprocessor
Relay

Transient Induced Misoperation:
Approach II

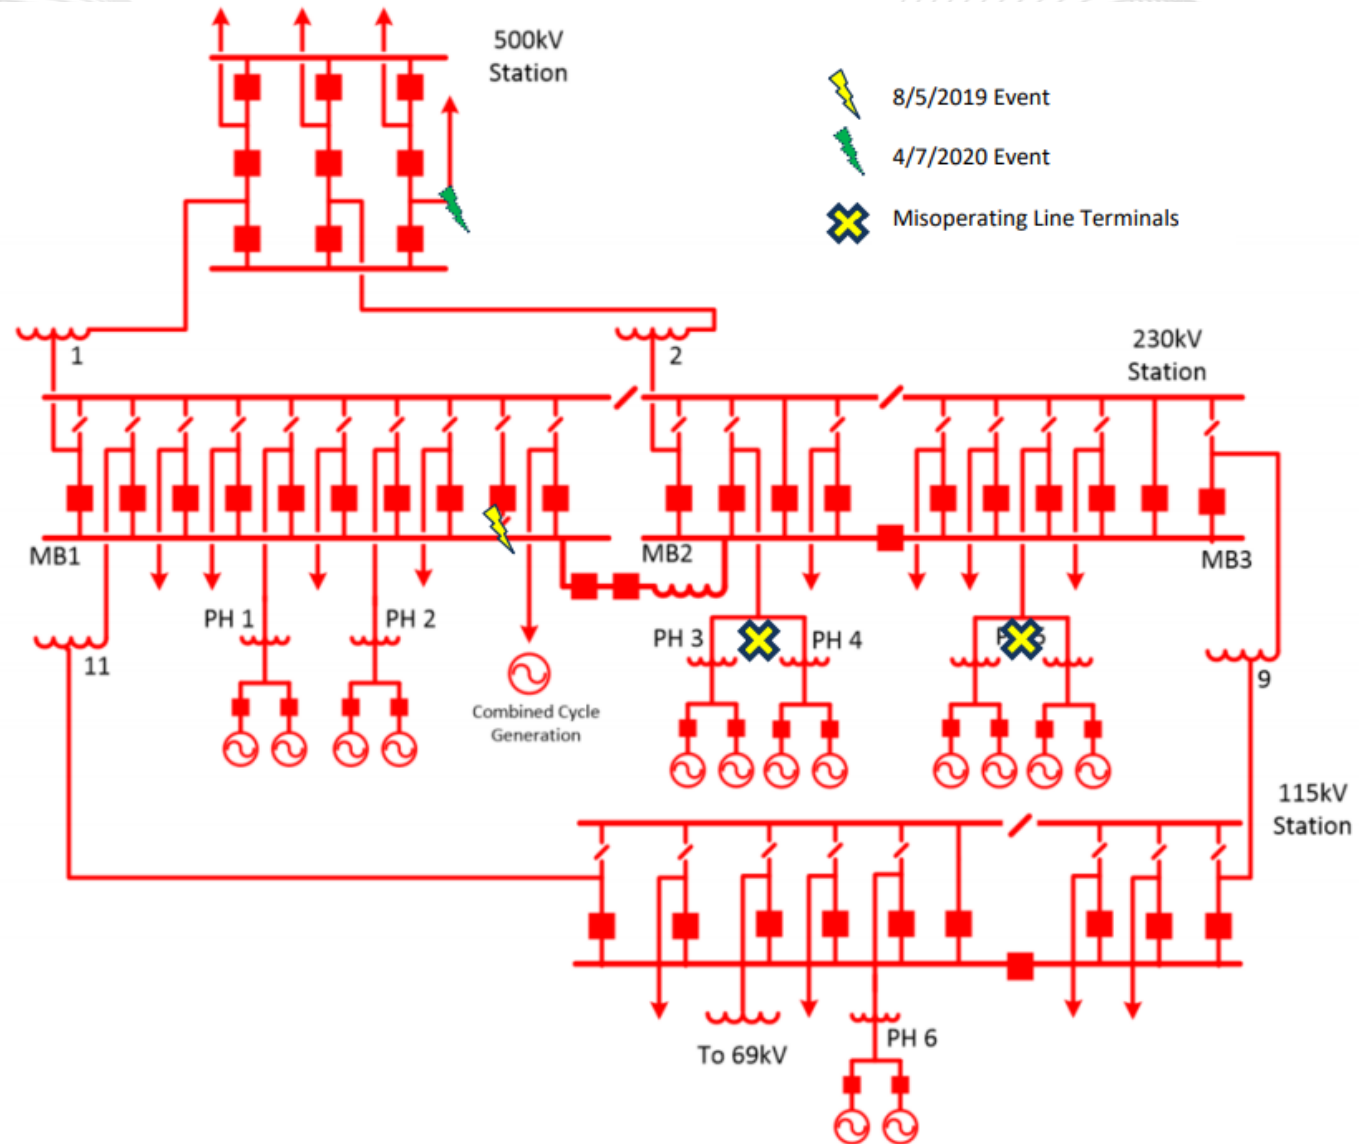
- 2019:
 - Voltage transients from 230 kV bus fault initiated protective relay inputs to a hydroelectric dam
 - Created multiple powerhouse line misoperations and tripping 221 MW generation
 - 47 k Ω resistor was added on all line relays to dampen fault
 - 15 kHz continuous recorder was installed to monitor relay input
- 2020:
 - Single phase fault on 500 kV line
 - Misoperation of same 2 powerhouse lines tripped 315 MW

Figure 1: One line diagram of the impacted station.
 Line relay misoperations occurred on powerhouse lines 3/4 and 5 [1]

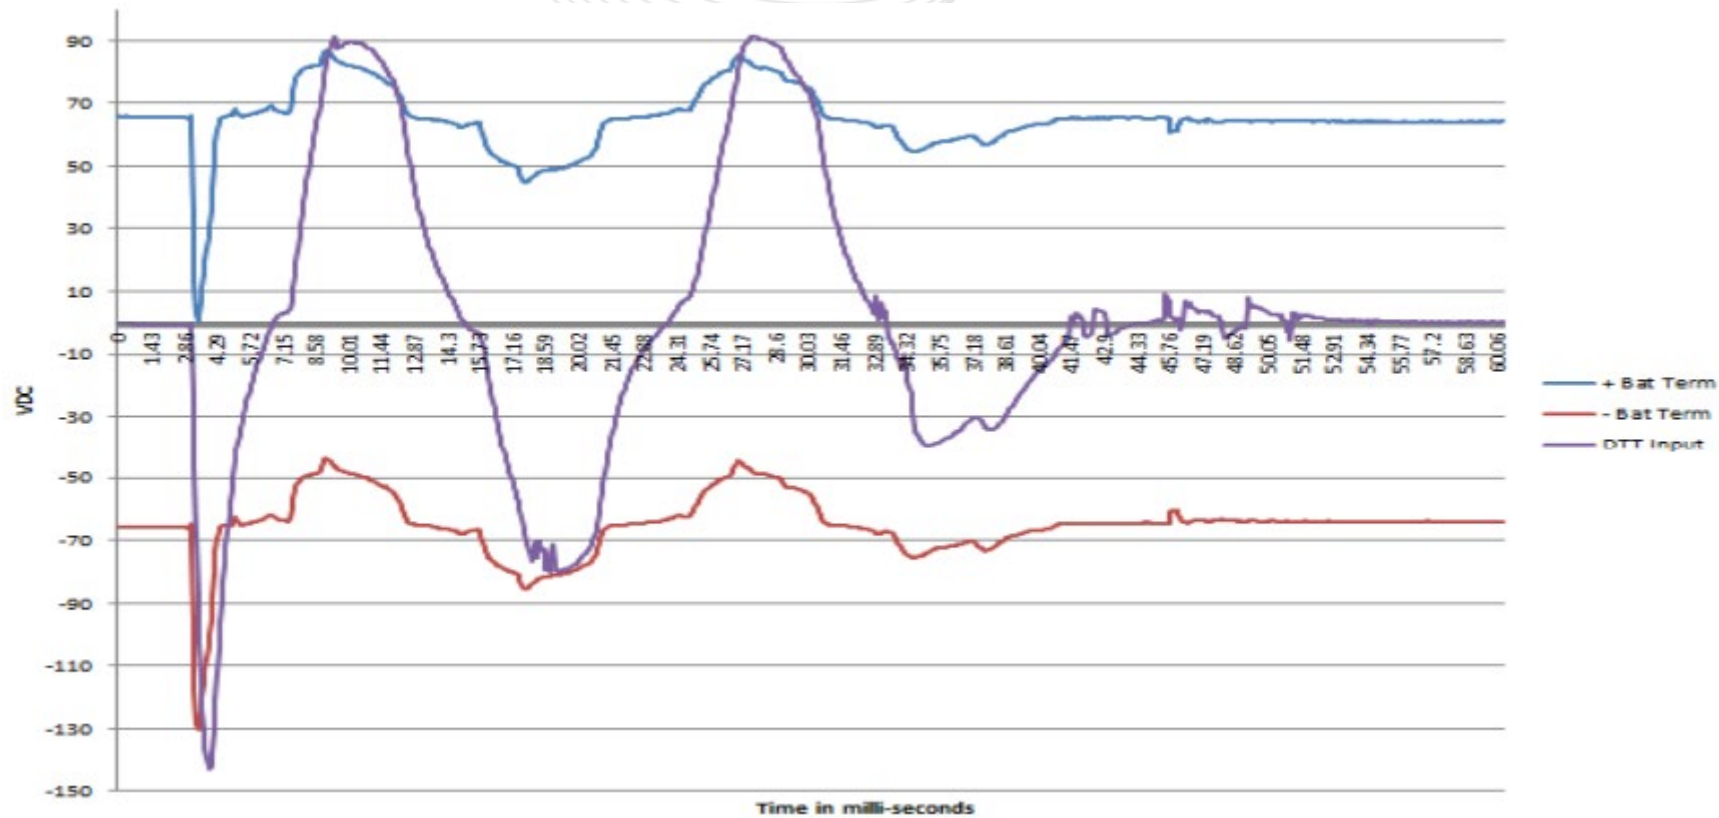
Figure 2: 15 kHz continuous recorder data measuring relay supply voltage (Blue and Red) and the DTT input voltage across the installed resistor (Purple) [1]

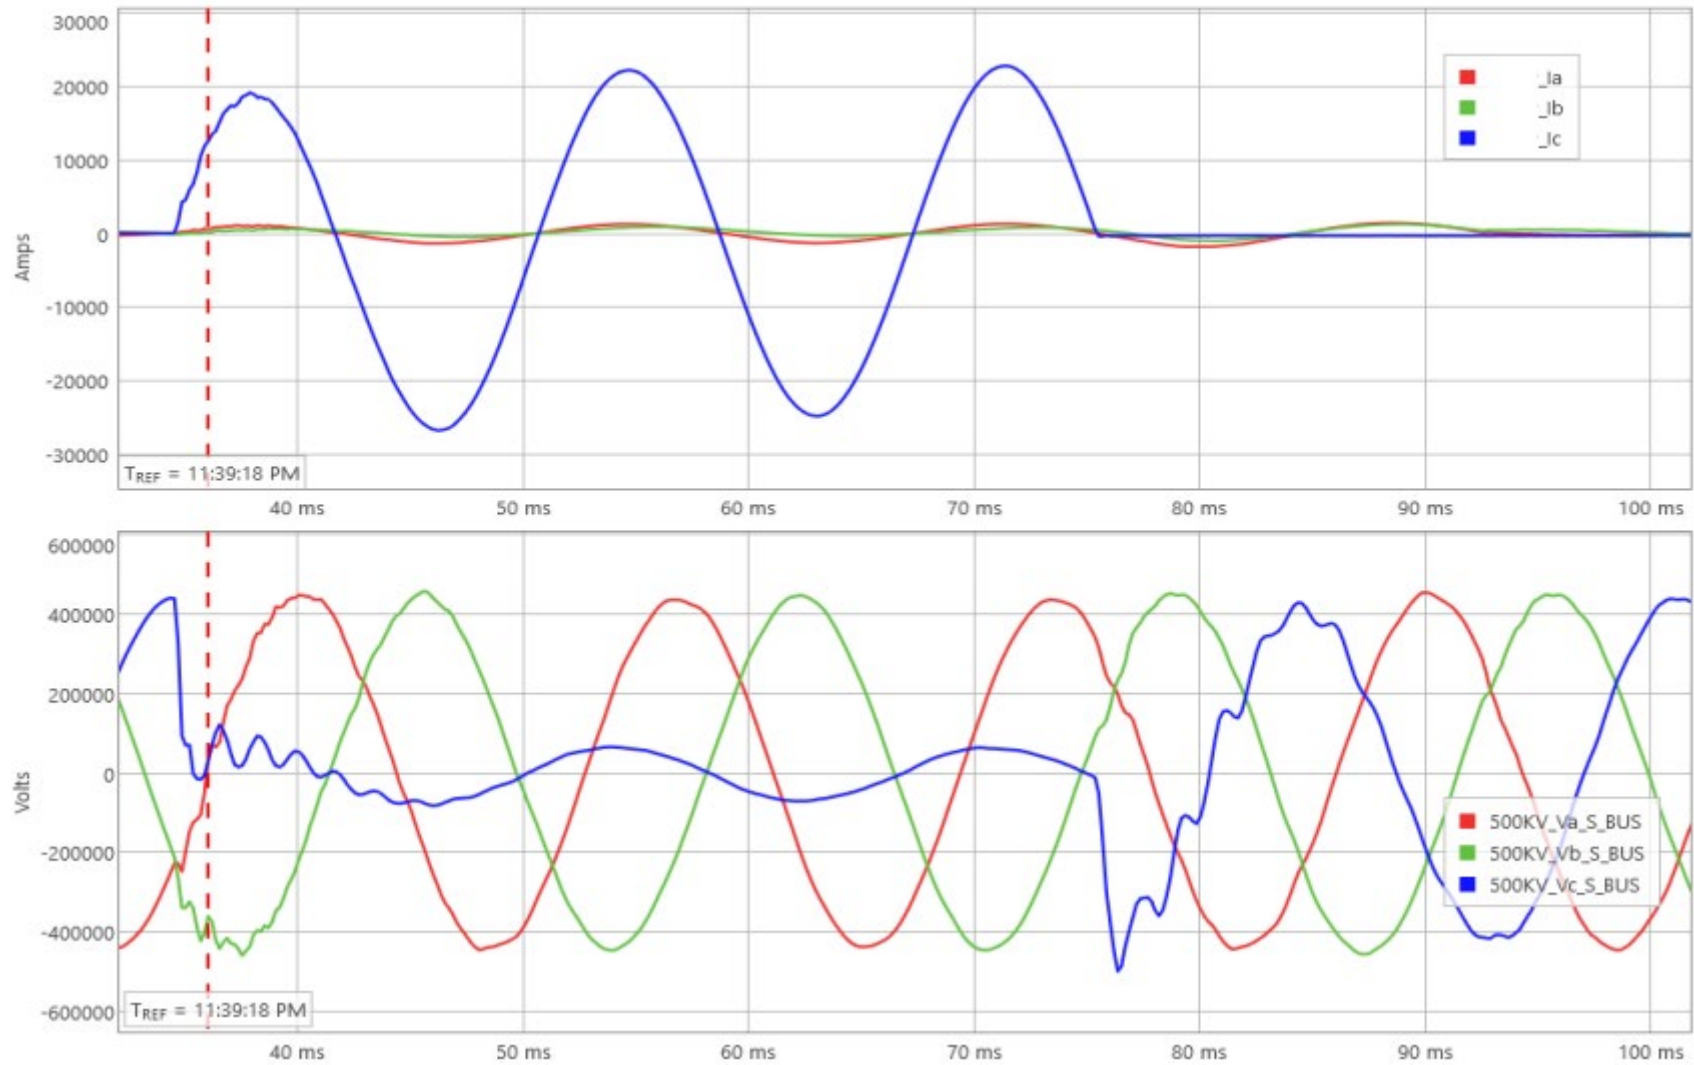
Figure 3: Event from digital fault recorder, located at the substation adjacent to the powerhouse, showing line current (top) and bus voltage (bottom) during the 2020 500 kV line fault [1]

- Issues at powerhouse began after the addition of a second 1,300 MVA 500/230/34.5 kV autotransformer in 2016
- Root Cause: result of high ground current present at the powerhouse during high magnitude ground faults
- Change to a more effective 23 k Ω resistor
- Current Transformer grounds were checked and tested to rule out coupling between CT and DTT control circuit during faults
- Install relay-to-relay communication from GSU protection to alternate powerhouse line relay
- Powerhouse relay protection replaced with microprocessor relays

- Resistors have been added and monitoring equipment has been installed
- Situations like this happens when various generations of equipment and designs are combined together at a single site
- Reduce cabling connected to single input
- Increase burden of microprocessor relay input
- Evaluate system before installing relays or equipment

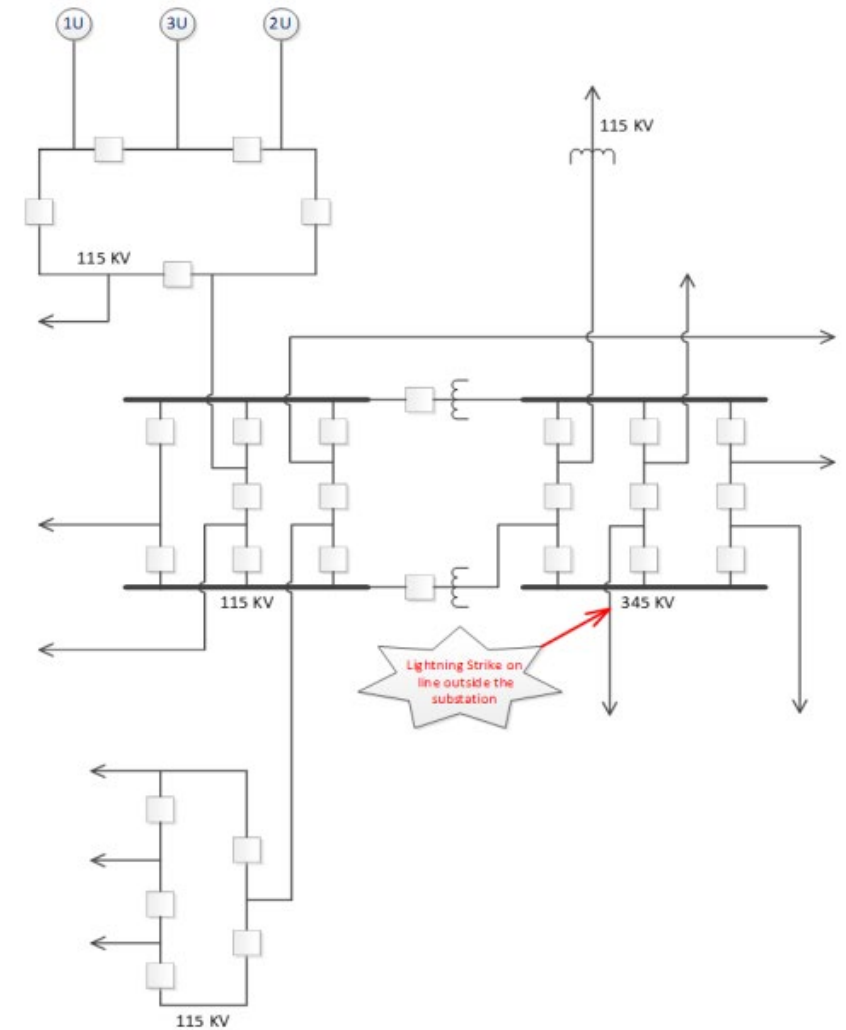
- Lightning strike induced fault of 345 kV transmission line
- System 1 and 2 protection groups shut down
- Neither system cleared the fault
- Terminated 345/115/13.8 kV substation
- Fault continued over 1.5 seconds
- Protection at remote terminal tripped

Figure 4: One Line Diagram [2]

- Fault was not cleared by System 1 or 2 as they were rebooting simultaneously, 14 remote terminals cleared the fault
- System 1
 - Directional Comparison Blocking via power line carrier
 - Line operated via DBC communication assisted elements in 4.5 cycles
- System 2
 - Line Current Differential via optical ground wire
 - Did not operate due to the loss of communication with powered off relay

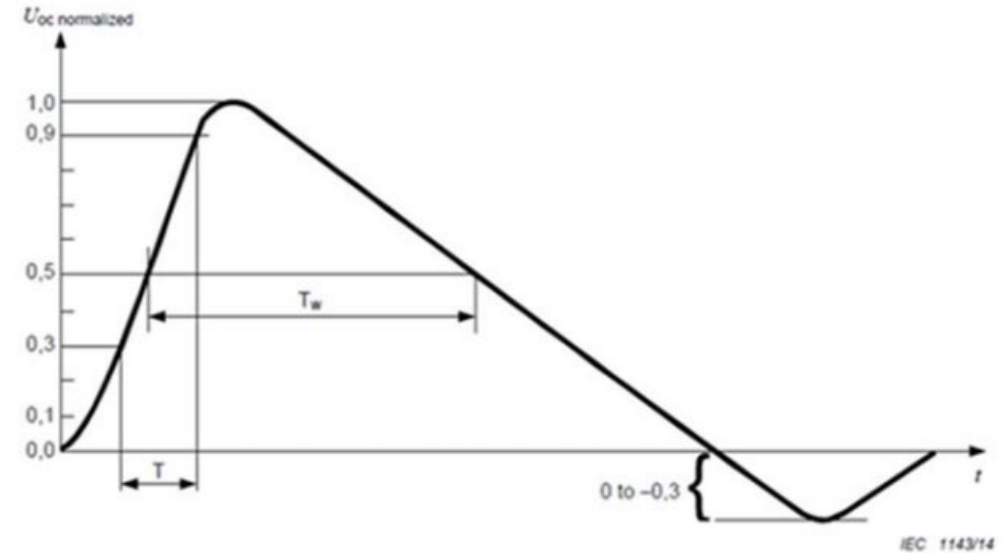
- System 2 testing subjected 4.0 kV surge
- Ground potential difference exceeded the surge withstanding capability of the relay, resulting in a reboot
- System 1 did not withstand surge, no reboot

Figure 5: IEEE Surge Withstand [2]

- Protection system owner must consider the surge withstand rating of the equipment being installed
- Protective relay systems, when exposed to surges beyond their specified criteria, may not operate as intended or fail as expected
- As substations are modified, cabling should be upgraded to comply with latest design
