Transmission Expansion Advisory Committee AEP Supplemental Project

Conesville – Bixby 345 kV

Need Number: AEP-2022-OH039

Process Stage: Need Meeting 4/12/2022

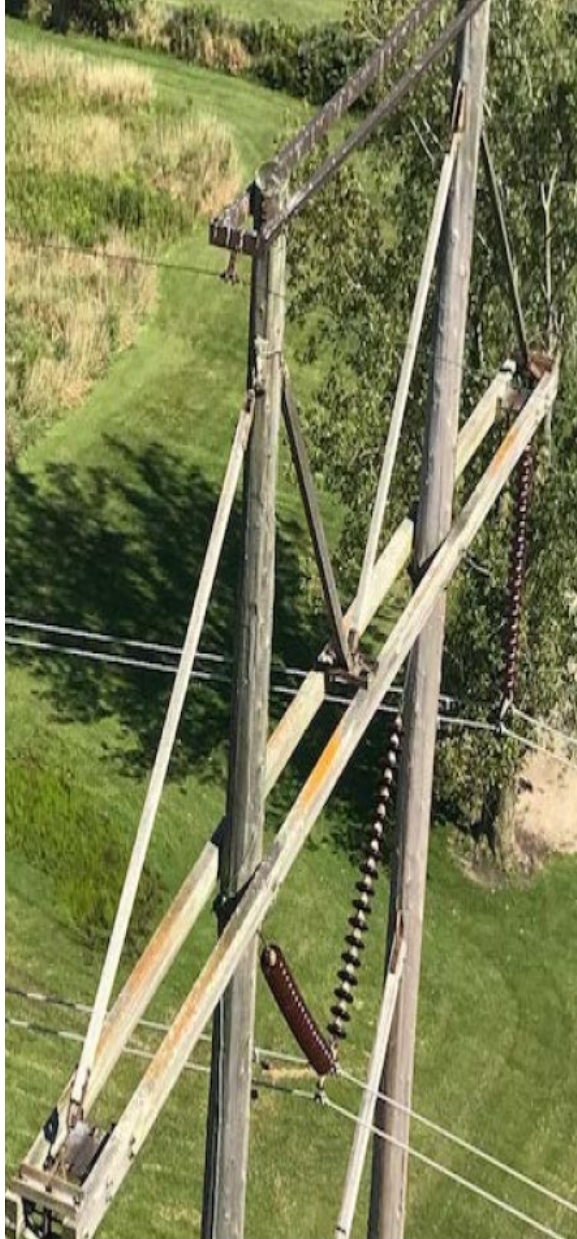
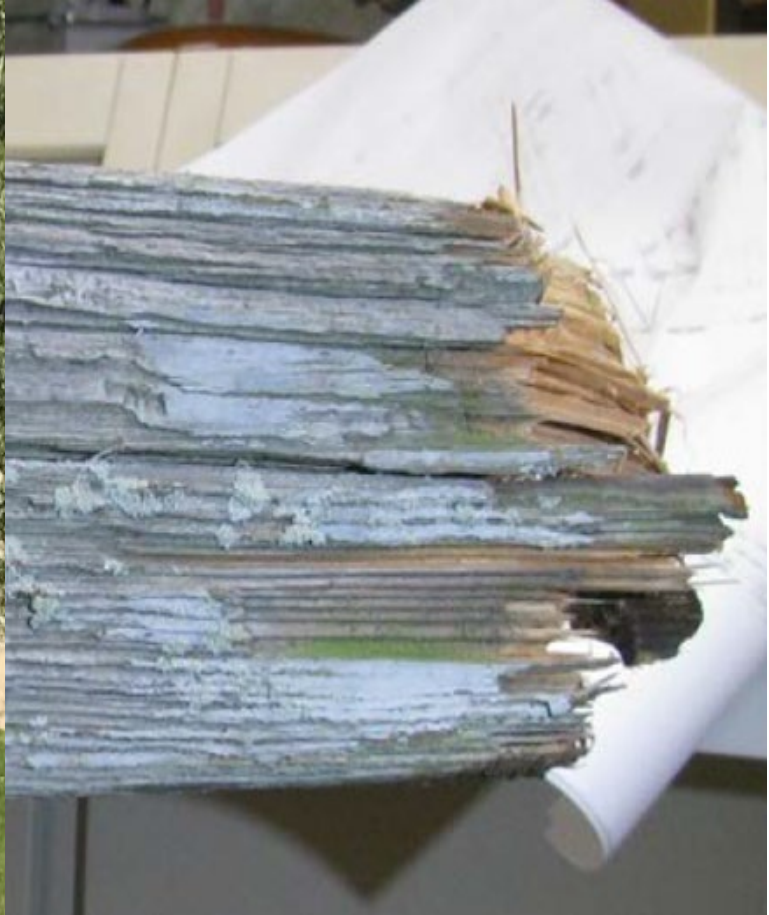
When the 345 kV line was constructed in the 1970's, it was done so utilizing an H-frame design with wood poles that involved the use of laminated crossarms rather than solid wood crossarms. Recent inspections have revealed signs of noticeable deterioration of the laminated crossarms. The green decay and orange rot as shown in the pictures is irreversible wood decay on the laminated crossarms.

There are limited inspection techniques available to identify areas of concern in laminated crossarms before a loss in functionality occurs and causes a permanent outage. Various industry organizations have attempted to analyze the stages of crossarm decay with varying degrees of success. This is the last line left on AEP's eastern footprint with this type of crossarm design.

AEP's experience with these laminated cross arms is that over time, due to the decay and delamination issues associated with the crossarm design, along with limitations to determine loss of functionality, failures on the line have historically been catastrophic in nature.
