## Lesson Learned

### Loss of Wind Turbines due to Transient Voltage Disturbances on the Bulk Transmission System

#### Problem Statement

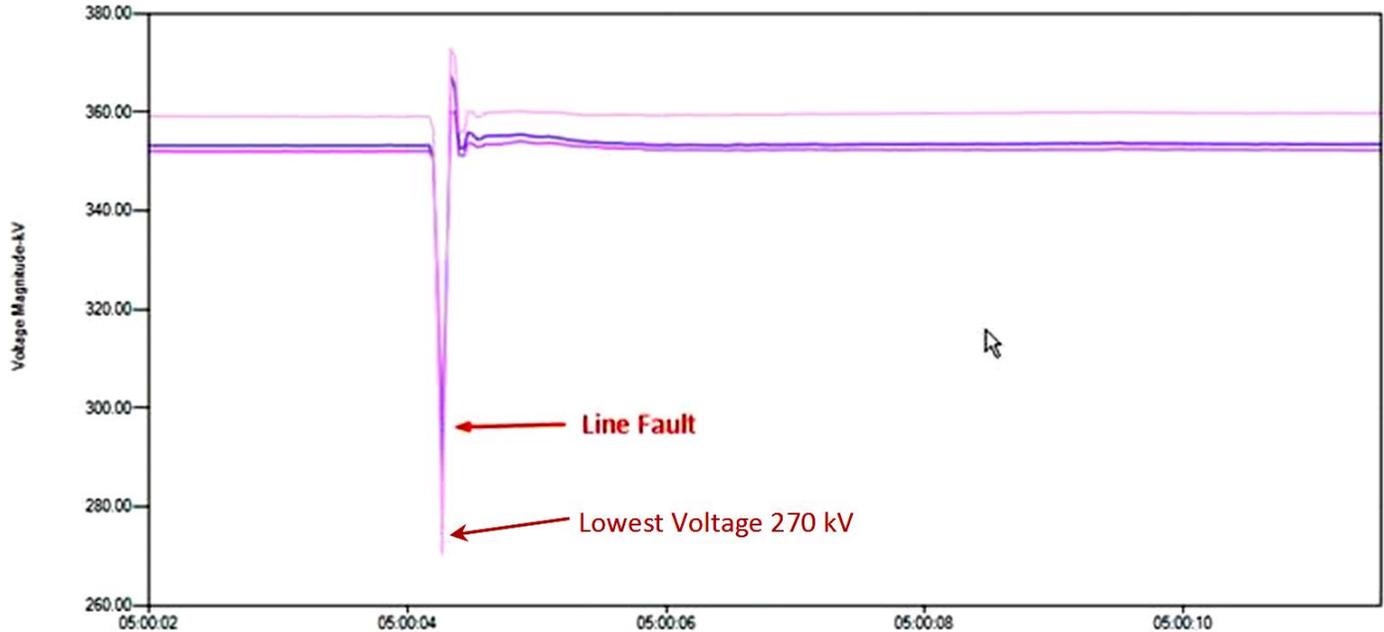
**Figure 1 (Event 3)**

- **Event 3:** A 345 kV line fault caused a single-phase low voltage excursion (see Figure 1), resulting in the loss of 343 MW of wind generation across seven wind plants (a loss of approximately 48 percent of the pre-event output). Phasor measurement unit (PMU) data in the vicinity of the disturbance showed a voltage oscillation between 0.78 and 1.07 per-unit for less than 0.5 seconds. System frequency dipped to 59.864 Hz as a result of the loss of generation and recovered to 60 Hz in less than four minutes.

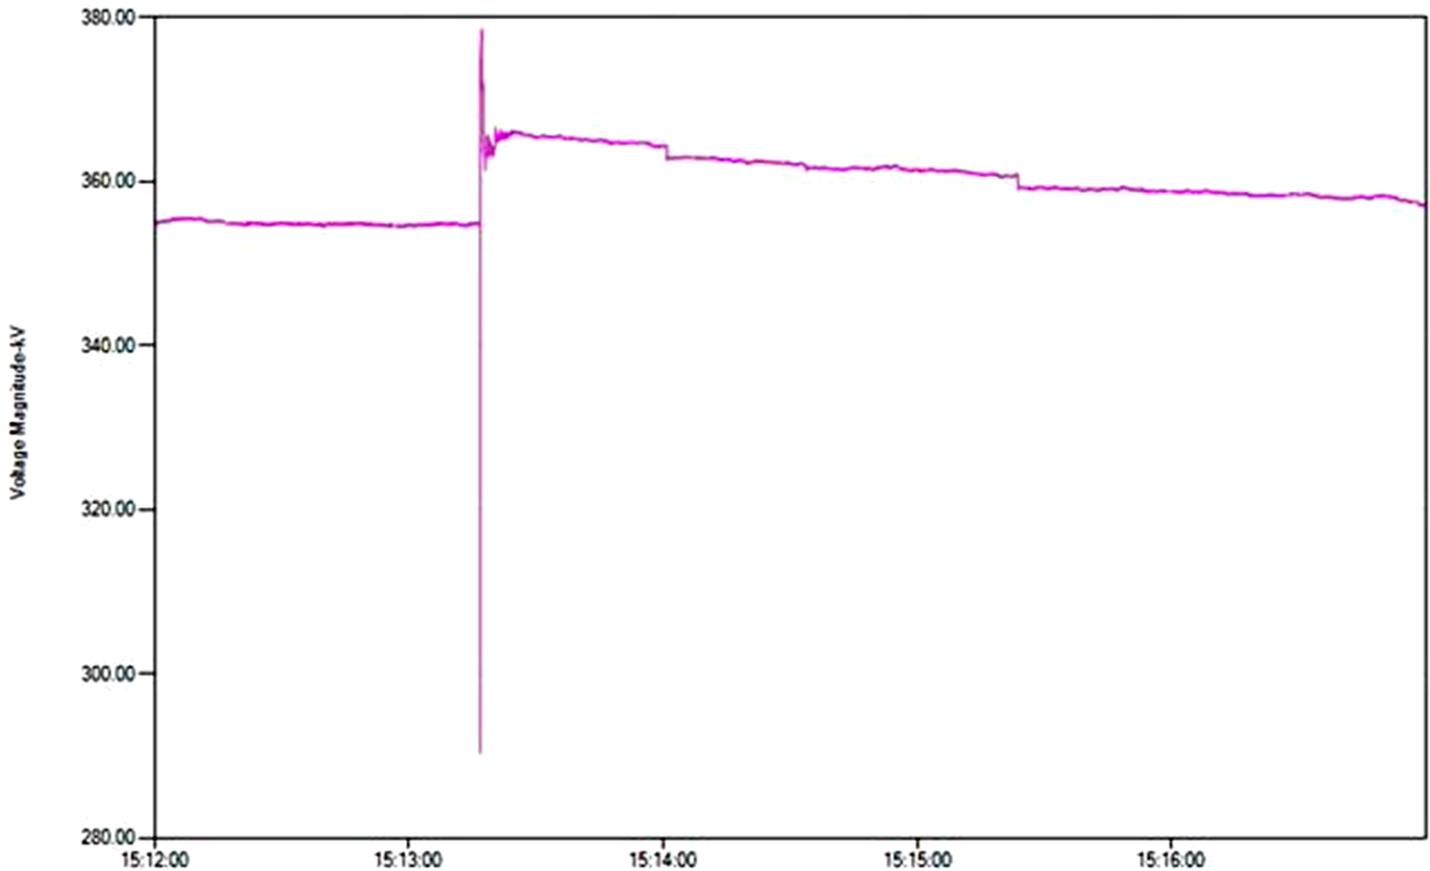
**Figure 2 (Event 5)**

- **Event 4:** A 69 kV bus fault caused a low-voltage excursion, resulting in the loss of 230 MW of wind generation across seven wind plants (a loss of approximately 85 percent of the pre-event output). All of these wind plants were connected to the 138 kV transmission grid. PMU data from the 138 kV system in the area showed a low-voltage magnitude of 0.86 per unit and recovery to pre-event magnitude in 0.2 seconds.
- **Event 5:** A 138 kV line fault caused a low voltage excursion, resulting in the loss of 404 MW of wind generation across six wind plants (a loss of approximately 53 percent of the pre-event output). Five of these wind plants were connected to the 345 kV transmission grid. PMU data from the 345 kV system in the area showed a voltage oscillation between 0.84 and 1.09 per-unit for approximately

0.2 seconds (see Figure 2). System frequency dipped to 59.902 Hz as a result of the loss of generation and recovered to 60 Hz in five minutes.

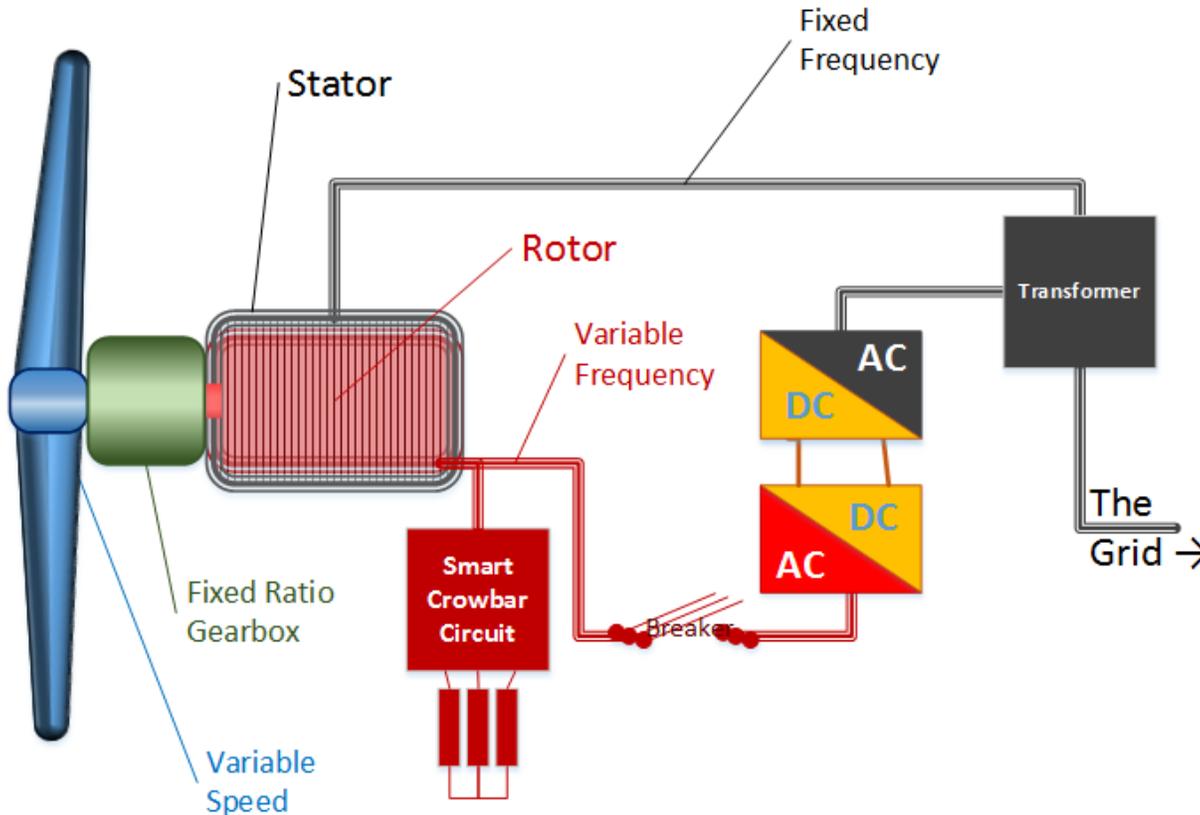
## Attachment 1: Simplified DFIG Wind Turbine diagram for explaining Crowbar Circuit use

Most recently built wind turbines use Doubly Fed Induction Generators (DFIG) that have their stator windings connected directly to the grid, making the rotor winding susceptible to high currents induced during grid faults. The back-to-back converter subsystem (variable-AC to DC to fixed-AC) is very sensitive to over-currents.

Various methods have been used to provide low voltage ride-through capability and some ability to contribute to voltage support during and after grid faults. One method is to dump excess energy with a crowbar system, which intentionally shorts out the rotor windings through large resistors when predetermined thresholds of measured parameters are reached, usually based on the DC-link voltage level in the back-to-back conversion system. In addition, a combination of blade pitch control and braking is typically used to quickly reduce the mechanical energy input.
