NERC Lessons Learned

Insulator Flashovers Due to Combination of Salt Spray Deposits Followed by Light Rainfall Initiating Loss of Load

August 6, 2021

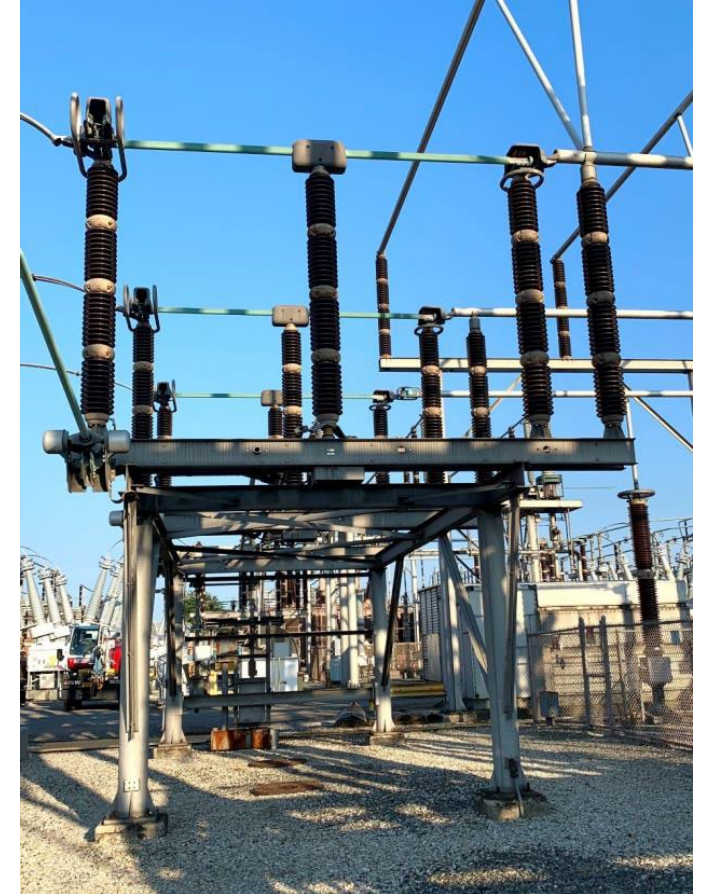
- Parallel insulators in a bulk power substation exposed to salt spray during a tropical storm
- Flashed over two and a half days later when light rain began to fall
- Flash overs were attributable to dry band arcing
- Relay misoperations in the presence of the flashover faults resulted in loss of load

Figure 1: 345 kV Disconnect Switch w/Center-Pivot Horizontal Swing Arms [1]

- Substation has been in service for 56 years
- Never experienced simultaneous column insulator flashovers
- None of the other waterfront substations of similar design in the entity's service territory have experienced this type of problem
- Leakage current detectors are being installed on selected insulator columns so that the phenomenon can be tracked and trended over time

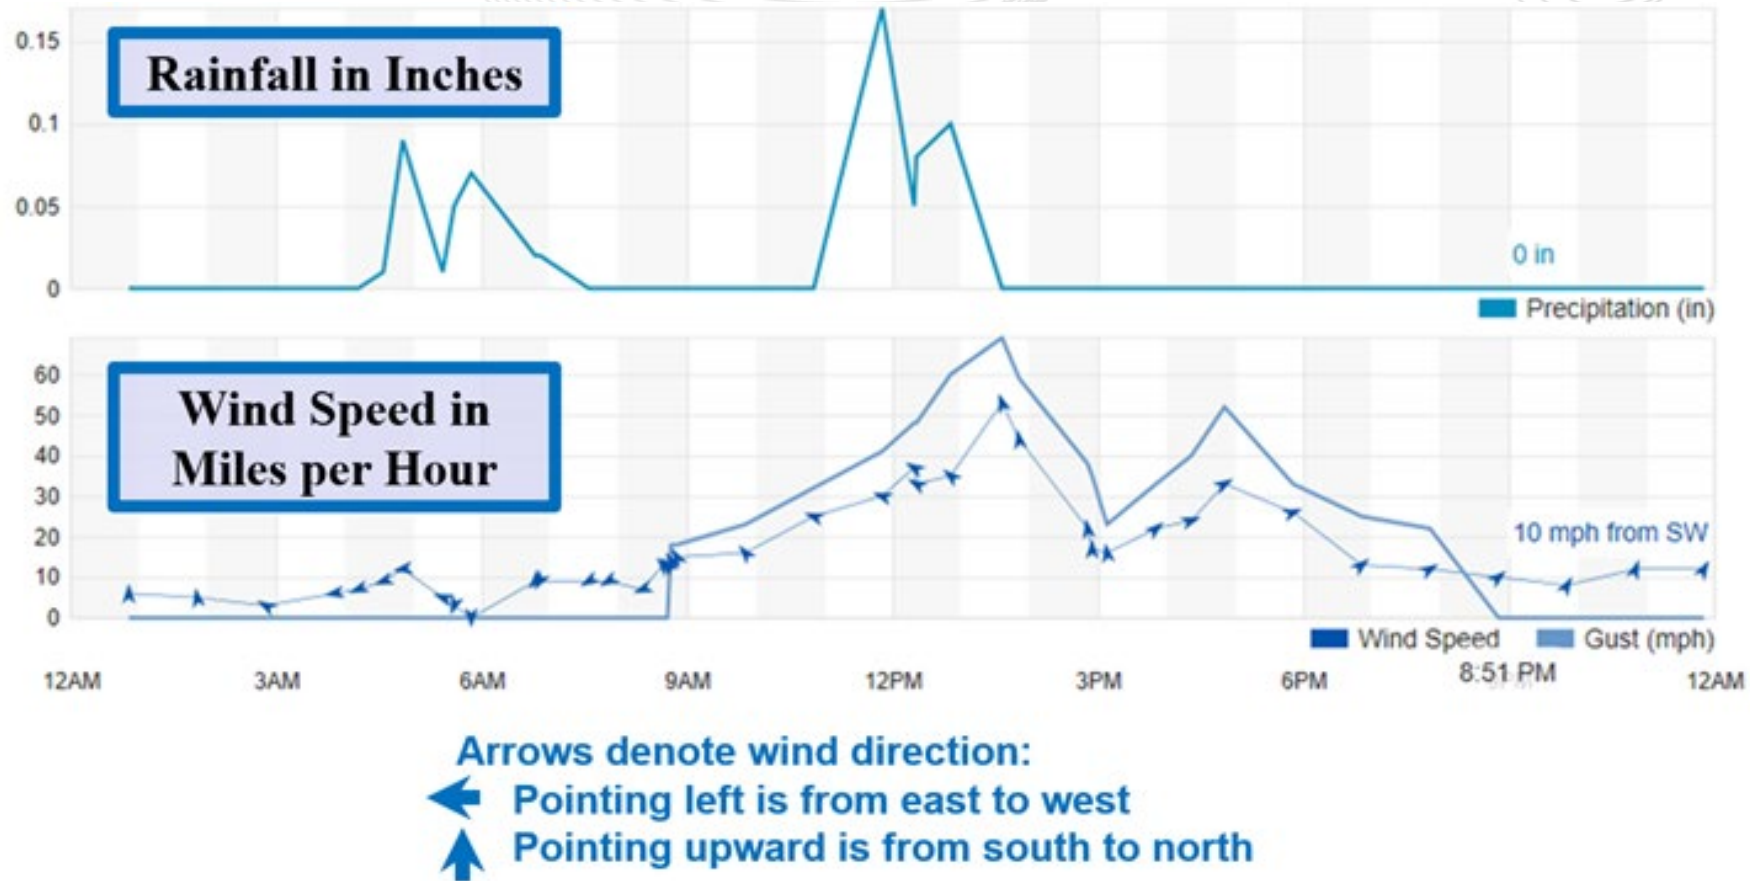
Figure 2: Rainfall, Windspeed, and Wind Direction During Tropical Storm [1]

- During inclement weather, an unusual combination of strong winds, high tide, and absence of rain can cause airborne salt spray to deposit in surfaces, leaving a dry film
- Wetting of that film during subsequent rainfall, even days later, can wreak havoc with the overall dielectric withstand capability of insulator columns
- The probability of flashovers is significantly increased where parallel columns are used as arcing on one column can jump across and meet up with arcing on the adjacent column
- The event described in this Lesson Learned was driven by a more rapid contamination process than generally considered for scheduled insulator cleanings
