Transmission Expansion Advisory Committee AEP Supplemental Project

Conesville – Bixby 345 kV

Need Number: AEP-2022-OH039

Process Stage: Need Meeting 4/12/2022

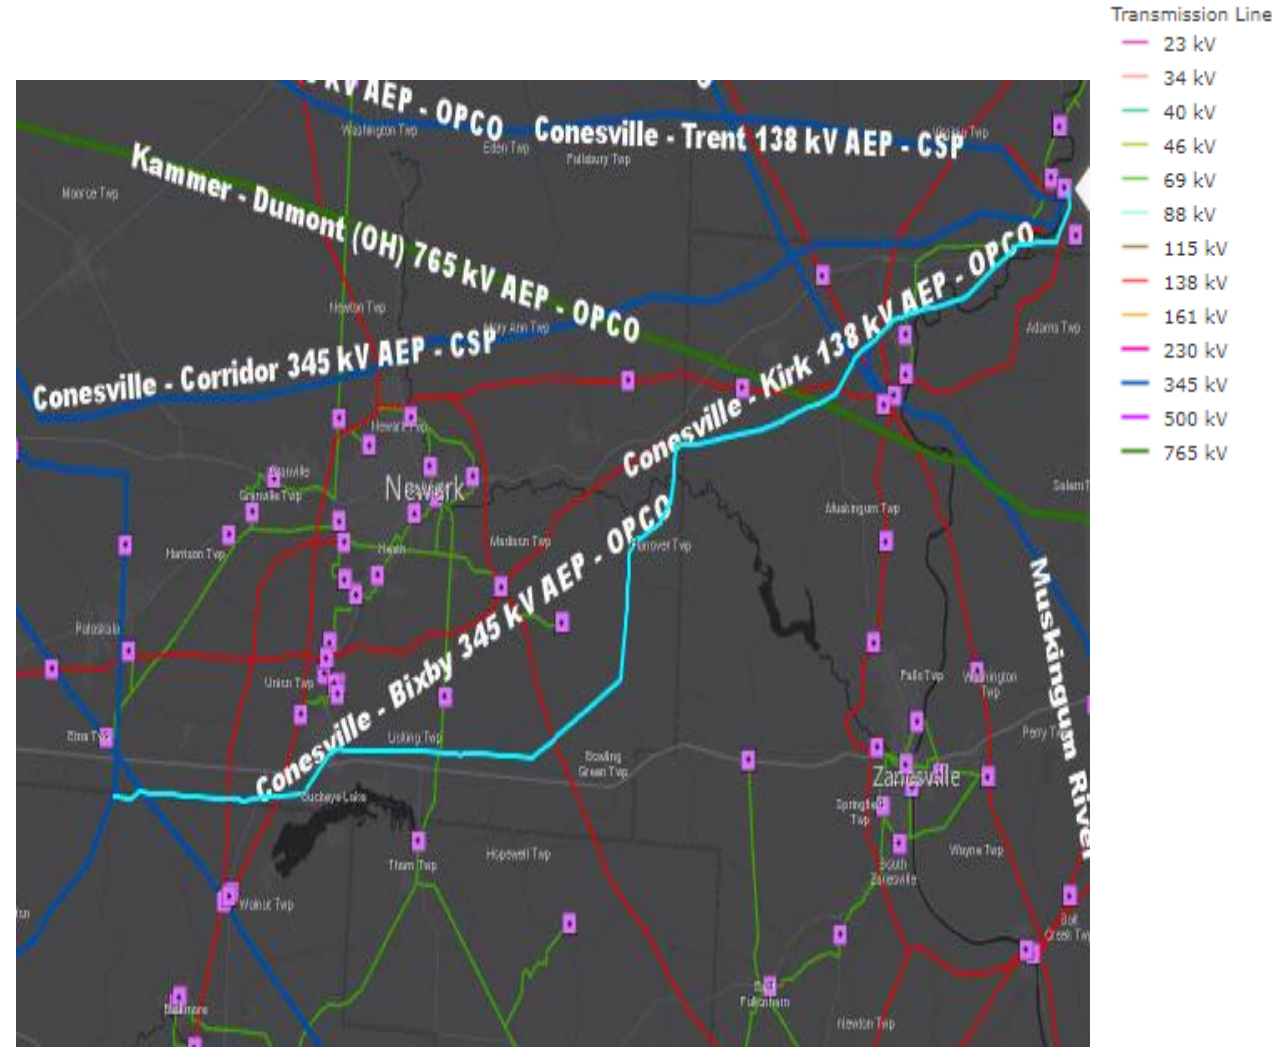
- Length of Line: 51.10 Miles
- Total Structure Count: 342
 - ~73% of the structures are wood structures from the early 1970's.
 - ~25% of the structures are steel structures installed between 2010 and 2021. Replacements were performed proactively mostly at and along major interstates
 - The remaining ~2% are steel structures installed in the early 1970's.
- Conductor Types: 954 ACSR 45/7, 954 ACSR 54/7
- Outage History: 5 Momentary and 5 Permanent outages since 2015
- Open Conditions:

There are currently 30 structure based open conditions consisting of rot heart, rot shell, broken knee/vee brace, heavy rust, broken/burnt/damaged poles, leaning transverse poles sitting in water, and woodpecker damage. There are additional concerns over delamination of crossarms on the line as detailed in the next slides.

There are currently 12 hardware based open conditions consisting of loose clamps, missing bolts, burnt, chipped and gunshot damage to insulators.

The line fails to meet current AEP structural strength requirements and utilizes inadequate shielding angles for current AEP lightning protection standards.
