First Energy (MetEd) Local Plan Submission for the 2020 RTEP

Need Number: ME-2019-039

Met-Ed Transmission Zone M-3 Process Campbelltown – Middletown – North Hershey 69 kV Line Rebuild

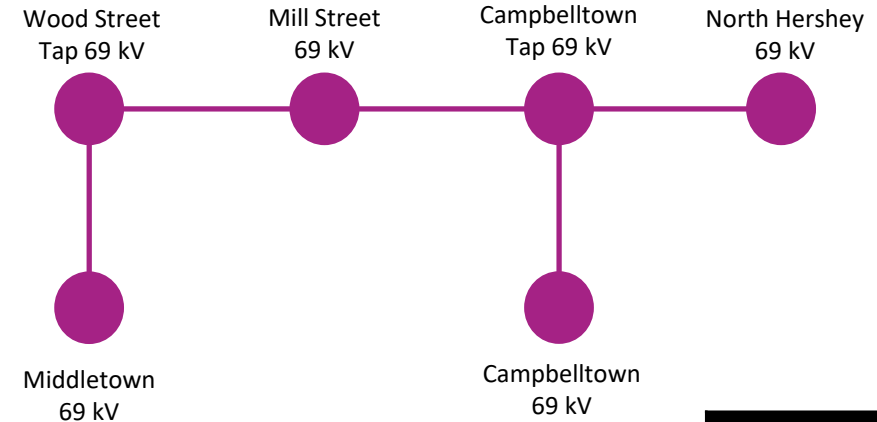
Selected Solution:

Rebuild and reconductor approximately 15.1 miles of the 19.7 mile line (s2170.1)

Replace line relaying, substation conductor, and disconnect switches (s2170.2-5)

Transmission Line Ratings:

- Middletown – Wood St Tap 69 kV Line:
 - Before Proposed Solution: 82/103 MVA (SN/SE)
 - After Proposed Solution: 139/169 MVA (SN/SE)
- Wood St Tap – Mill Street 69 kV Line:
 - Before Proposed Solution: 80/96 MVA (SN/SE)
 - After Proposed Solution: 139/169 MVA (SN/SE)
- Mill Street – Campbelltown Tap 69 kV Line:
 - Before Proposed Solution: 74/90 MVA (SN/SE)
 - After Proposed Solution: 139/169 MVA (SN/SE)
- Campbelltown Tap – North Hershey 69 kV Line:
 - Before Proposed Solution: 74/90 MVA (SN/SE)
 - After Proposed Solution: 136/169 MVA (SN/SE)
- Campbelltown – Campbelltown Tap 69 kV Line:
 - Before Proposed Solution: 71/91 MVA (SN/SE)
 - After Proposed Solution: 82/103 MVA (SN/SE)

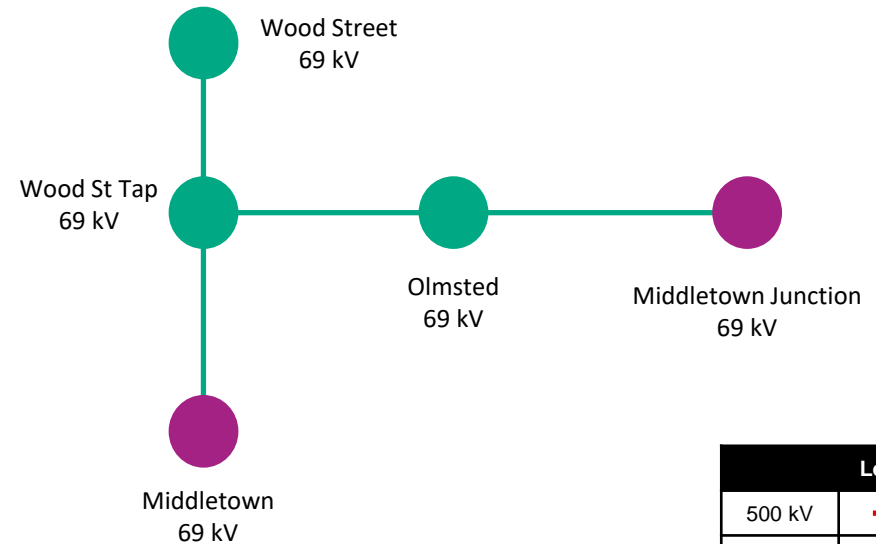
Selected Solution Solution:

Middletown Junction 69 kV substation:

- Replace circuit breaker, disconnect switches, line relaying (s2171.1)

Middletown 69 kV substation:

- Replace circuit breaker, disconnect switches, line relaying, substation conductor (s2171.2)

Transmission Line Ratings:

- Middletown Junction – Olmsted 69 kV line
 - Before Proposed Solution: 62/72 MVA (SN/SE)
 - After Proposed Solution: 62/77 MVA (SN/SE)
- Wood St Tap – Middletown 69 kV line
 - Before Proposed Solution: 51/66 MVA (SN/SE)
 - After Proposed Solution: 139/169 MVA (SN/SE)

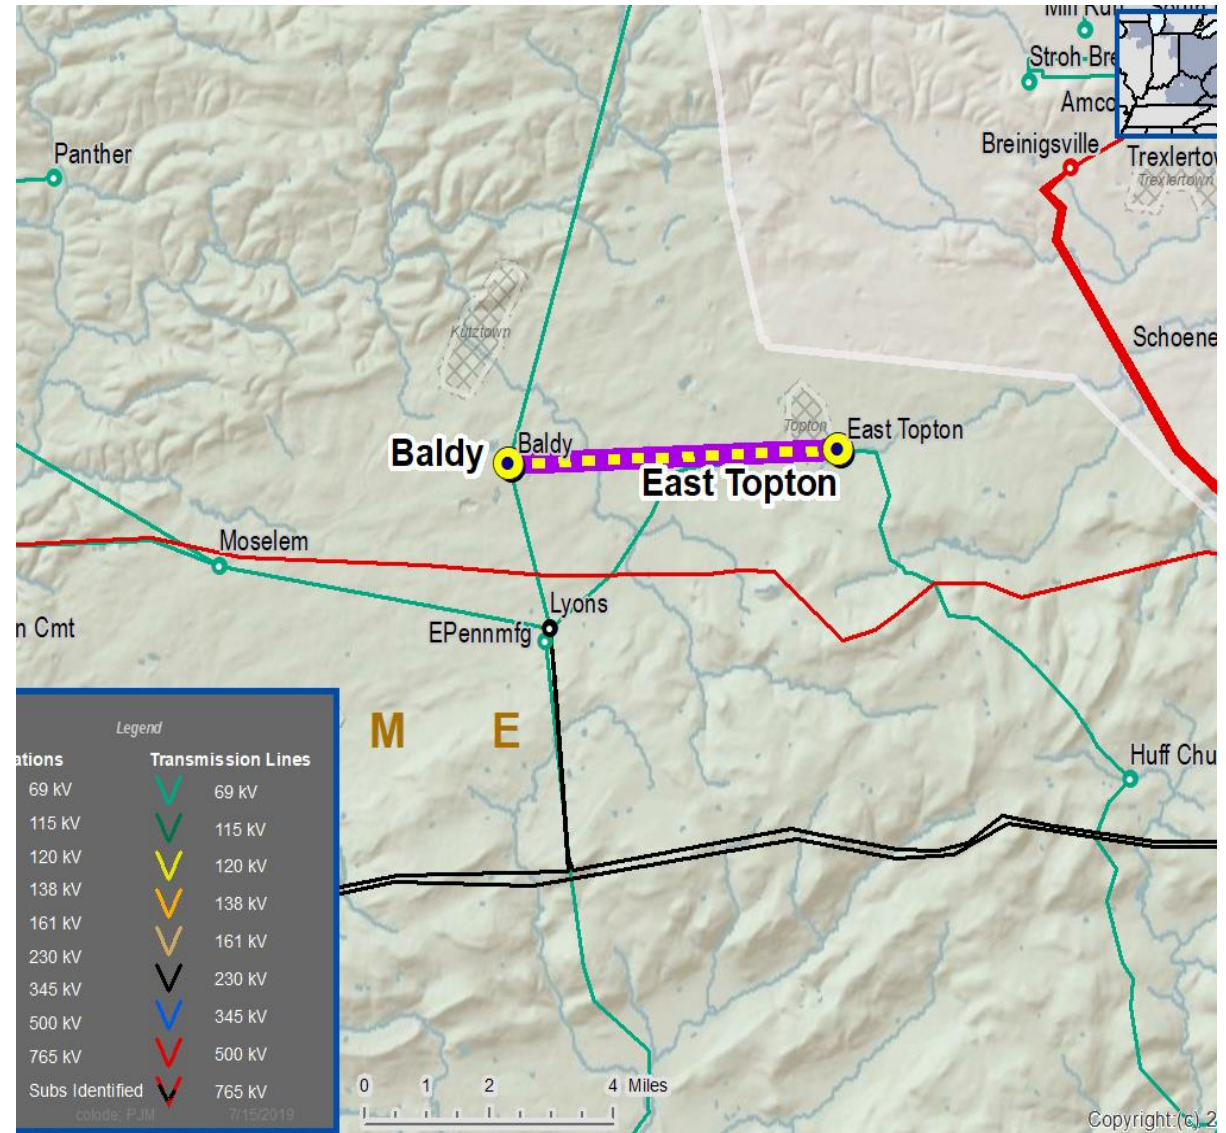
Baldy – East Tipton 69 kV line – Terminal equipment has an increased risk of failure (circuit breaker and line relaying) due to obsolescence of equipment. Limited spare parts are available.

- East Tipton circuit breaker is 40+ years old with Type U bushings and has a history of failed oil dielectric strength

Kutztown – East Tipton 69 kV line (substation conductor, line relaying)

- Existing line rating: 62/62 MVA (SN/SE)
- Existing conductor rating: 80/96 MVA (SN/SE)

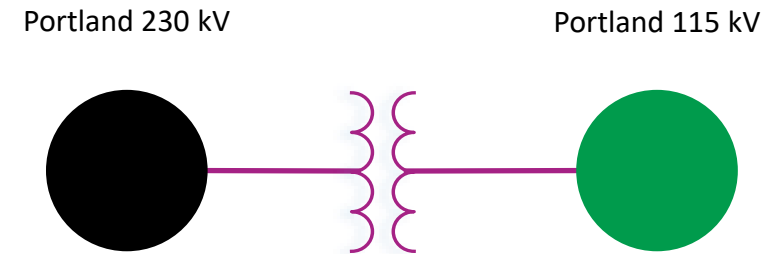
- Replace the #3 230/115 kV transformer and associated equipment with a 180/240/300 MVA transformer

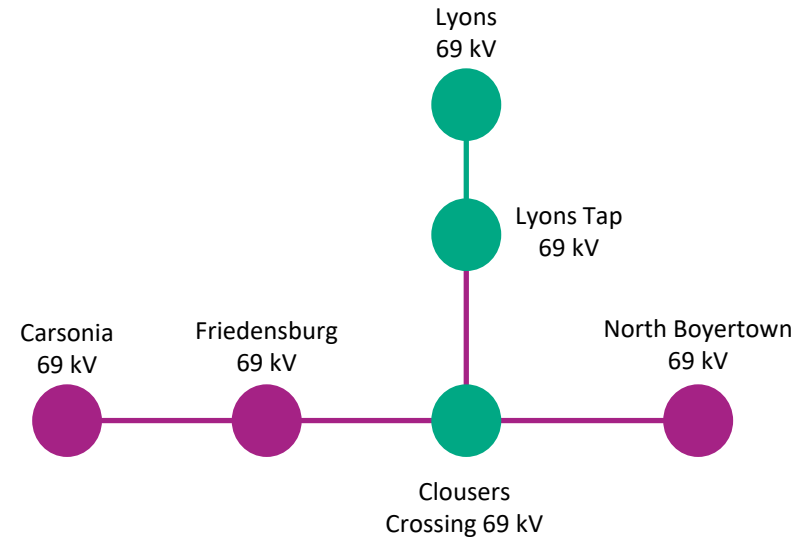
- Replace disconnect switches, substation conductor, and line relaying

- Replace disconnect switches and substation conductor

- Replace circuit breaker and disconnect switches
