Sub Regional RTEP Committee PJM West

June 26, 2018

Baseline Reliability and Supplemental Projects

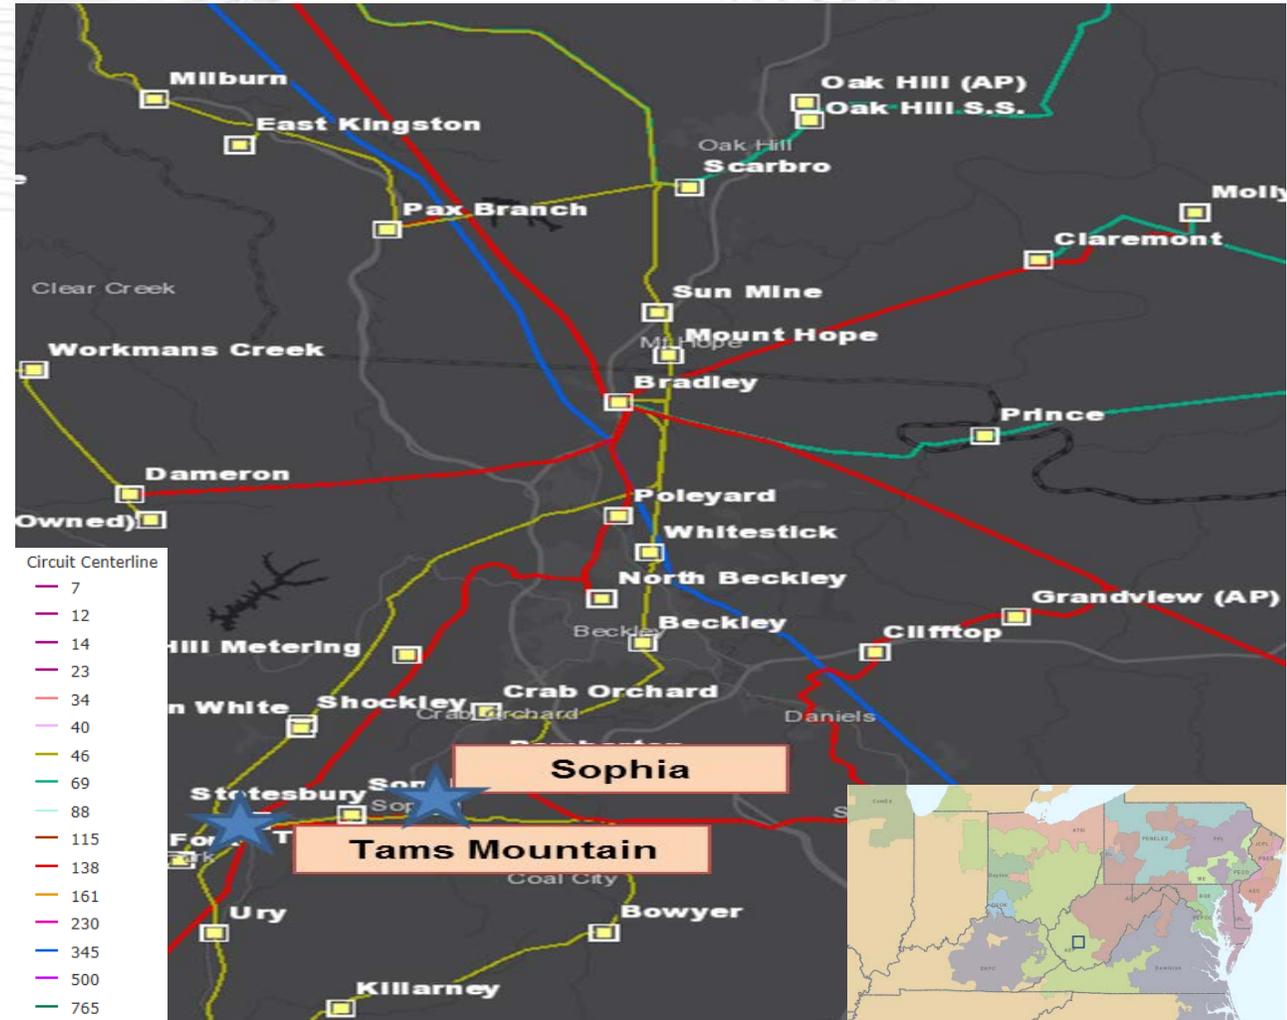
AEP Transmission Zone: Supplemental Tams Mountain Station Rebuild

Tams Mountain 46 kV circuit breakers A, B, C, D and E are all oil-filled breakers installed in 1965. In general, oil breakers are difficult to maintain. Oil spills are frequent with failures and routine maintenance which is also an environmental risk. All five 46 kV breakers have exceeded the manufacturer's expected number of 10 fault operations; A: 237 fault ops, B: 248 fault ops, C: 113 fault ops, D: 84 fault ops, E: 63 fault ops.

Tams Mountain 138/69/46 kV XFR #1 (vintage 1965) is showing rising ethane, ethylene, and methane levels. All three gas concentrations are trending upwards. Despite decreasing moisture content, the dielectric strength has continued to decline. The short circuit strength has been deteriorated by the amount of thermal through faults.

Sophia 46 kV circuit breaker C is an oil-filled breaker manufactured in 1965. In general oil breakers are difficult to maintain. Oil spills are frequent with failures and routine maintenance which is also an environmental risk. Breaker C has experienced 41 fault operations which exceeds the manufacturer's expectation of 10 fault operations.

At Tams Mtn. Station, replace all 46 kV CB's (A, B, C, D, E) with 3000 A 40 kA CB's designed to 138 kV standards in ring bus operated at 46 kV. Replace the 138 kV GR. SW. MOAB with a new circuit switcher. Retire 138 kV bus tie breaker 'F' and establish one 138 kV bus. Install two new 3000 A 40 kA 138 kV CB's on Pierpont 138 kV line and Pemberton 138 kV lines. Replace existing 138/69/46 kV 40 MVA XFR with a new 138/69/46 130 MVA XFR. Reconfigure transmission lines entering the station to accommodate new ring configuration.

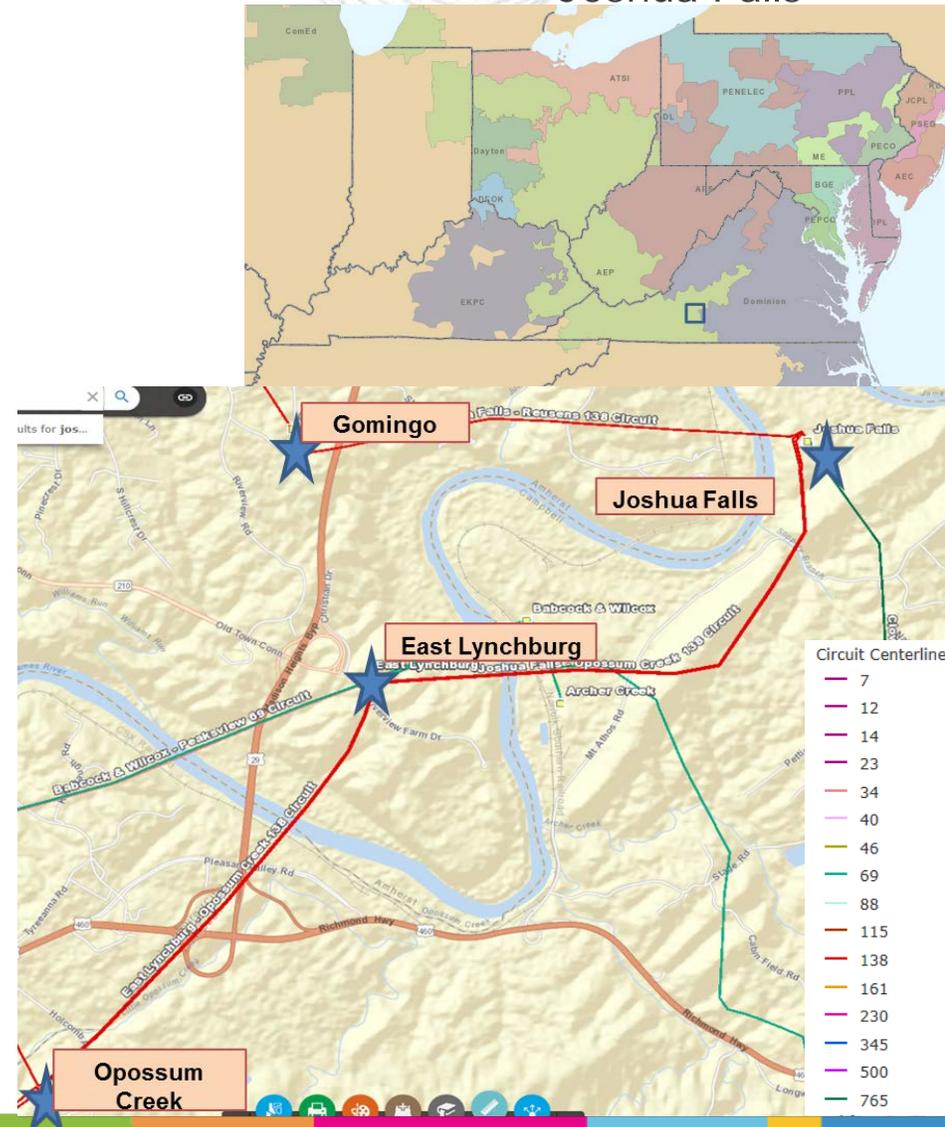
At East Lynchburg, install a new 3000 A/40 kA 138 kV circuit breaker "L" towards Opossum Creek. Replace the existing circuit breaker 3000 A/50 kA "K" with a 3000 A/40 kA 138 kV circuit breaker. Install a new 3000 A/40 kA circuit breaker "F" on the 69 kV station exit. Replace the existing 1200 A/17 kA 34.5 kV circuit breaker "A" with a 1200 A/25 kA breaker. Install a new station service transformer on the 138 kV bus and replace the existing 34.5 kV station service transformer (used for a backup). Retire capswitcher "AA" and 57.6 MVAR capacitor bank. **Estimated Cost: \$3.7M**

There are currently three dissimilar zones of protection at East Lynchburg station: 138 kV Opossum Cr. line, 138/69/34.5 kV XF #1, and the 69 kV Babcock & Wilcox line. This configuration can lead to misoperations and over tripping.

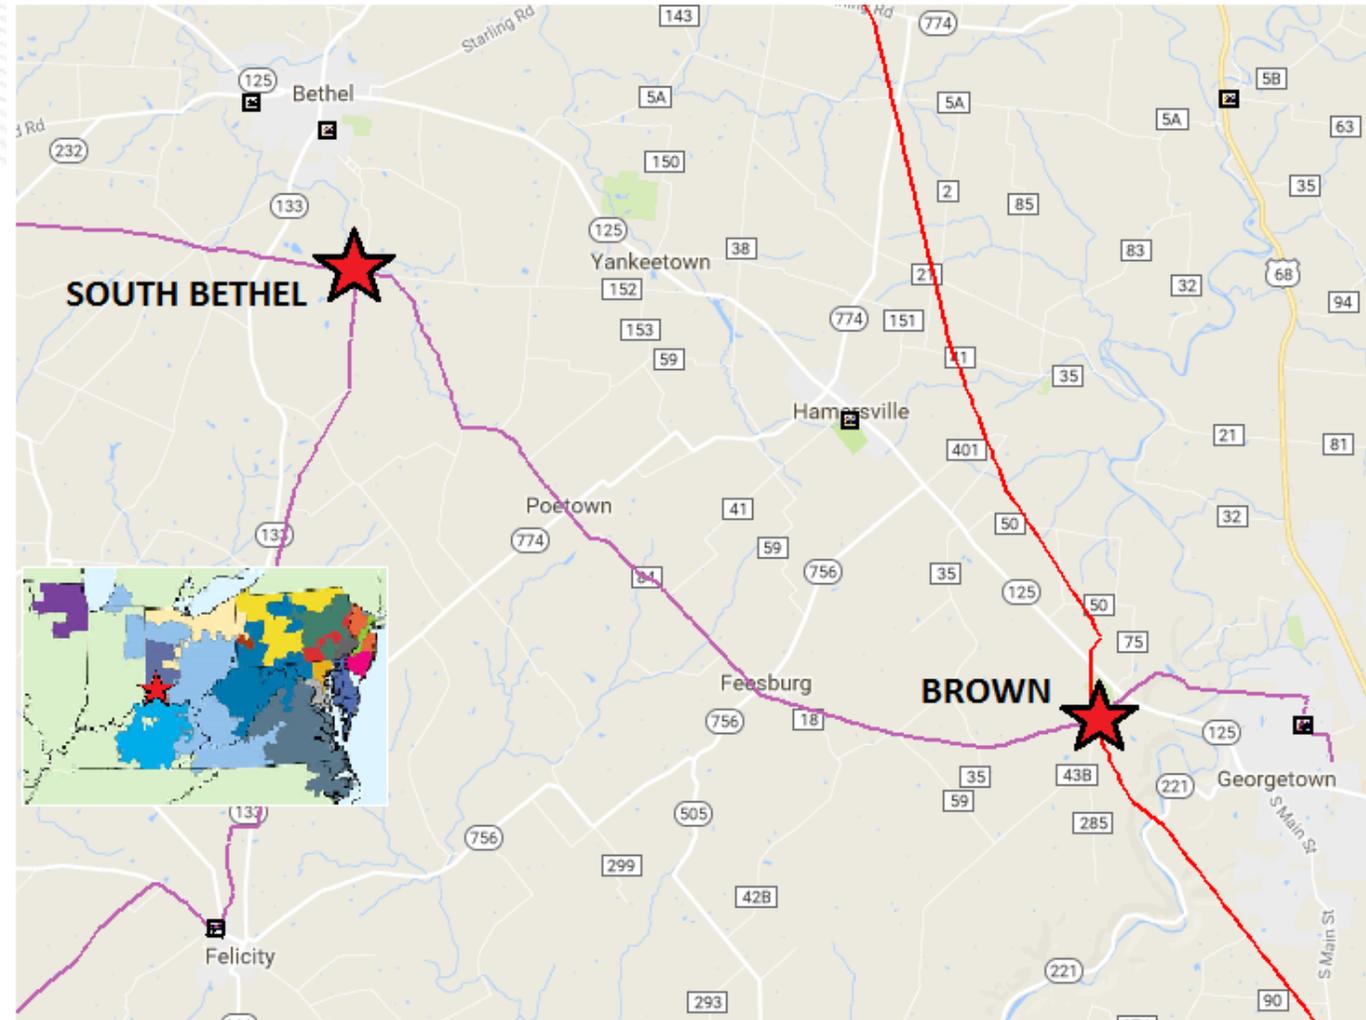
The 69 kV feeder between South Bethel and Brown substations is aged and in deteriorating condition (1970's era).

Rebuild 9.8 miles of feeder between South Bethel and Brown substations with new structures, hardware, and conductor. Replace one 69 kV switch. Capacity of the line will increase from 97 MVA to 150 MVA (conductor limited).
