SRRTEP Committee Western AEP Supplemental Projects

July 24, 2019

AEP Transmission Zone M-3 Process Fayette County, WV

Need Number: AEP-2019-AP023

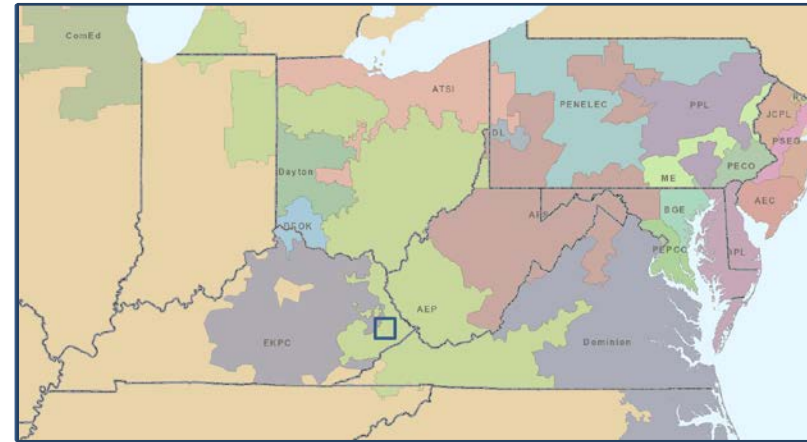
Need Number: AEP-2019-AP025

- The existing Allen station has historically experienced severe flooding due to the stations current location in the flood plain. Historical flooding issues have lead to significant deterioration of the stations foundations and structures.

- The 46 kV Circuit Breakers (CBs) A, B, C, & D are oil filled breakers without oil containment manufactured in 1960s. Oil filled breakers have much more maintenance required due to oil handling that their modern, SF6 counterparts do not require. These units comprise 4 of the remaining 12 of the FZO-69-1500P model family on the AEP System. Spare parts for these units are difficult to impossible to procure, and this model type is no longer vendor supported.

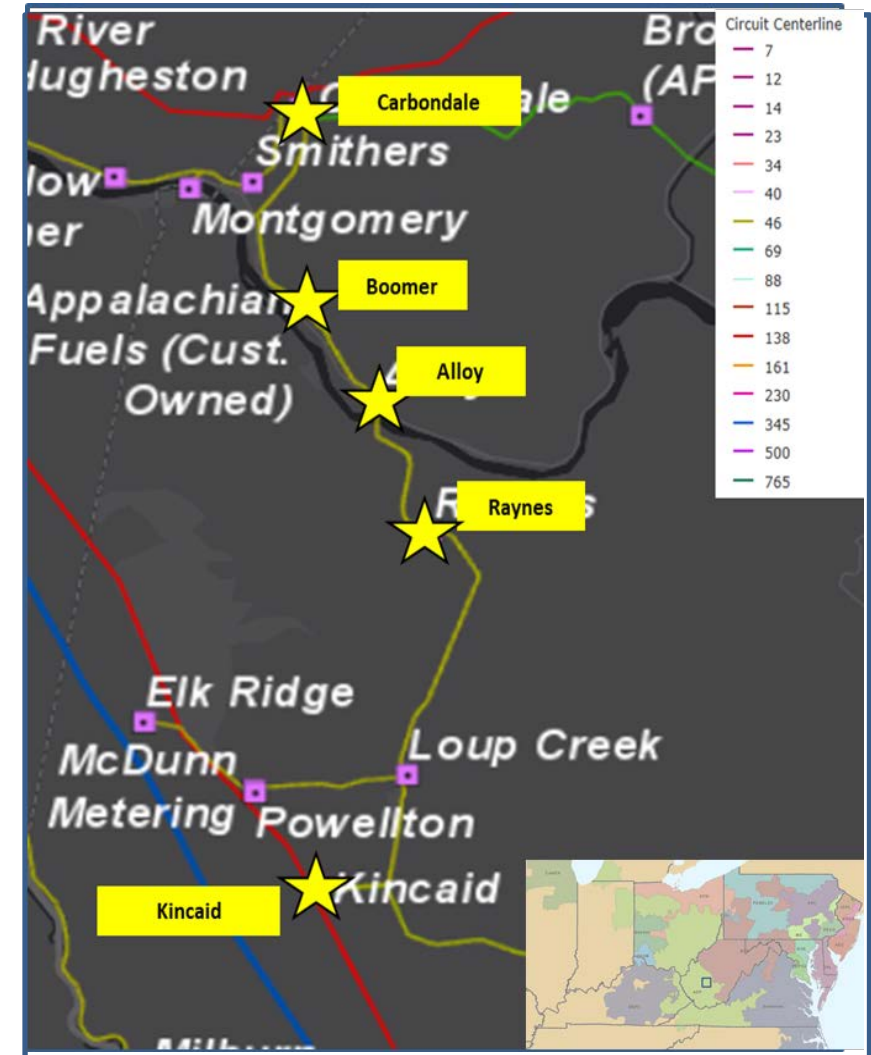
Need Number: AEP-2019-AP026

Carbondale – Kincaid 46 kV #1 (~14.8 miles)

- Majority of the circuit is constructed with 1950s wood and lattice structures
- The conductor is greater than 65 years old. Grounding on this line does not meet current standards.
- Between 2015-2018 the circuit experienced 16 momentary and 6 permanent outage resulting in approximately 140k customer minutes of interruption

Carbondale – Kincaid 46 kV #2 (~18.6 miles)

- Majority of the circuit is constructed with 1950s wood and lattice structures
- The conductor is greater than 65 years old. Grounding on this line does not meet current standards.
- From 2015-2018 the circuit has experienced 16 momentary and 7 permanent outages resulting in approximately 390k customer minutes of interruption

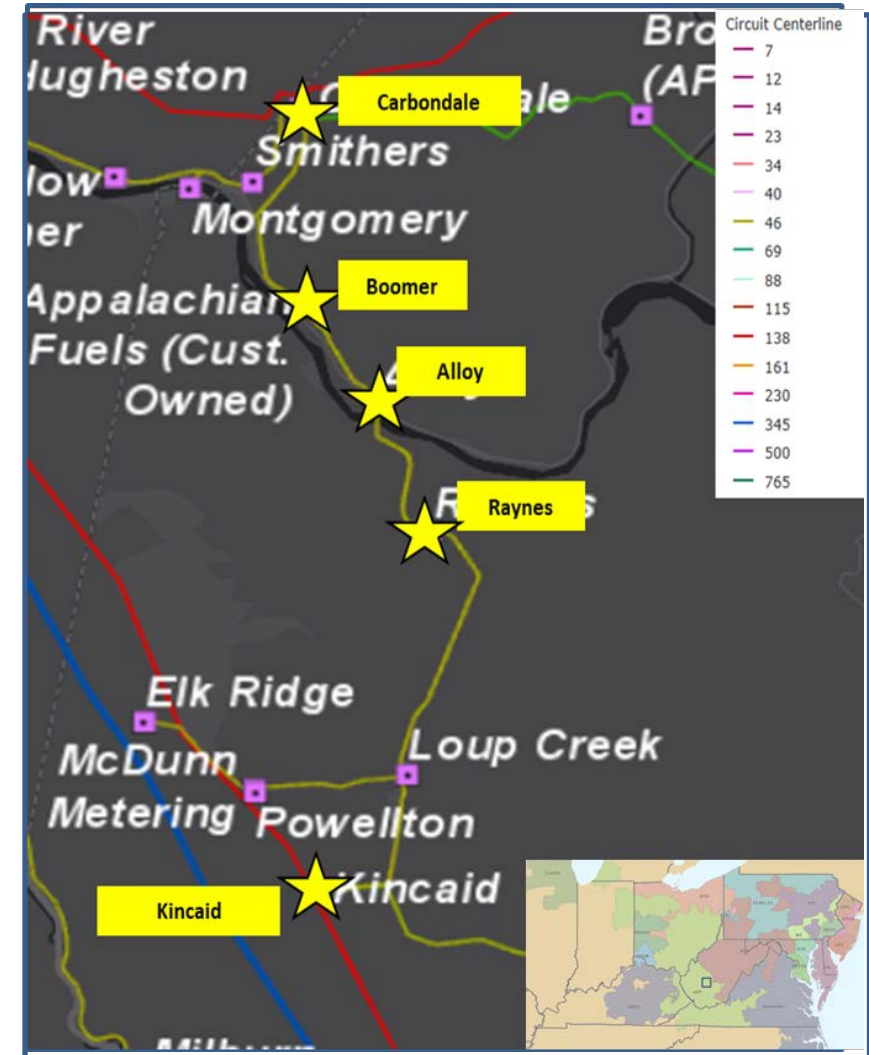
Carbondale 138/69/46 kV Station

- 46 kV and 69 kV CBs A, B, C, D, F and G are all 1968, CF-48-69-2500 type breakers.
 - Spare parts for these units are difficult to impossible to obtain, and this model type is no longer vendor supported

- Carbondale 138/69/46 kV transformer TR-1, manufactured in 1972, has experienced a sharp increase in combustible gas concentrations in January 2016.
 - Numerous gasses have remained at elevated levels, including acetylene at IEEE Condition 4 and ethylene at IEEE Condition 2.

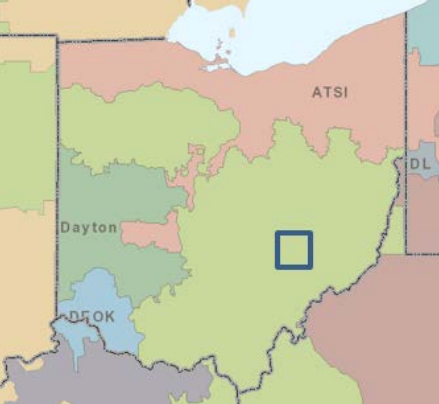
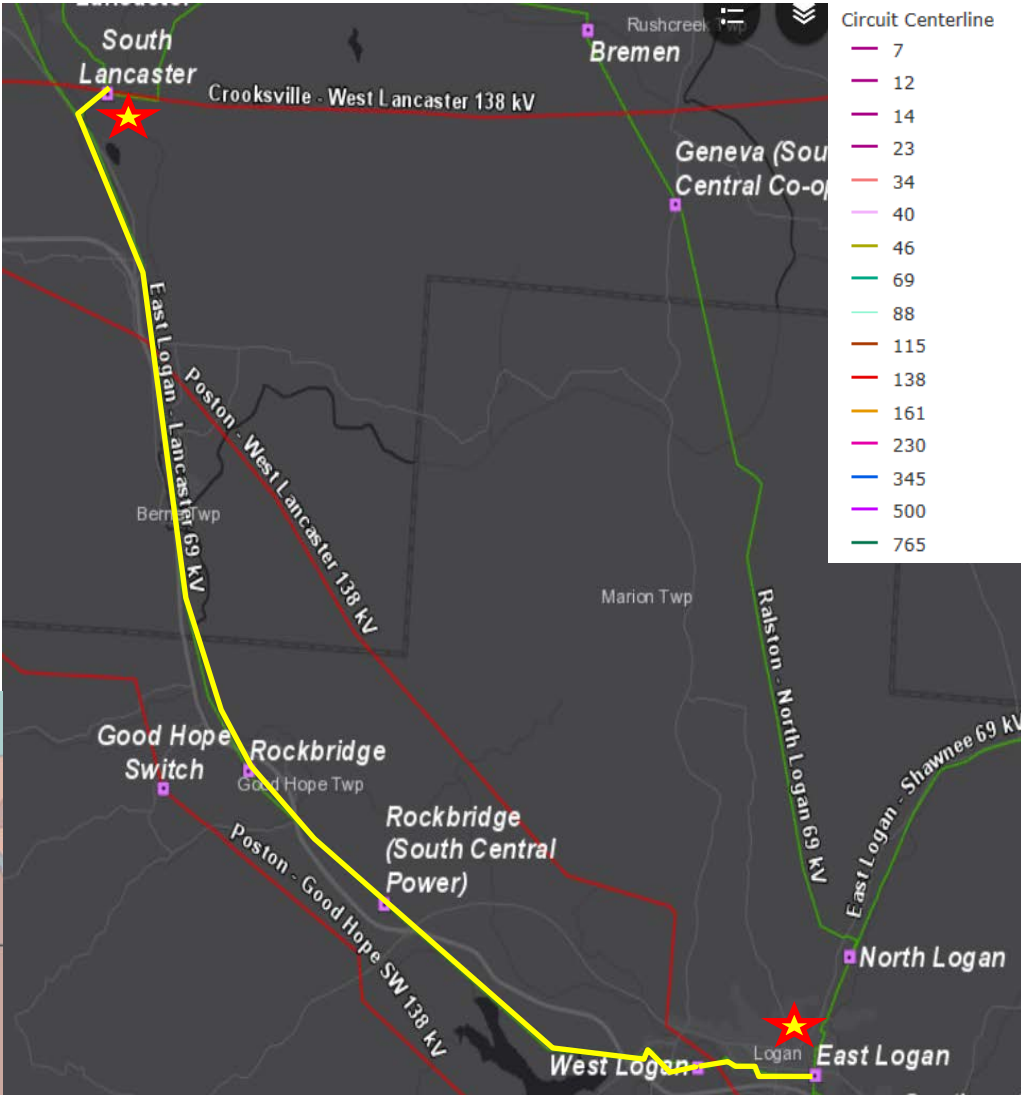
Need Number: AEP-2019-OH042

- Length: 16.43 Miles
- Original Construction Type: Steel Lattice/Wood
- Original Conductor Type: 2/0 Copper
- Momentary/Permanent Outages: 43 total outages
- CMI: 872,607 in the last 3 years
- Number of open conditions: 40
 - Open conditions include: Burnt/broken insulators, pole rot, insect damage, damaged conductor

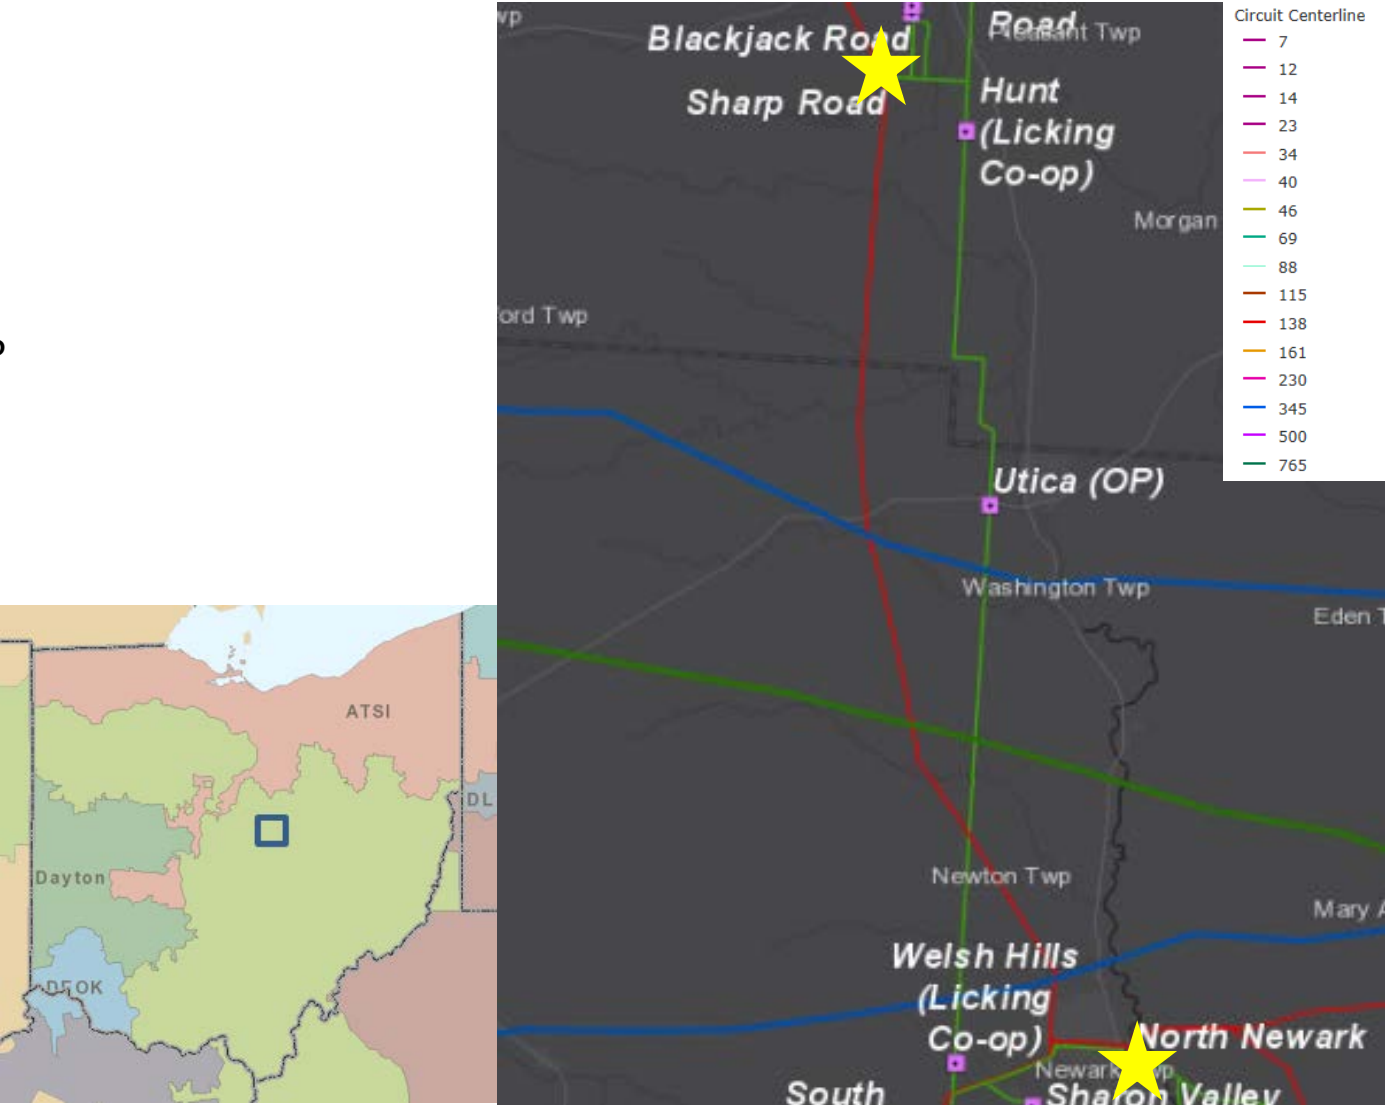
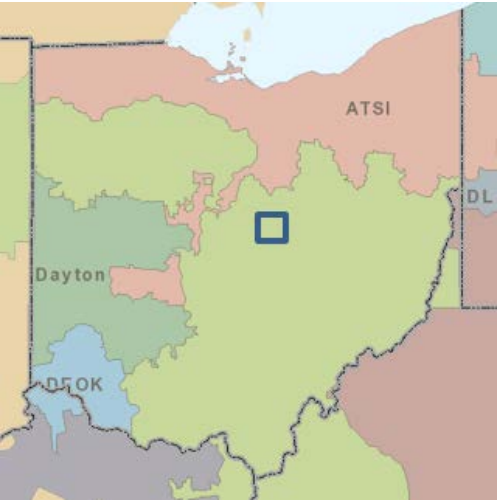
Need Number: AEP-2019-OH43

- Length: 19.38 Miles
- Original Construction Type: Wood Pole
- Original Conductor Type: 477 kcmil Hawk
- Number of open conditions: 68
 - Open conditions include: Burnt insulators, insect damage, pole rot, woodpecker damage

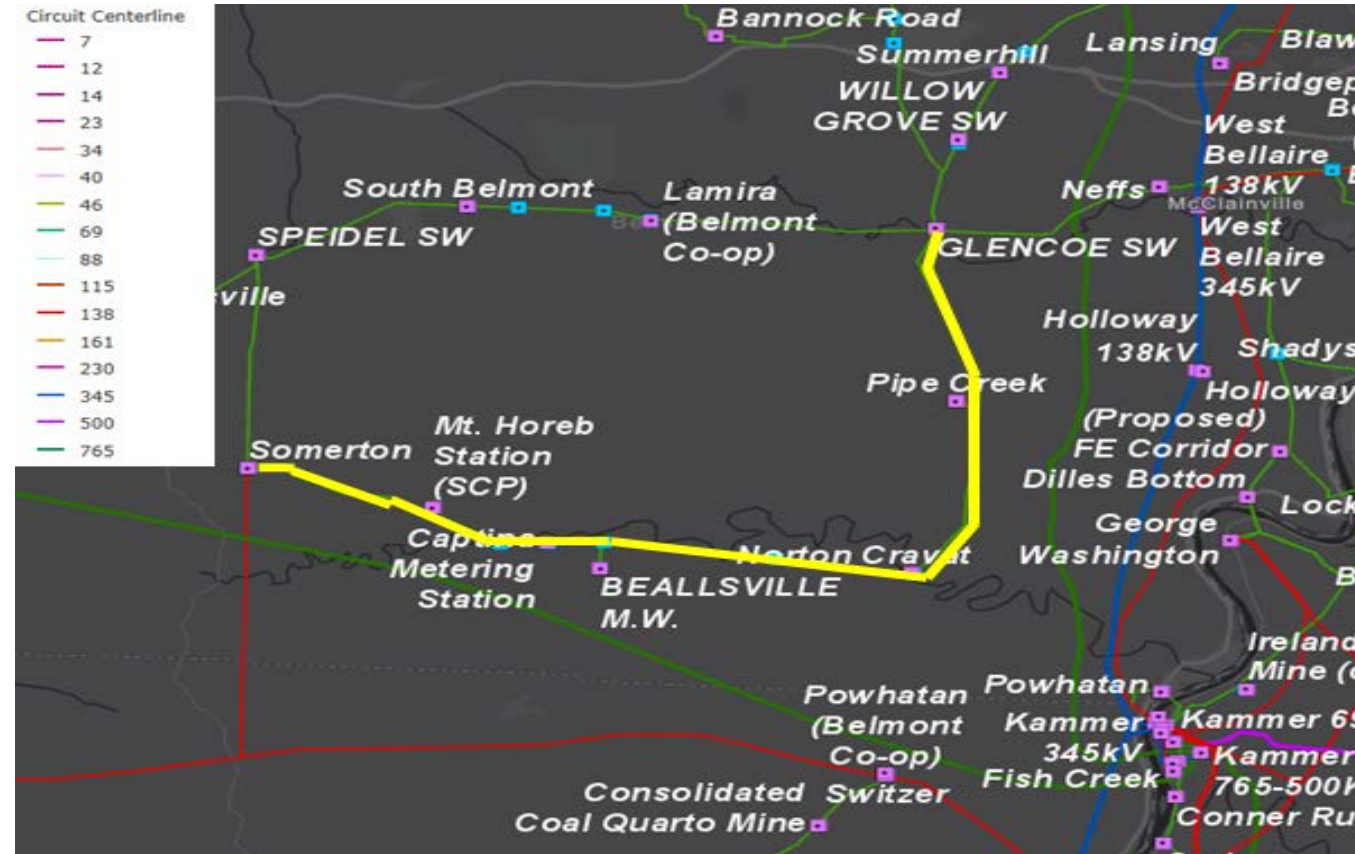
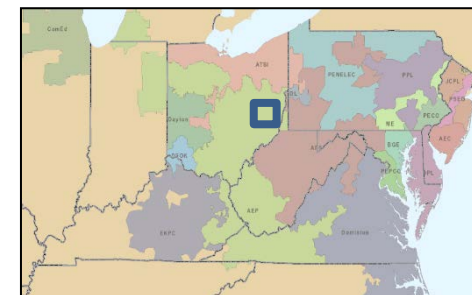
- The Glencoe-Somerton 69 kV circuit is 22.5 miles in length and has numerous condition issues. Within the last 5 years, it has experienced 18 momentary outages (3.6 per year) and 7 permanent (sustained) outages (1.4 per year). The average outage duration has been 13.7 hours. AEP and South Central Power Co-op customers served from this circuit suffered nearly 3.5 million minutes of customer interruption (CMI) during the 2015-2018 timeframe.

- The circuit currently has 148 open conditions (43 structural, 23 on conductor, 5 for shielding/grounding, 24 for hardware, and 53 for forestry/ROW). The majority of the wood poles were installed in 1953 and 1970 (84% of circuit length). The conductor was also primarily installed in 1953 (219 kcmil ACSR) and 1970 (336 kcmil ACSR). The majority of the outage causes have been attributed to T-Line condition issues.

- The two 69 kV delivery points for South Central Power Co-op's Beallsville and Pipe Creek stations are connected via hard taps (no sectionalizing switches present). This requires an outage to the customer whenever maintenance or emergency repairs must be done on either side of the customer tap.

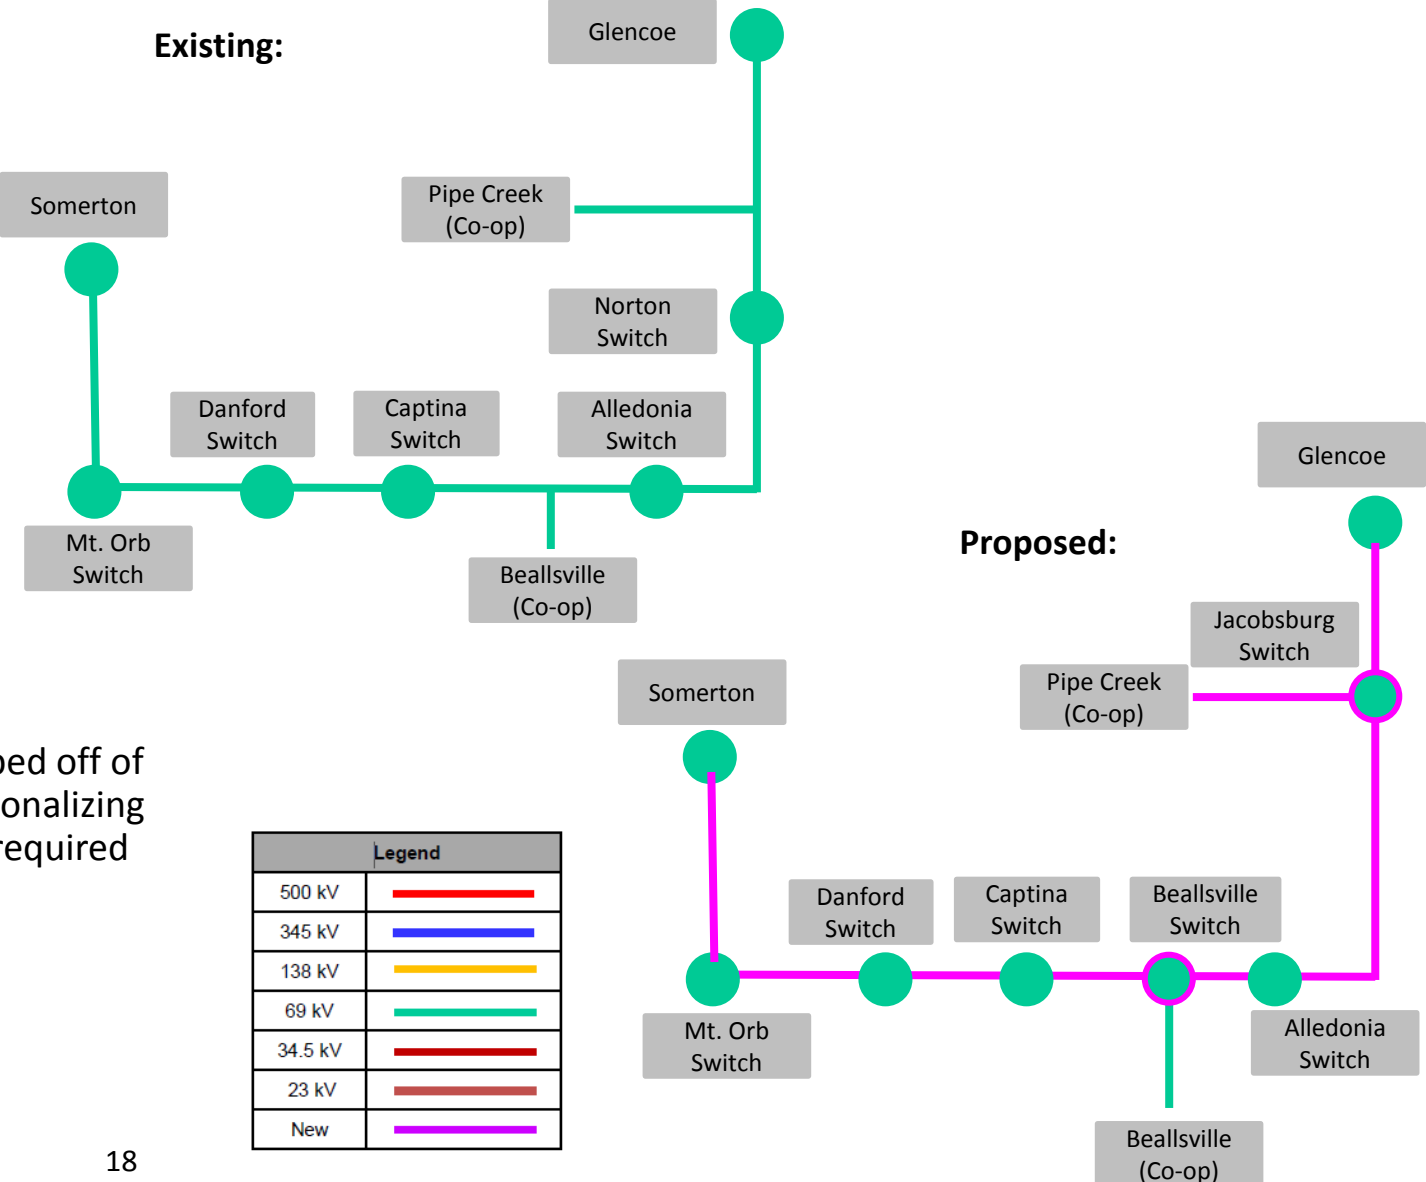
Need Number: AEP-2019-OH001

Replace the Pipe Creek hard tap with a 1200 A-rated 3-way switch (Jacobsburg Switch).

Replace the Beallsville hard tap with a 1200 A-rated 3-way switch (Beallsville Switch).
