Sub Regional RTEP Committee: Western DAYTON Supplemental Projects

April 20, 2020

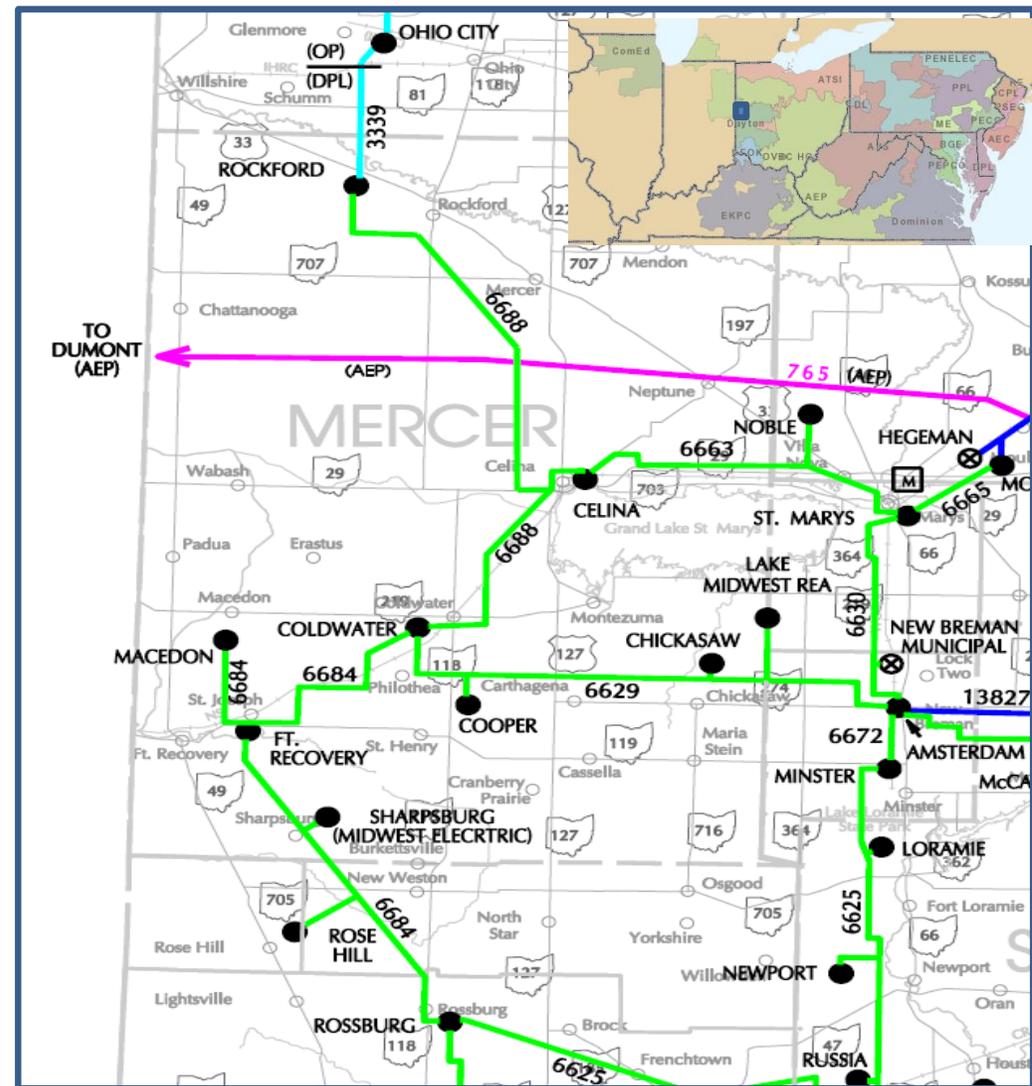
- DP&L provides 69kV service to the City of Celina from a very small 69kV switching station. This legacy design has a single point of failure that has become problematic for equipment maintenance and outages.

- The peak load for the City of Celina is ~43 MW.
 - A bus or line fault on Celina's system interrupts both of the 69kV deliveries to Celina.
 - Due to the size of the switching station, there is very limited ability to expand or improve the configuration.

—	= 345kV
—	= 138kV
—	= 69kV

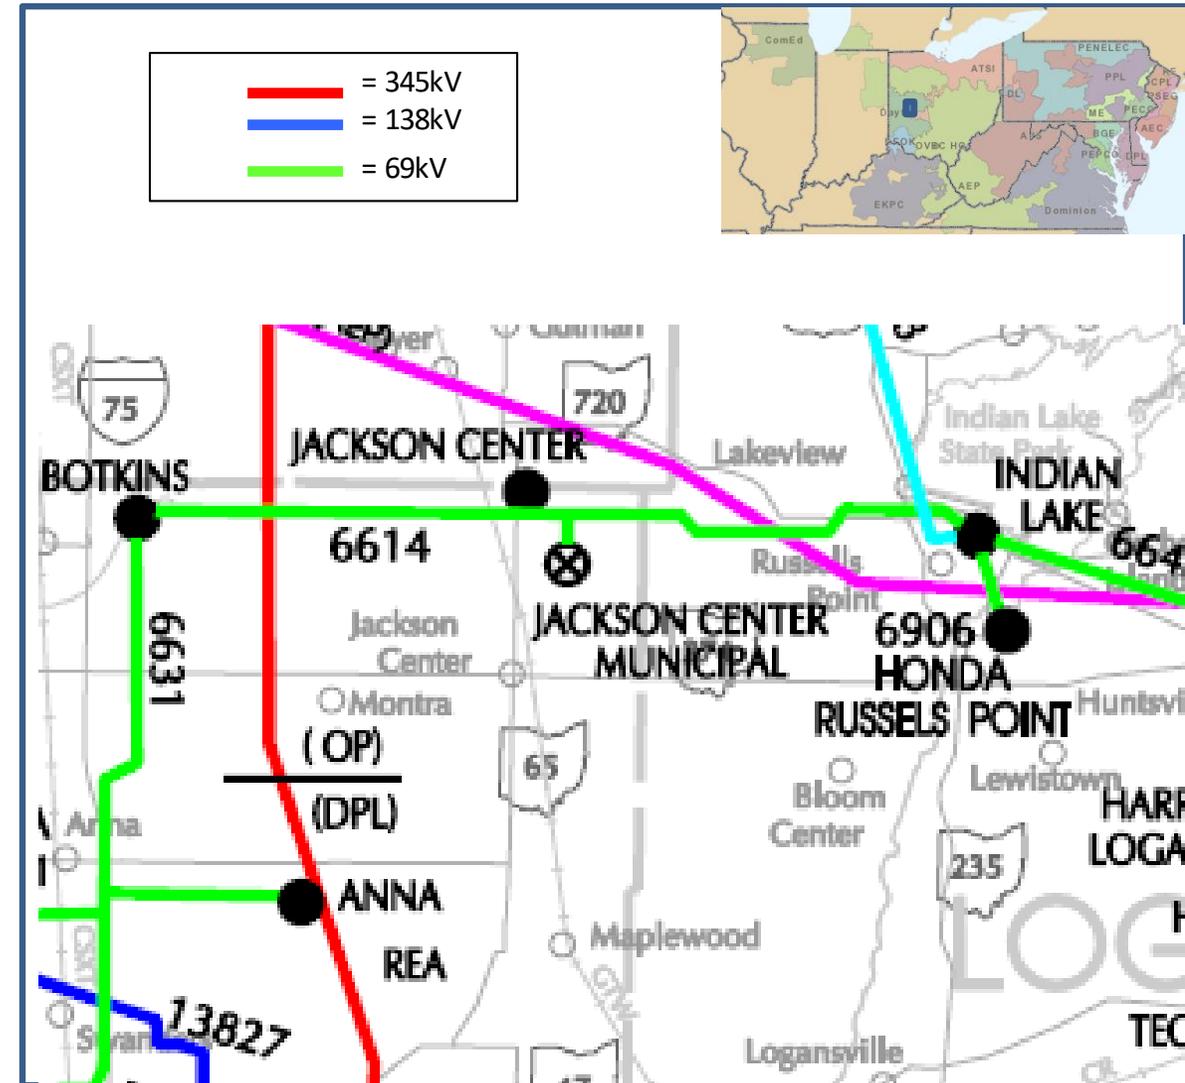
- The Village of Jackson Center is planning to add load and has constructed a second substation. The Jackson Center Municipal load is currently tapped off the Jackson Center-Indian Lake 6614 69kV transmission line in the northern part of Dayton's service territory.

- The Jackson Center-Indian Lake 69kV transmission line is approximately 13 miles long and was constructed in 1955 with wood poles and crossarm design, which is prone to weather related outages.

- This line has experienced 3 permanent outages and 3 momentary outages since 2016, with the majority of causes being equipment failure (static wire, breaker, phase down). A line fault results in an outage to the entire Village with no ability to transfer load.

- The point of interconnection for Jackson Center municipal is only 575 feet from Dayton's Jackson Center Substation. There is a switch that can be operated to sectionalize the line towards Indian Lake.

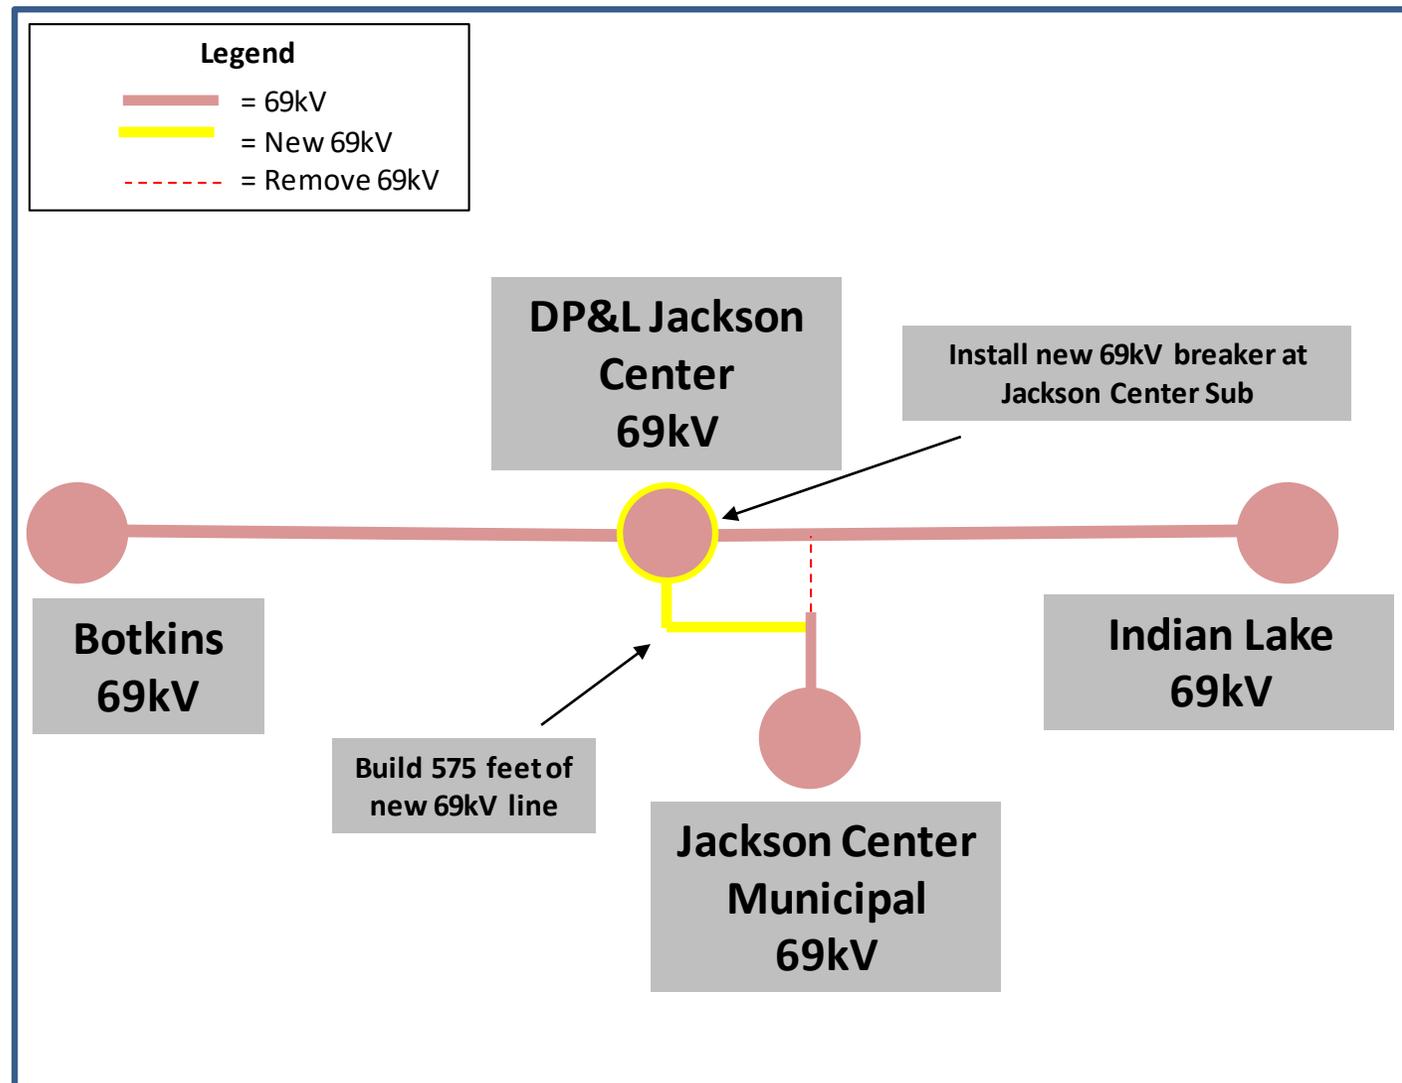
The solution to address this need will be to install a single 69kV circuit breaker at DP&L's Jackson Center Substation and bring the 69kV transmission line to Jackson Center Municipal into a breaker position at the DP&L Jackson Center Substation.

- This will reduce exposure as the Jackson Center Municipal load moves into a breaker position and the village will no longer experience outages from a fault on DP&L's Jackson Center to Indian Lake 69kV line.
- This configuration change will also help reduce overall system exposure and improve performance since the 69kV line supplying service to Jackson Center Municipal's two substations will add no additional exposure on DP&L's Jackson Center-Indian Lake 69kV line.

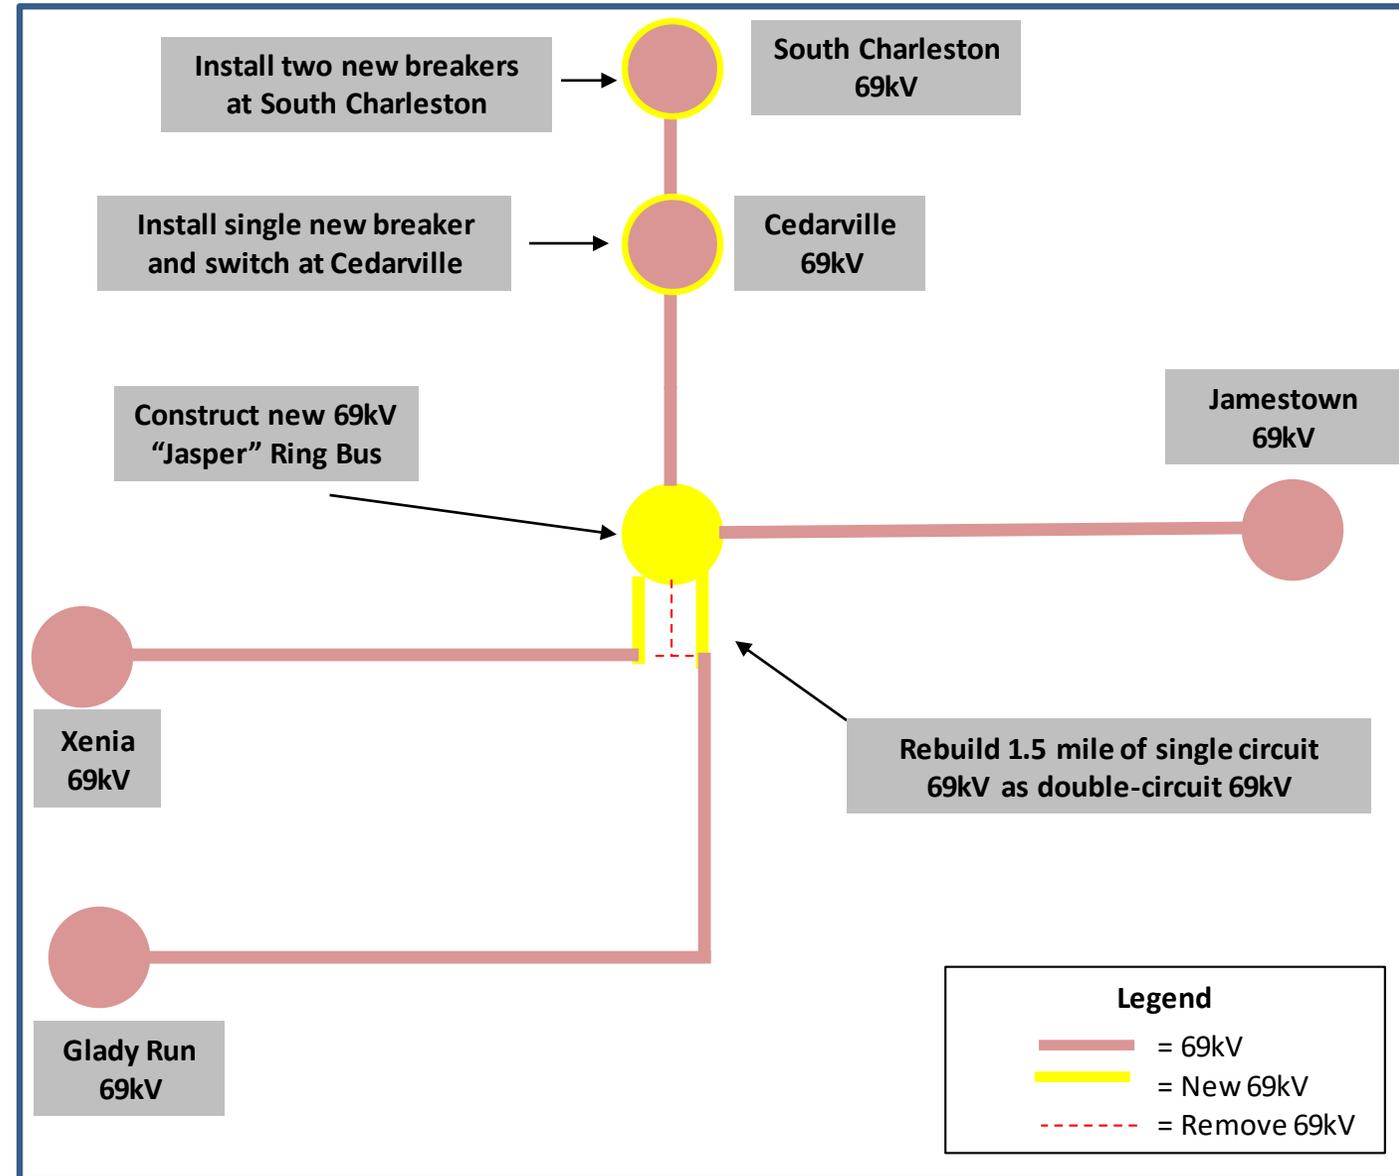
- The existing 32 mile 69kV transmission line (6636) from Xenia-Glady Run-Jamestown was constructed using wood pole, cross-arm and brace design in 1929, with some replacements made in 1951. This line provides transmission and distribution level service to five different substations serving approximately 8,000 customers in both Greene and Clark Counties in Ohio.

- A fault occurring anywhere on this 32 mile line will result in at least a temporary outage and possibly a permanent outage to 6 distribution transformers and all 8,000 customers served from the 6636 line.

- This is a three-terminal transmission line which causes protection and control concerns

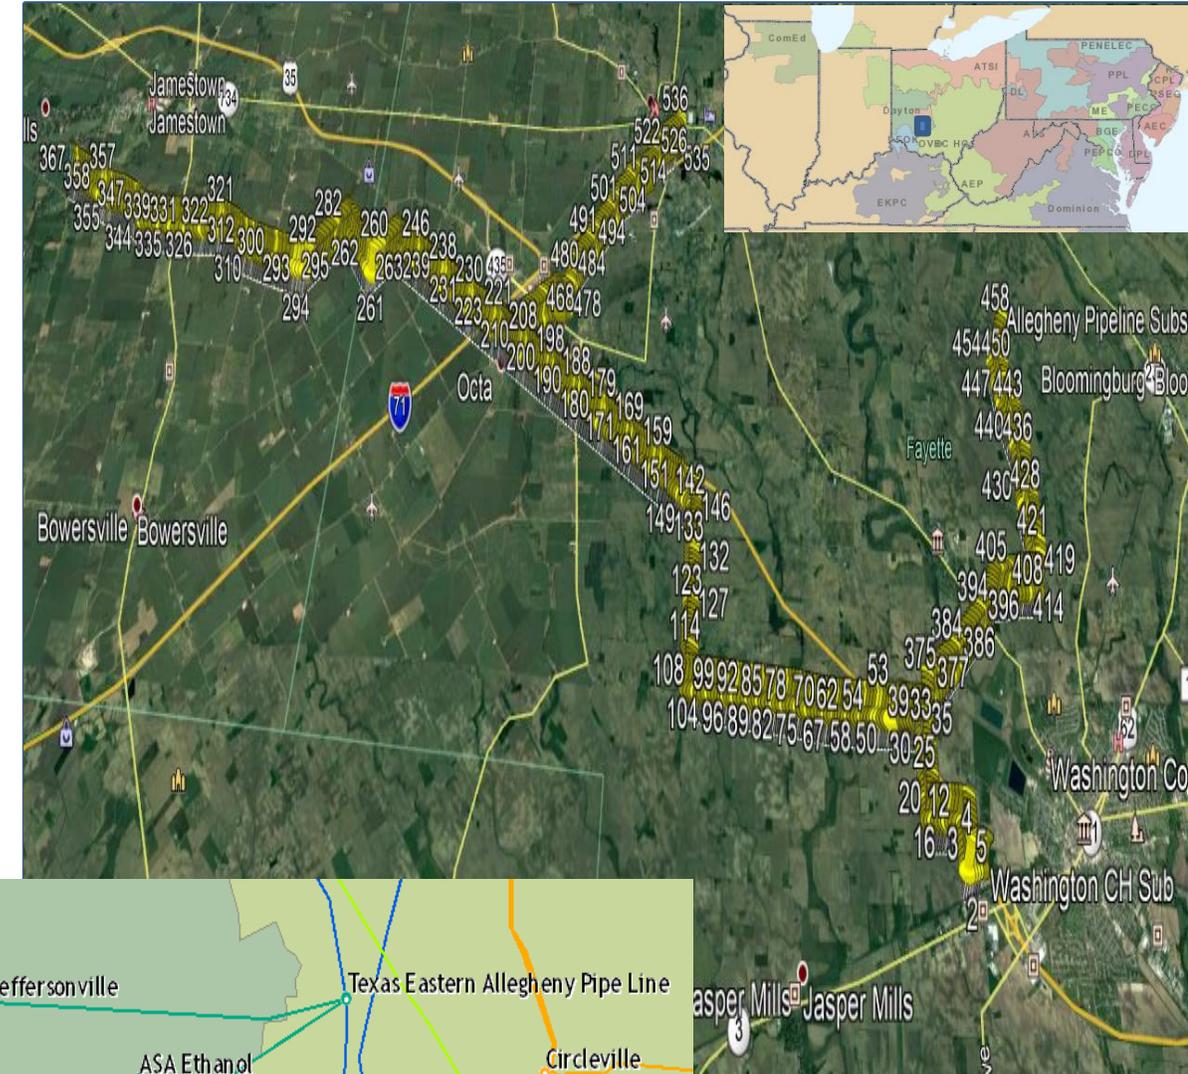
- A fault occurring anywhere on this 31 mile line will result in at least a temporary outage and possibly a permanent outage to all 3,800 customers.
- This line is one of the worst performing 69kV transmission lines in the Dayton zone. The line has experienced 25 outages (7 permanent and 18 momentary) since 2016, and the total duration of those outages was ~1,719 minutes. Most of the permanent outages were caused by crossarm issues while most of the momentary outages were the result of weather.

- Large commercial and industrial distribution customers served from the three substations supplied by the 6902 line have experienced loss of supply events emanating predominantly from disturbances on the 6902 line.

- There are limited distribution switching capabilities out of Jeffersonville Sub since there are no nearby distribution substations located close to the load center.

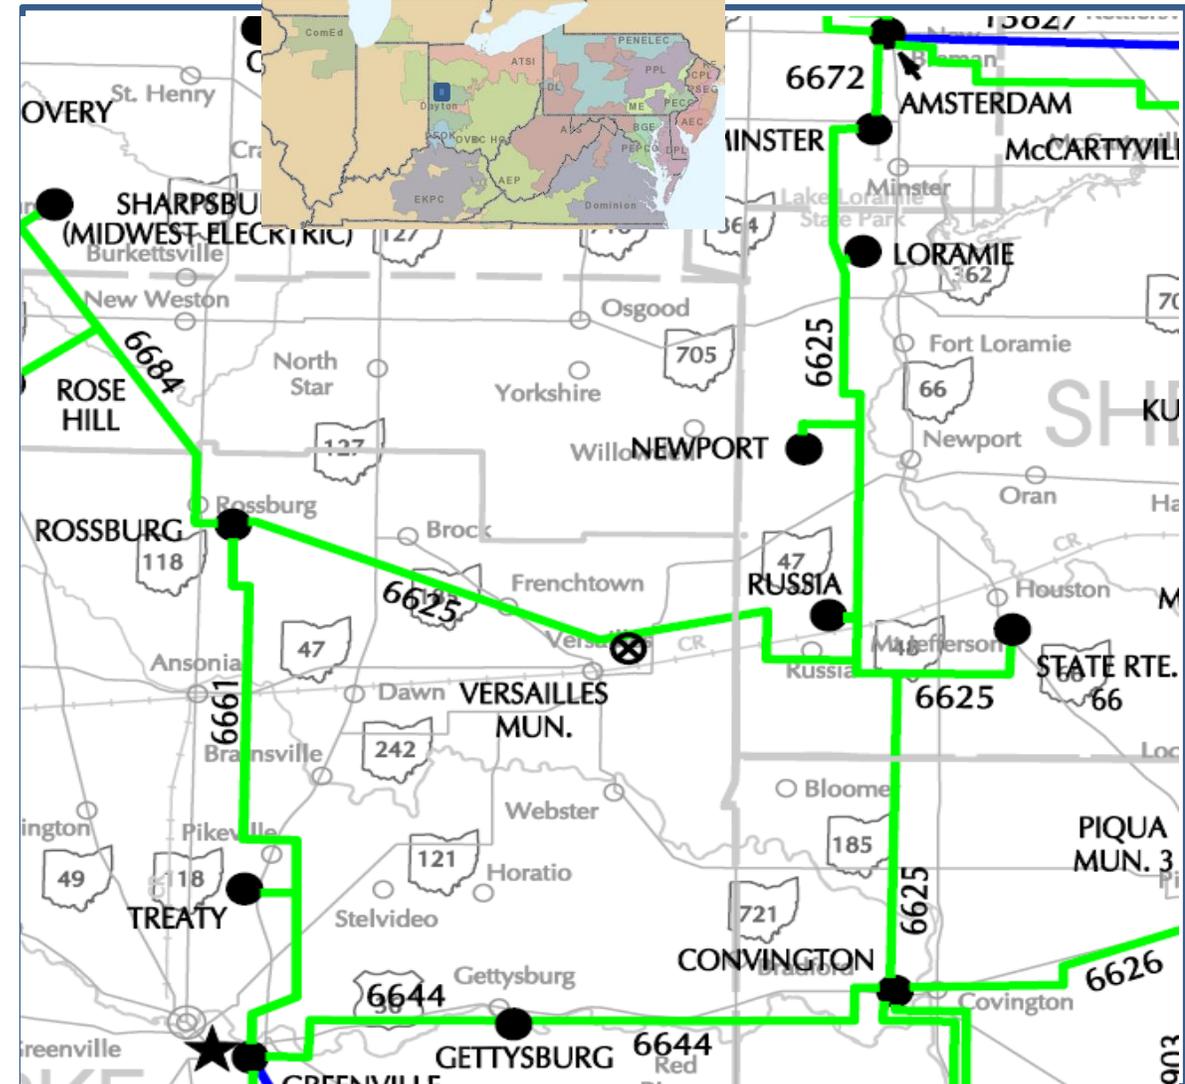
- This line is one of the worst performing 69kV transmission lines in the Dayton zone. The line has experienced 30 outages (5 permanent and 25 momentary) since 2016, and the total duration of those outages is ~3700 minutes. Most of the permanent outages have been caused by equipment related issues while most of the momentary outages have been the result of weather.

- This is a three-terminal transmission line which causes protection and control concerns which could lead to possible misoperation. There are existing sectionalizing switches to help reduce outage time but the switches have not operated reliably during outage conditions and will need addressed.
