SRRTEP Committee: Western AEP Supplemental Projects

July 17, 2020

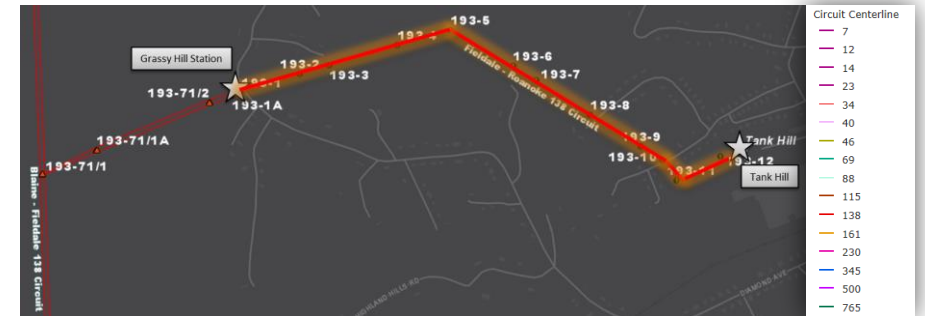
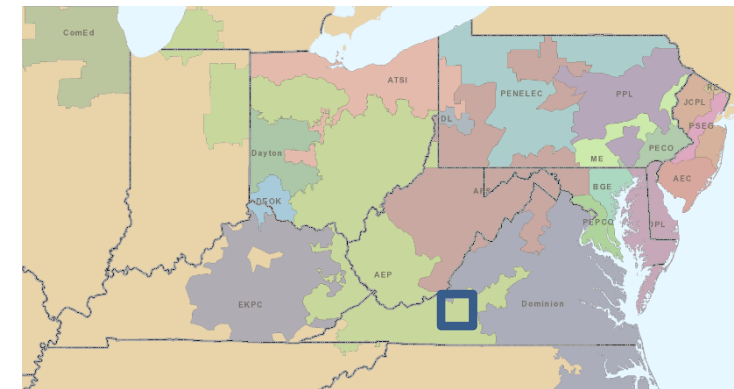
• **Grassy Hill Loop and Tank Hill Tap 138 kV Line Asset (1.3 mi.)**

- The single circuit wood pole structures that make up 0.95 miles of the 1.3 mile long Grassy Hill Loop and Tank Hill Tap 138 kV Line Asset are the focus of the concern.

- Recent field assessments have identified severe Woodpecker holes and cracking damage, accounting for 67% of the 12 single pole structures on the radial line.

- Weather cracks range in size from 2 to 7 feet in length, with many poles having multiple.
 - Woodpecker holes range in size from 1 to 5 inches in diameter and the poles have 10 to 30 of them.

- A pole appears to be hollow on the inside.
 - A pole has mold on the upper portion, that is 10 feet in length.
- The radial line feeds sensitive industrial customers in the Rocky Mount, VA area. These customers operate 24 hours a day and do not take outages. The Tank Hill station that is fed from the Fieldale – Roanoke line is the only station that can handle the industrial load.

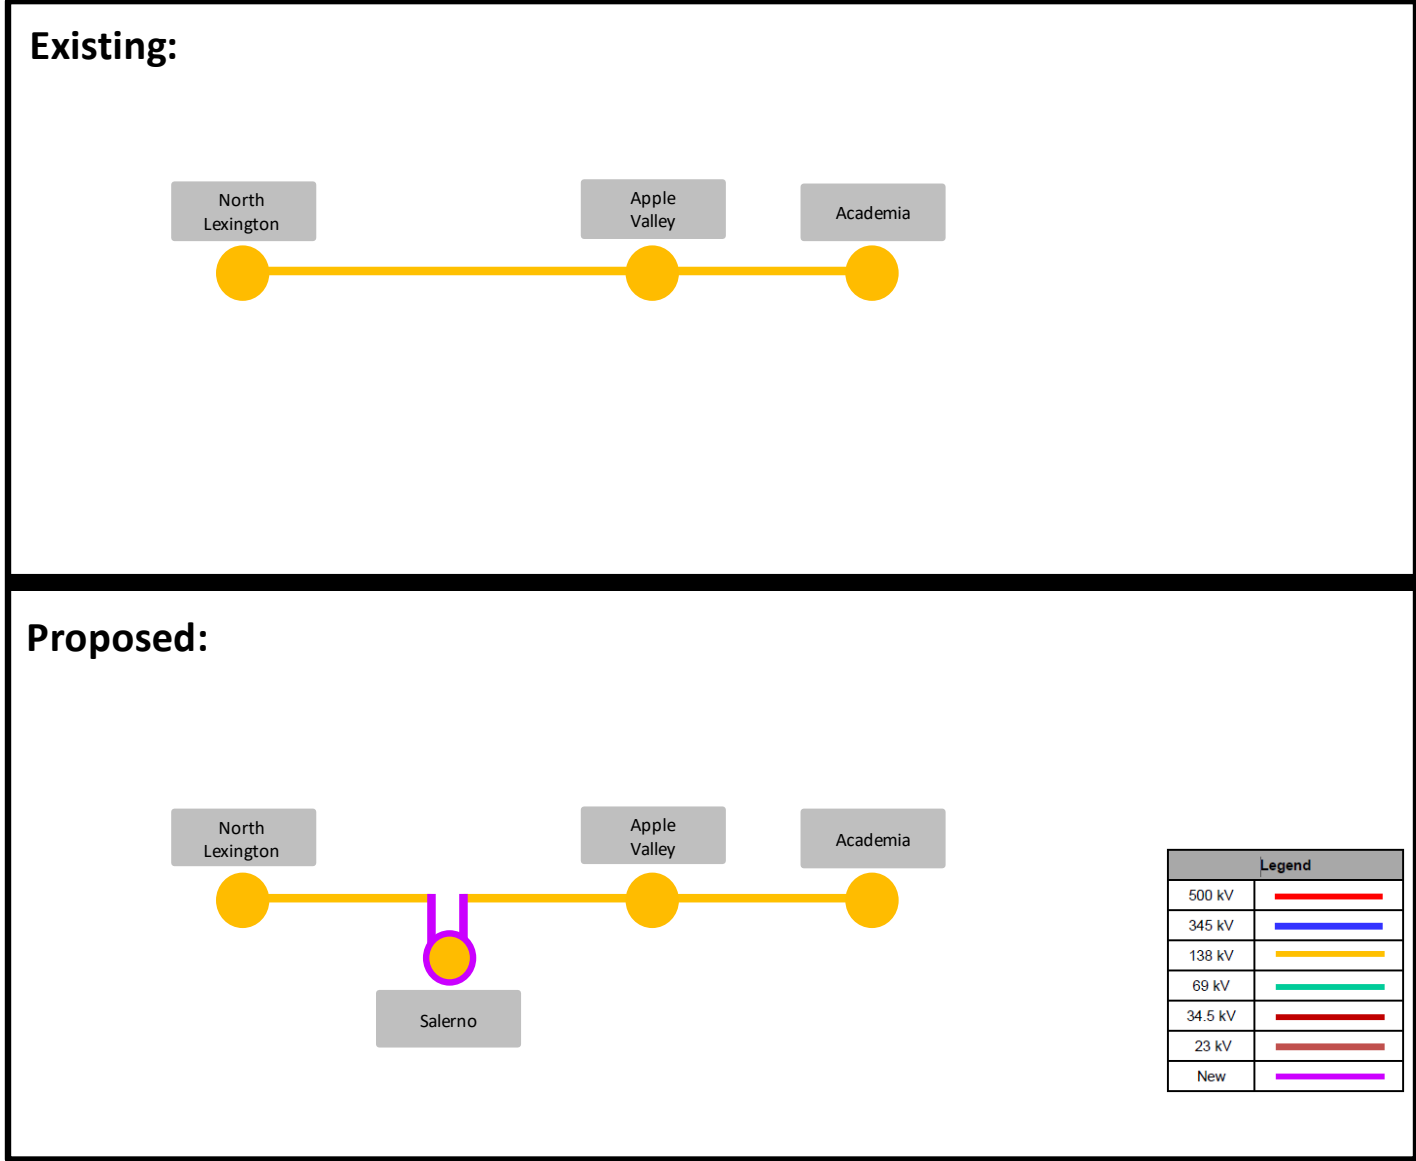
Proposed Solution:

- Install a greenfield 138kV in-out station (“Salerno”) with one auto sectionalizing switch on the line exit towards Academia one non-auto sectionalizing switch on the line exit towards North Lexington. **Estimated Cost: \$1.4M**
- Install two 138kV single circuit lines, approximately 0.1 miles each, to tie the greenfield Salerno station to the Academia-North Lexington 138kV circuit with 795 ACSR. **Estimated Cost: \$0.6M**
- Remove/Relocate approximately 0.1 mile of line on the Philo – Howard Line asset. Install ~1.7 miles of fiber to provide SCADA connectivity to Salerno. **Estimated Cost: \$0.3M**

Total Estimated Transmission Cost: \$2.3M

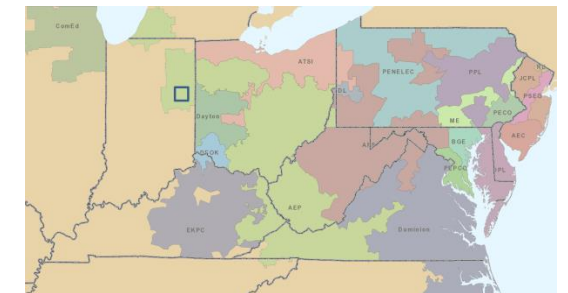
- The Colony Bay – Melita circuit has ~5.8 miles of primarily 1960 wood pole structures
- This section has 34 open conditions across 26 unique poles (~17% of line). These conditions include, but aren't limited to Stolen/broken ground leads, broken insulators, damaged and rotting poles.
- An additional 23 poles on this section (~15%) were found to be decayed to the point of failure. These poles had steel reinforcers installed to allow them to last until a more permanent fix was available.
- The 2014-2019 5 year period this line was subject to 3 momentary outages and 3 permanent outages.

Hadley 69kV station

- Station has a bus tie switch that breakers the bus differential. AEP has been addressing these as we have the opportunity

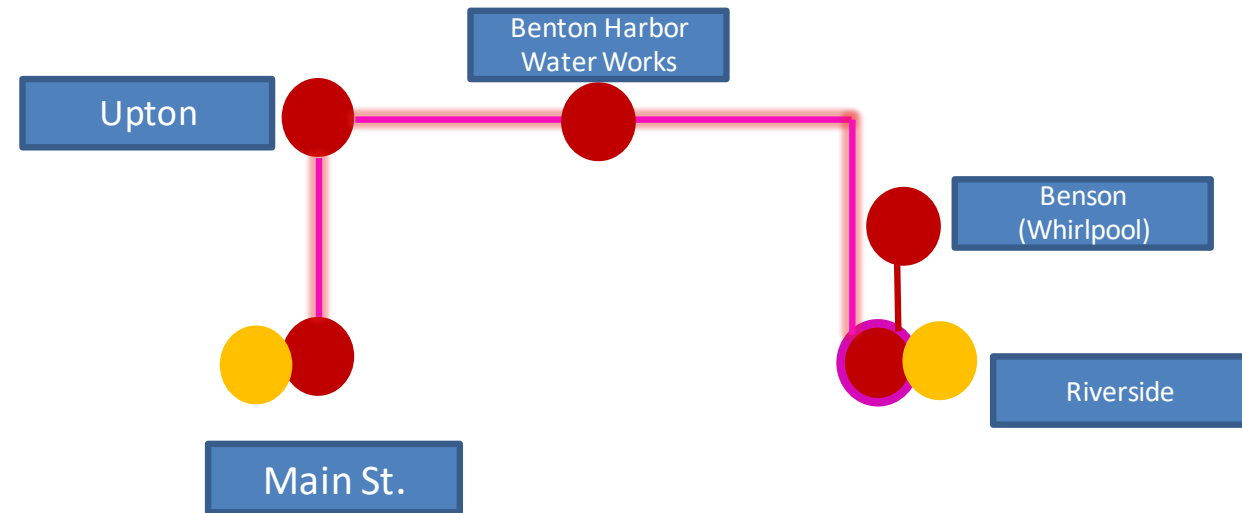
Replace (2) 138kV breakers and (2) 34.5kV breakers at Riverside. While at the station and taking advantage of the outage AEP will install a new 34.5kV breaker to bring Whirlpool customer, whose delivery point is currently one tower outside of the station, into Riverside station. Install high side circuit switcher to 138/69-34.5kV transformer.

Rebuild the line on a new greenfield route. The location of the taps on this line, and the lake immediately west there are no more feasible line routes in this area. To continue service to the customers tapped on this line the line must be rebuilt on the existing route.

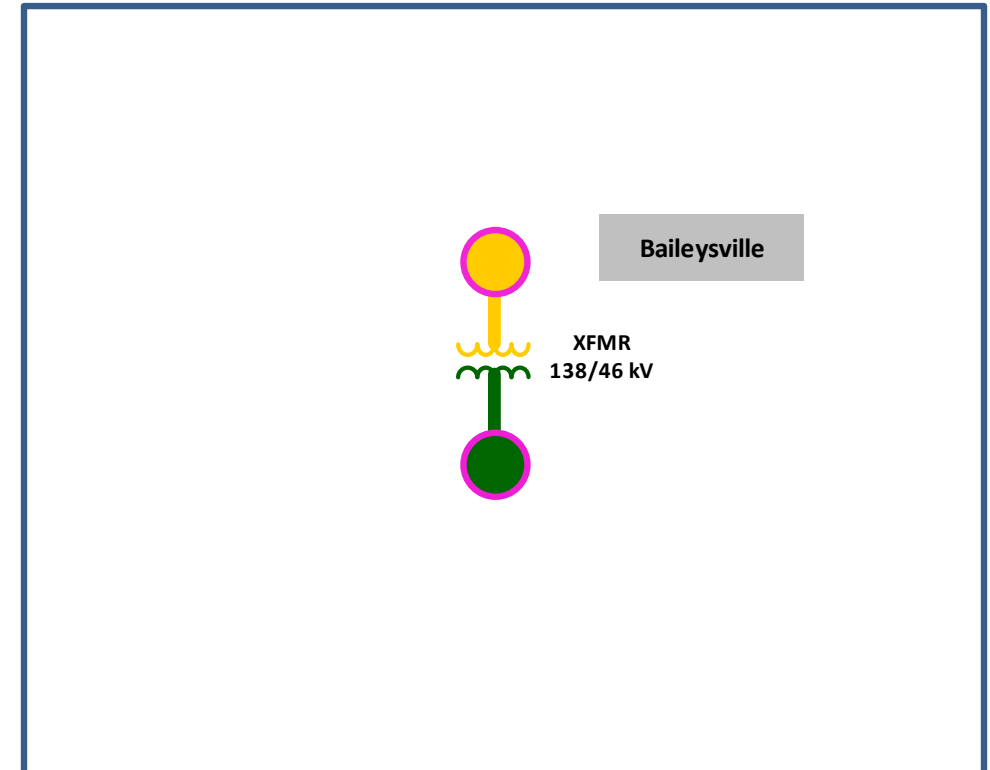
Replace existing 138 kV CBs G, H, I, K, L and N with six new 138 kV 40 kA circuit breakers. Replace existing 138 kV cap bank BB and install a new 138 kV breaker on the new cap bank. Replace existing 46 kV cap bank switcher with a new cap bank switcher. Install a high side circuit switcher on the existing 138/46 kV transformer. Upgrades will be made to the existing road into the station to improve access and space constraints. A flood wall will be installed to mitigate flooding concerns.

*Note: 138 kV CS CC failed and has been replaced.

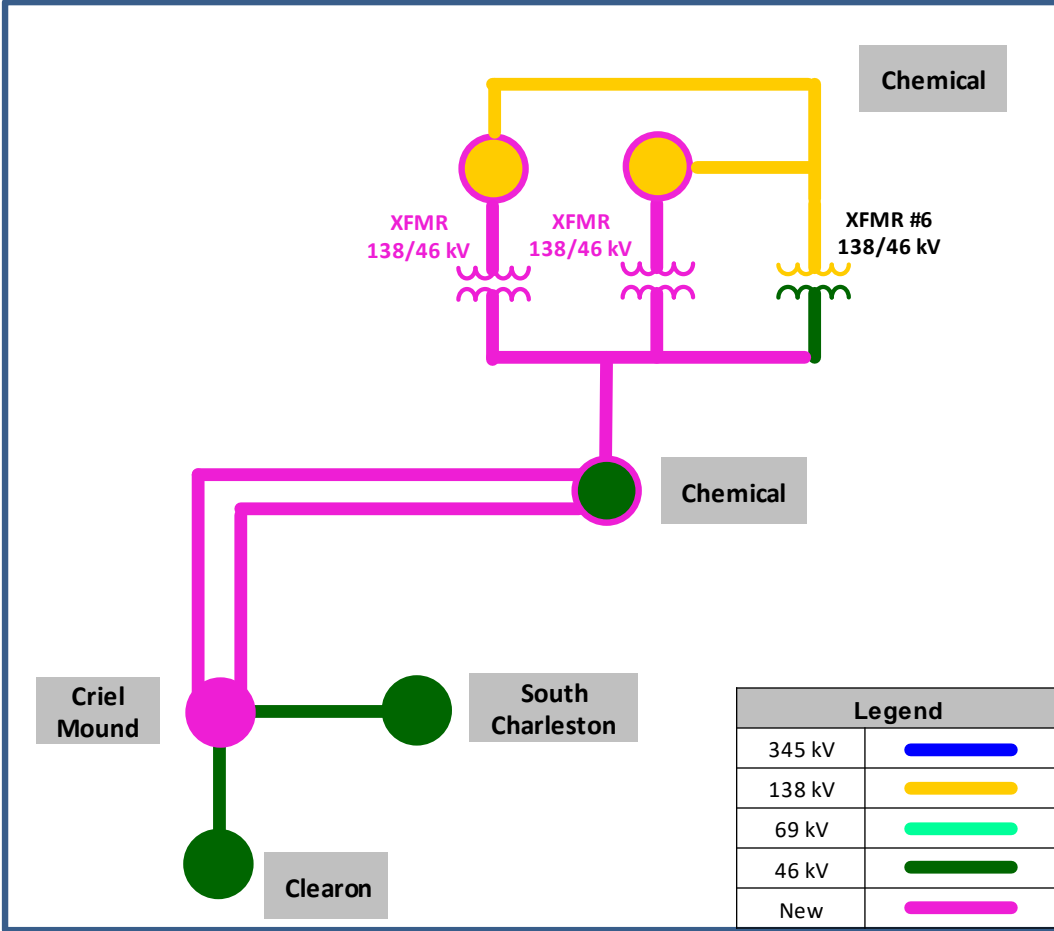
At Chemical station, replace existing 138/46 kV 45 MVA transformers #1 and #2 with two new 138/46 kV 90 MVA transformers and install two 138 kV high side circuit switchers on each transformer. Retire 138/46 kV transformer #4. Retire 46 kV 18 MVAR capacitor and switcher “DD”. Retire 46 kV bus #1, bus #2 and bus #3. Rebuild the 46 kV into a fourteen breaker ring configuration. Replace grounding banks #7 and #8. **Estimated Cost: \$16.8M**

At South Charleston, retire the existing circuit breakers A and B and install four new 46 kV 40 kA circuit breakers in a ring at a new station (Criel Mound) adjacent to the existing South Charleston Station. **Estimated Cost: \$11.0M**

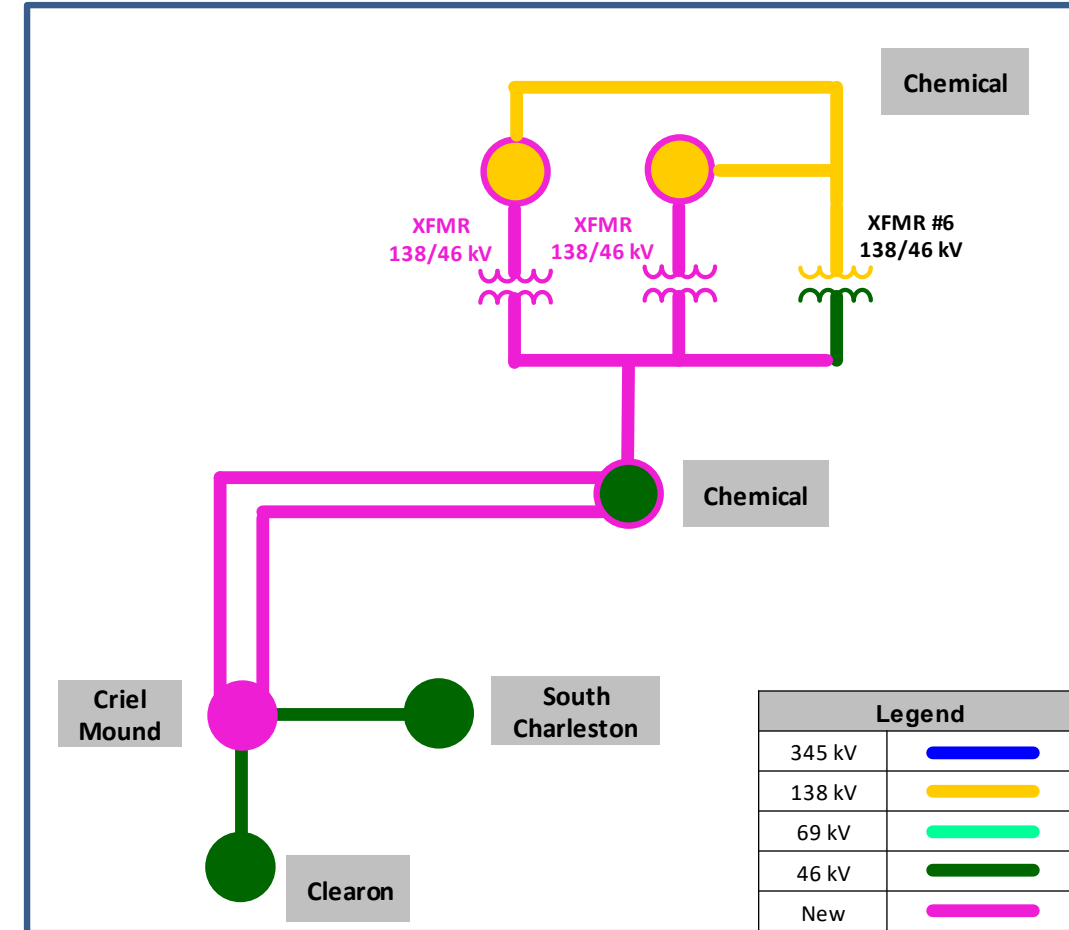
Replacing equipment at Chemical station in place is not preferred due to the significant outage constraints and constructability concerns. A breaker and half configuration was also considered at Chemical Station, however due to space constraints and the amount of site development required to achieve this configuration it was not pursued. Considering the availability of space at the existing station with the inability to expand and the outage time reductions of building in the clear, the ring bus configuration is recommended. **Estimated Cost: \$19.8M**
