Sub Regional RTEP Committee: Western AEP Supplemental Projects

May 21, 2021

Supplemental Project: S1851 (Need AEP-2018-AP001, posted to 2019 AEP local plan)

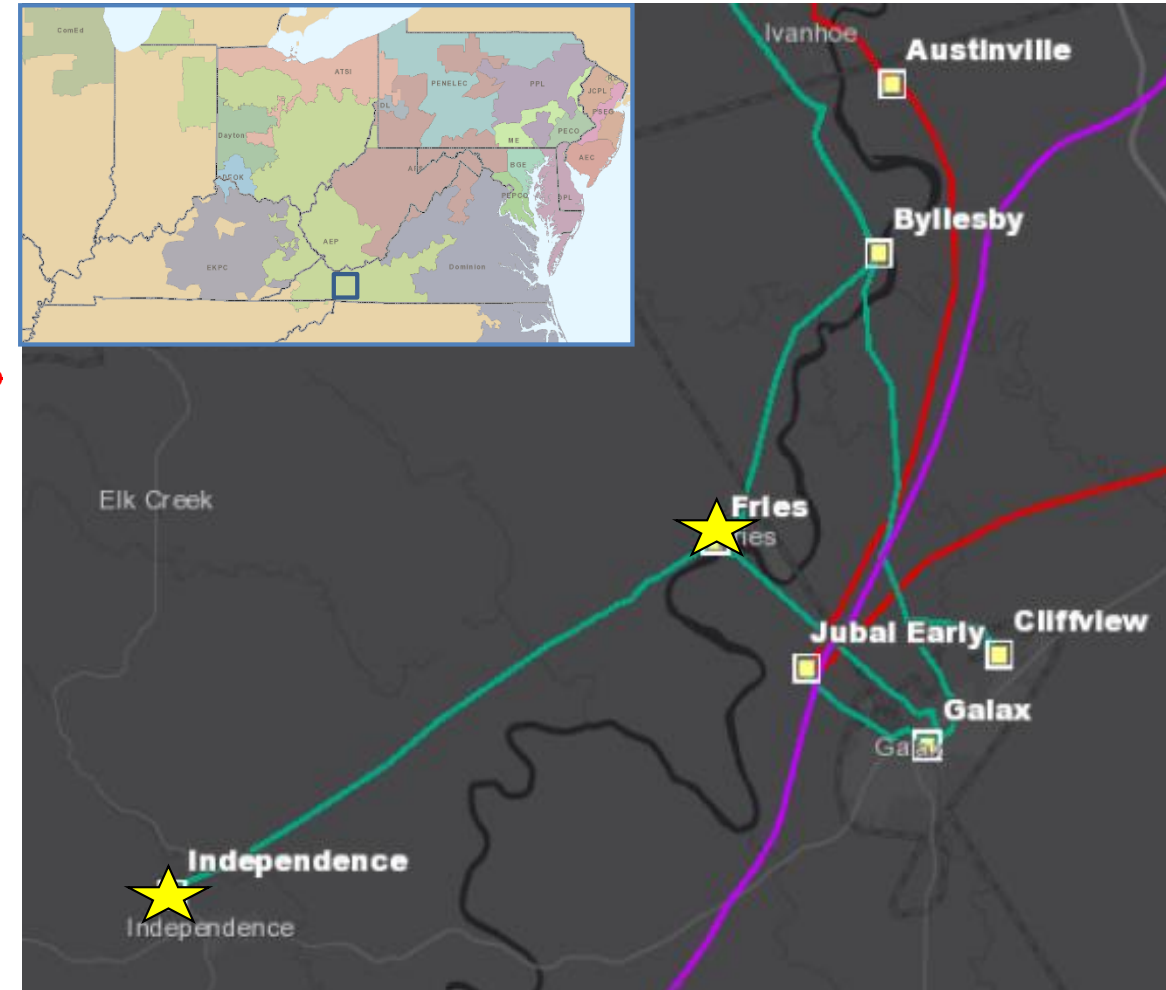
- Construct a new 69 kV line (approximately 14.25 miles) from Jubal Early Station to ~~Independence Point Lookout Station~~. Install a 69 kV circuit breaker at Jubal Early Station ~~and two 69 kV circuit breakers at Independence Station~~. The increased cost for the greenfield line is driven by an increase of rock and erosion control required for construction as well as access road along the new line route that was better defined as the scope was developed further.

- Relocate Independence Station to a new property and rebuilt as Point Lookout Station. Point Lookout Station will consist of a 69 kV bus, a 11.5 MVAR cap bank, two 69 kV circuit breakers. The station will also include a 69/34.5 kV 30 MVA transformer with two 34.5 kV distribution circuit breakers and a 69/12 kV 20 MVA transformer with one 12 kV distribution circuit breaker. The new cap bank at Point Lookout Station is replacing the existing cap bank at Fries Station due to the space limitations at Fries Station associated with remote end work. The cap bank at Fries Station can not be retired due to a voltage violation scenario and the new cap bank will maintain the voltages above our criteria thresholds. **Estimated Transmission Cost: \$0 (station is considered Distribution) (S1851.1)**

Reasons for the scope change: Due to the space restrictions at Independence Station, the station will be relocated to a new property.

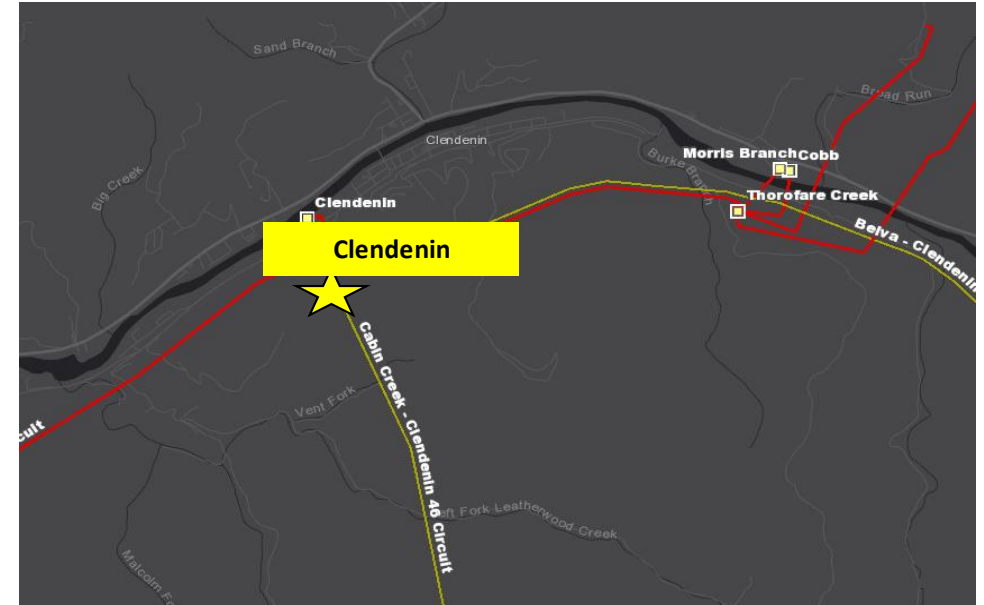
Replace the existing Clendenin Station with the new Jarrett Station, approximately ~~0.2~~ **0.1** miles away from Clendenin Station, located outside of the flood plain. Install a new 138/46 kV 90 MVA XFR, with a high side circuit switcher. Install two 138 kV 40 kA CBs and three 46 kV 40 kA CBs. Install a ~~9.6~~ **34.6** MVAR capacitor bank. Re-route the existing 138 kV and 46 kV transmission lines into the new station.

Reason for Revision: Prior to the 2020 RTEP window, preliminary analysis identified radial 715 criteria voltage violations on the following 138 kV buses: Jarrett (.83pu), Morris Branch (.83pu), Cobb (.83pu), Broad Run (.83pu), Thorofare S.S. (.83pu), and Ambler Ridge (.83pu) for the loss of Jarrett – Coco 138 kV (AEP_P1-2_#11225) and Ambler Ridge – Linden Road 138 kV (AEP_P1-2_#9102), which requires a larger cap bank to be installed. These are not considered baseline because the configuration change associated with the supplemental rebuild caused the violations; therefore, the cap bank size increase is supplemental.

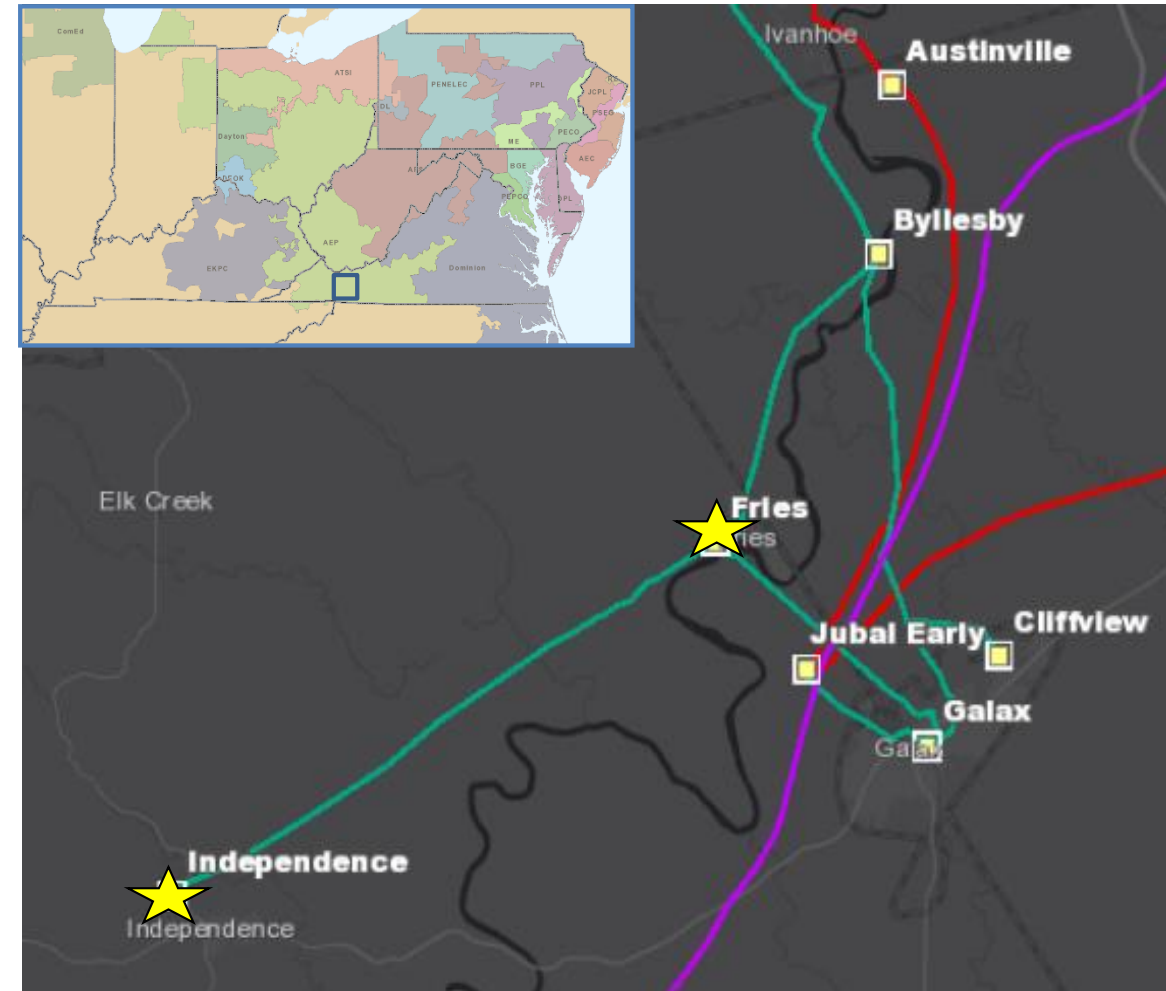
The Fries – Independence 69 kV line has 35 open conditions associated with the structures that make up 41% of the line. Conditions include woodpecker damage and rot top. Majority of the circuit utilizes 1950s wood structures.

The structures on the Fries – Independence 69kV Circuit fail to meet 2017 NESC Grade B loading criteria, fail to meet current AEP structural strength requirements, and fail to meet the current ASCE structural strength requirements. The line is grounded using the butt wrap method which does not meet current AEP standards. The line shielding angle on the typical tangent structure is measured at 33°, which is inadequate for current AEP shielding angle requirements.

S1851 was updated to present a scope change at Independence station due to space constraints and a cost update. The remaining need on the condition of the existing line is presented here.

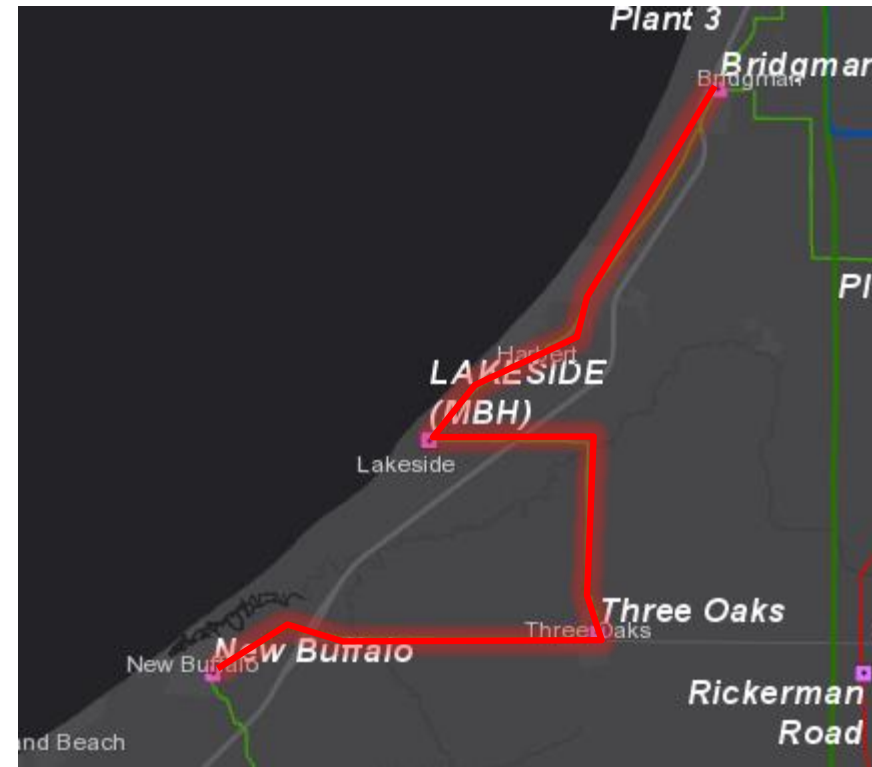
New Buffalo – Bridgman 69kV line:

- 22.1 miles of mostly 1964-68 wood pole
- Conductor is 336.4 ACSR and 4/0 ACSR
- Since 2015 there have been 4 momentary and 6 permanent outages on the Three Oaks – Bridgman circuit.
- Since 2015 there have been 8 momentary and 2 permanent outages on the Three Oaks – Bosserman circuit.
- 4,488,189 CMI from 2015-2020 on the Bosserman – Three Oaks circuit
- Structures fail NESC Grade B, and AEP Strength requirements with portions failing ASCE structural strength standards
- 23 of 53 structures assessed had wood decay such as rot, heavy checking or woodpecker damage.
- All inspected poles show moderate to heavy shell decay

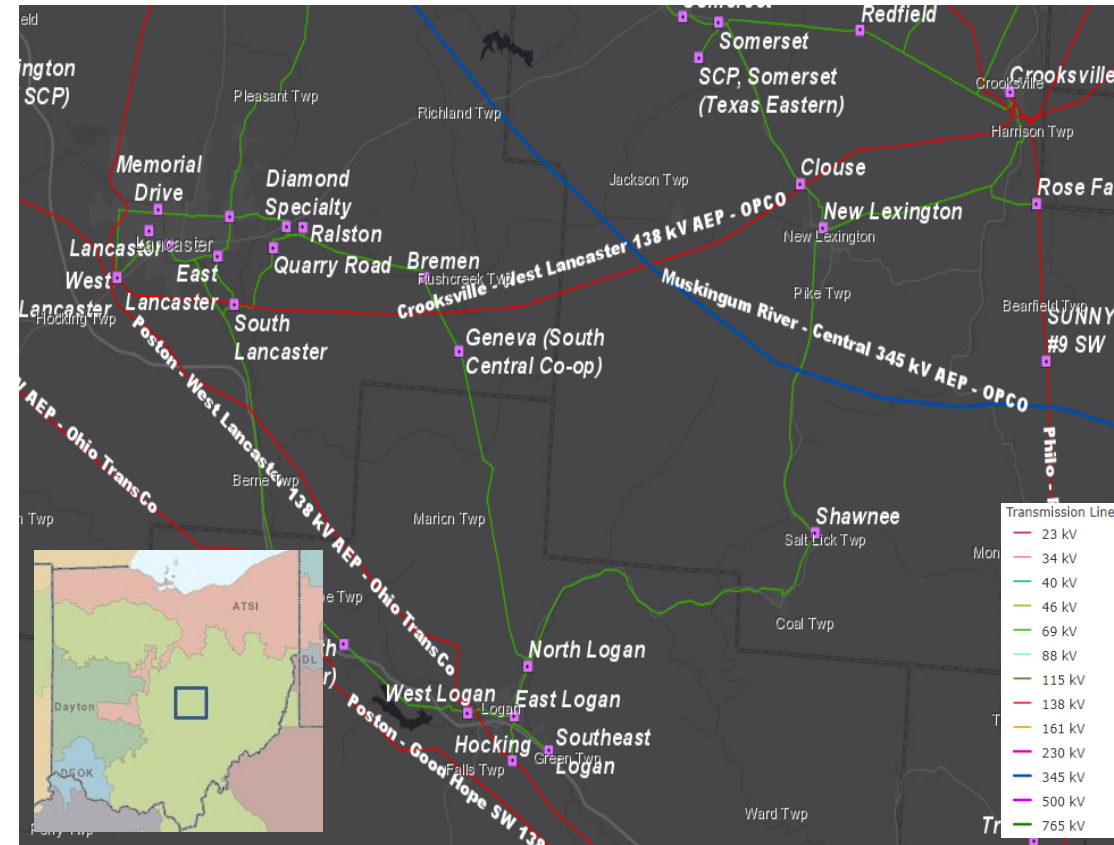
- Age: 1955
- Length of Line Section: ~0.02 Miles
- Structure Count: 2
 - Structure Type: Wood
- Conductor Type: 556,500 CM ACSR 18/1 (Osprey)
- Outage History: 12 Momentary and 4 Permanent outages with a total CMI of 3,113,139.
- This is currently a three terminal line, which can cause miss-operations and over-tripping of the line.

- Age: 1965
- Length of Line Section: ~0.01 Miles
- Structure Count: 1
 - Structure Type: Wood
- Conductor Type: 556,500 CM ACSR 18/1 (Osprey)
- Outage History: 8 Momentary and 2 Permanent outages
- This is currently a three terminal line, which can cause miss-operations and over-tripping of the line.

- Age: 1942
- Line Length: ~22.78 Miles
- Total Structures: 106
 - Structure Type: Steel Lattice
- Conductor Type: 397,500 CM ACSR 30/7 (Lark)
- Outage History: 6 momentary and 3 permanent outages with a total CMI of 208,134
- Open conditions: 60 total open conditions; 9 out of 106 structures have at least 1 open condition 8.5% of structures.
- Junction City Switch (2005): SCP has backup capability for Junction City, but only during light loading conditions. During peak loading, they cannot back feed their load.

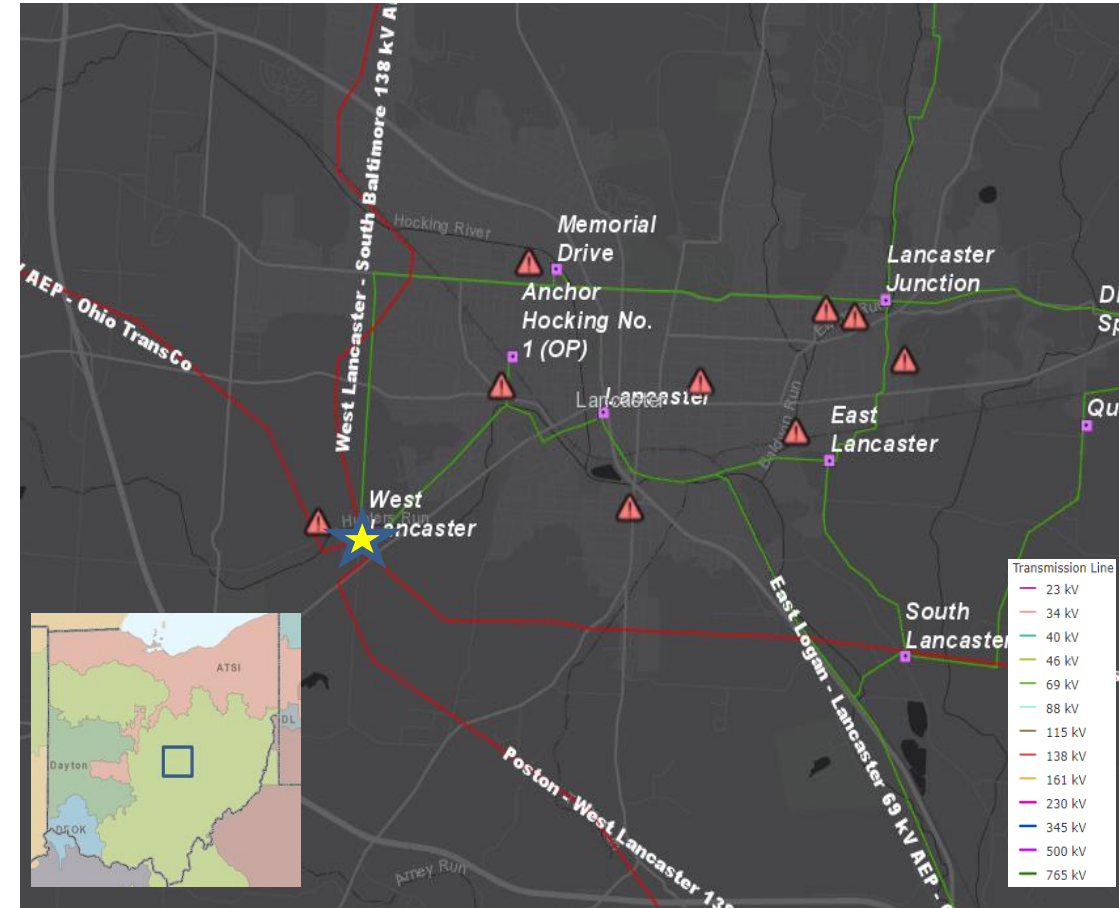
- Switcher Age: 1989
- Interrupting Medium: (SF6)
- Additional Info: This switcher is a Mark V type that has no gas monitor and currently in-service units on the AEP system have experienced 110 malfunctions from May 2000 to August 2019. Failed operational components including high contact resistance, gas loss, and interrupter failure represent half of these malfunctions. Two malfunctions of note were catastrophic equipment failures involving failures to trip.

- Age: 1966
- Overheating events indicate decomposition of the paper insulation that impairs the unit's ability to withstand future short circuit or through fault.
- No oil containment.
- High side disconnect switches need replaced.
- Additional Info.: Currently no sectionalizing on either side of Transformer 1 & 2, there are three dissimilar zones of protection (138 kV Bus, Transformer & 69 kV Bus) .

Currently, 40 of the 74 relays (54% of all station relays) are in need of replacement. There are 38 of the electromechanical type and 2 of the static type which have significant limitations with regards to fault data collection and retention. These relays lack vendor support and have little to no access to spare parts.

- Asbestos on walls, roof and cables
- Structural Integrity is in question – this needs replaced as soon as possible.
- Relays systems are not set up for dual battery configuration
- Cable entrance is 100% full

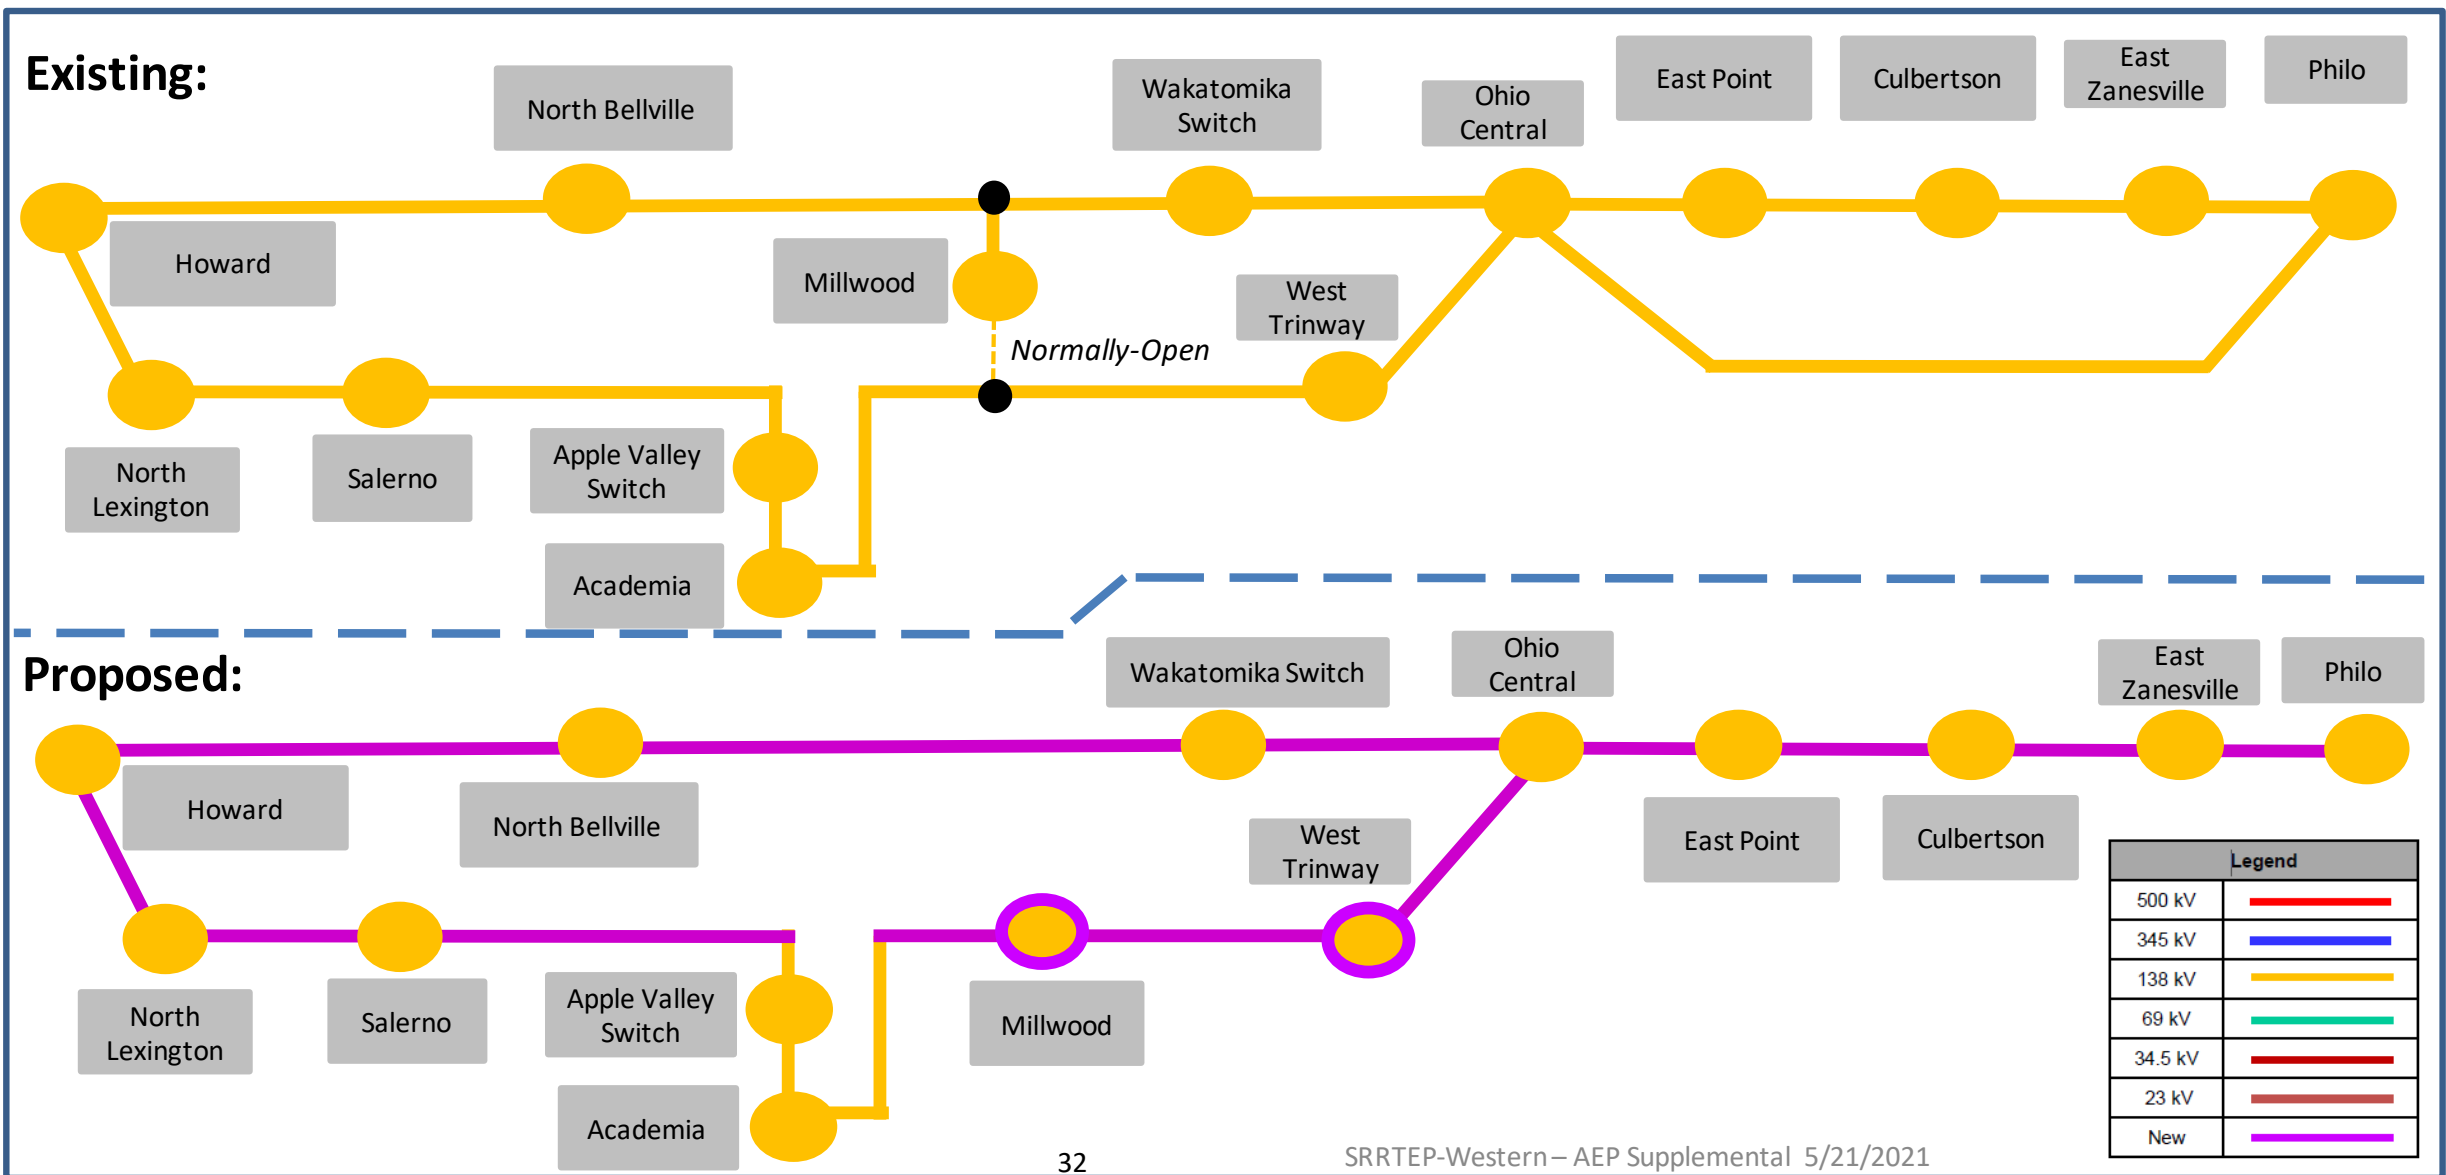
Rebuild from Howard to Ohio Central as 138kV double-circuit (64 miles), using 795 ACSR conductor. Note that the approx. 0.5 mile 138kV line segments outside Ohio Central station will not be rebuilt, as they are newer and in better condition; connect these existing T-line segments to the rebuilt Philo-Howard line asset. **Estimated Cost: \$142.26 Million**

At Millwood station, retire the 138kV flip-flop switching scheme, including the 2- 138kV switches. Install 2 new 138kV switches and replace the 138kV through-path risers & bus. Reconfigure the 138kV T-line entrances. **Estimated Cost: \$1.32 Million**

At West Trinway station, replace 138kV through-path risers & bus. **Estimated Cost: \$0.12 Million**
