Sub Regional RTEP Committee: Western AEP Supplemental Projects

June 15, 2022

AEP Transmission Zone M-3 Process Logan County, West Virginia

Need Number: AEP-2022-AP033

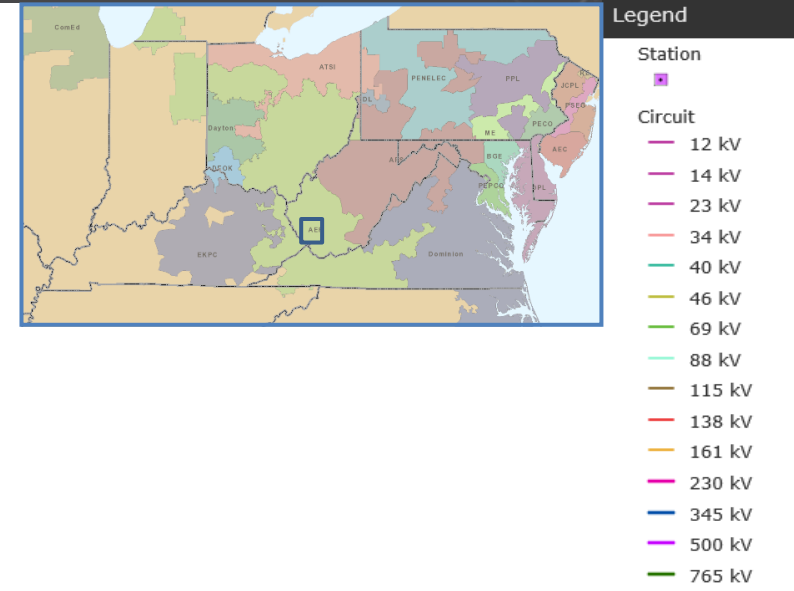
Line Name: Chauncey Tap 138kV Line

Original Install Date (Age): 1949

Length of Line: ~3.7 mi

Total structure count: 15

Conductor Type: 397,500 ACSR

- The outages include the Logan – Sprigg 138kV line because the Chauncey Tap is hard tapped to the Logan – Sprigg line and the outages travel onto the Chauncey Hard Tap and vice versa.

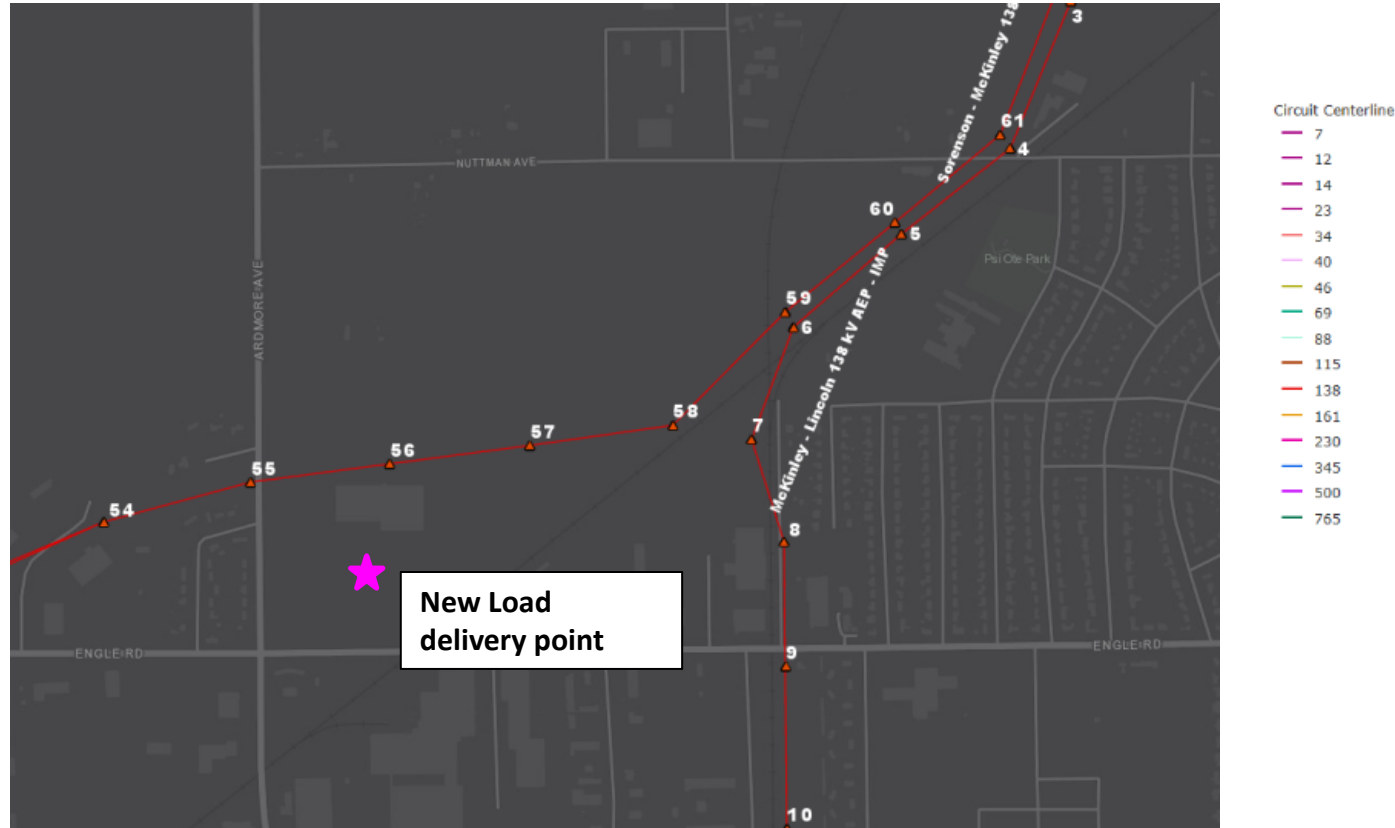
AEP I&M distribution has requested a new delivery point on the southern side of Fort Wayne to serve 13MW of load, transferred from McKinley station. The requested in service date is 6/1/2025

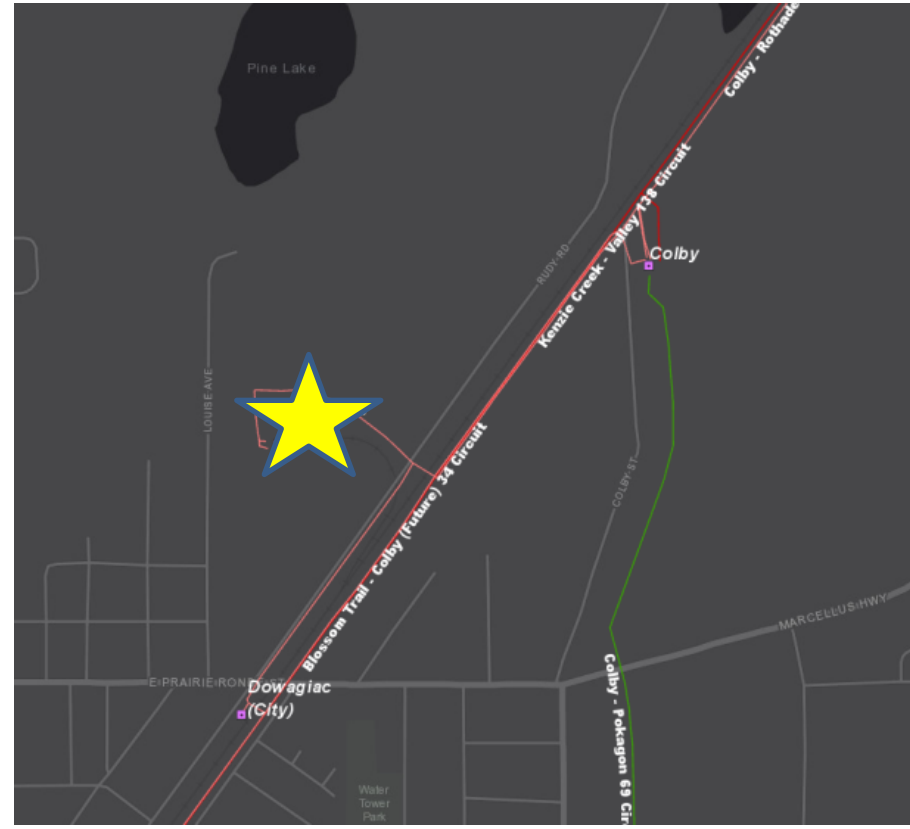
- Dowagiac Customer Growth:
- The customer served from Rudy Tap 34.5kV Sw has requested a load increase.
 - The customer has indicated a demand of 28MW at their existing delivery point with plans to expand and increase load significantly

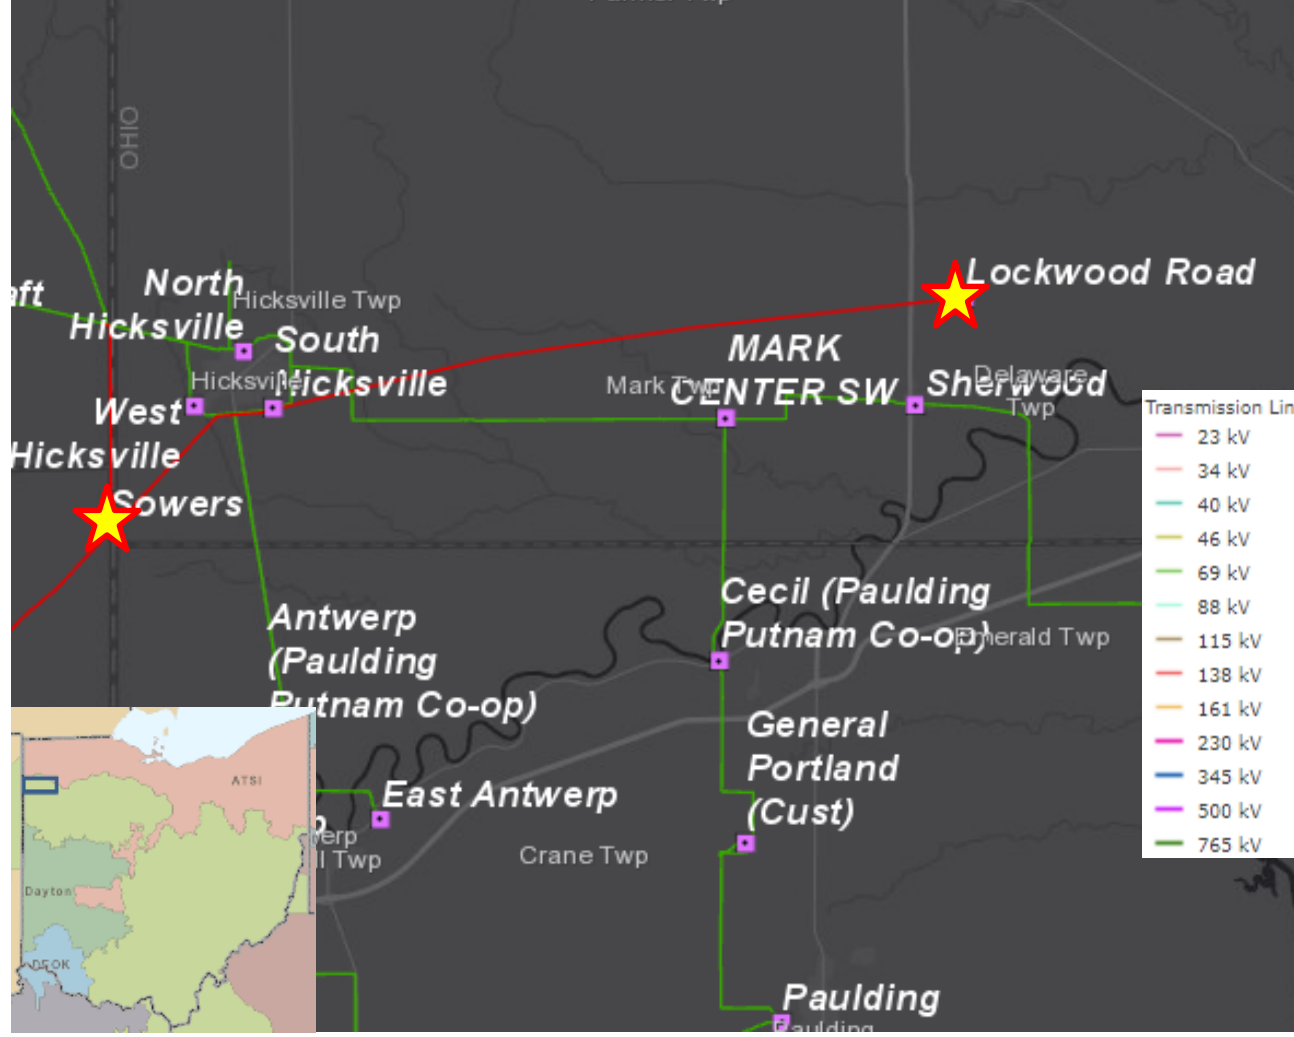
The Sowers – Lockwood Road line does not meet 2017 NESC Grade B loading criteria. The line is grounded with butt wraps which does not meet current AEP standards. There are emerging issues due to the age of this line being at a point where the rate of the wood pole decay to heart rot is going to accelerate. The life expectancy of crossarms vs. the life expectancy of the poles is mismatched as well as knee and vee braces. Ground based inspections may fail to detect crossarm decay on the top side of the arms, which typically occurs prior to visible decay on the sides and bottom. Crossarm failure is often the first indication that decay was ever present.

Eight sample structures were further assessed by a ground crew. 87.5% of those structures had reported conditions, which included the following: four structures had bowing poles/crossarms, five structures had moderate deterioration of poles and crossarms, and one structure had significant deterioration of pole toppers.

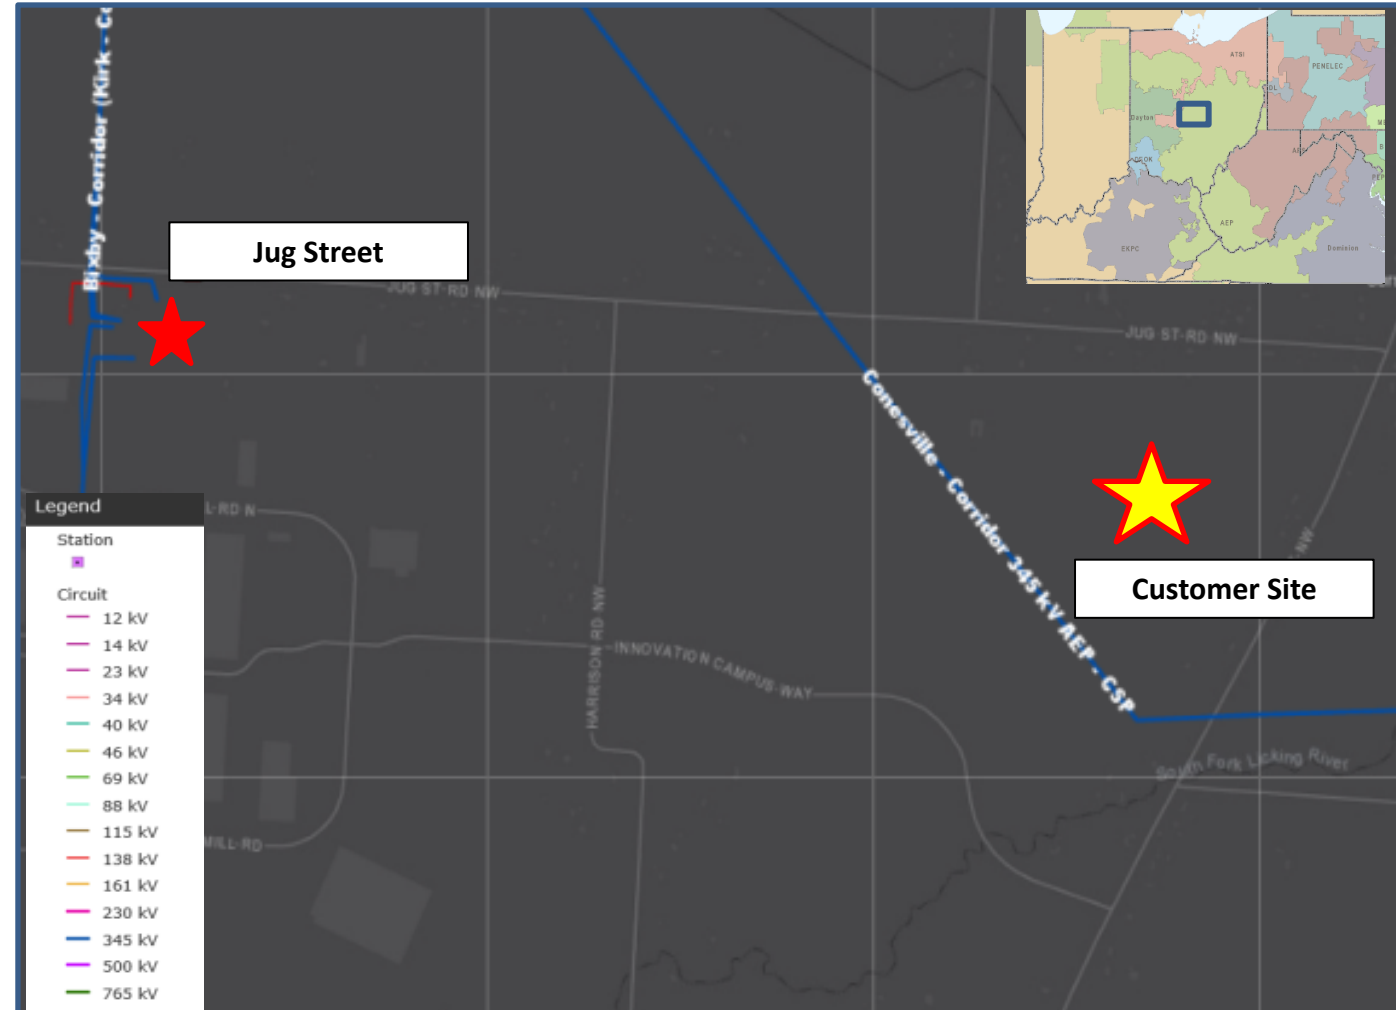
- A customer has requested transmission service at a site East of AEP’s existing Jug Street station in New Albany, OH.
- The customer has indicated their initial demand of 50 MW with an ultimate peak demand up to 400 MW in the future.
- The customer has requested an ISD of 6/28/2024

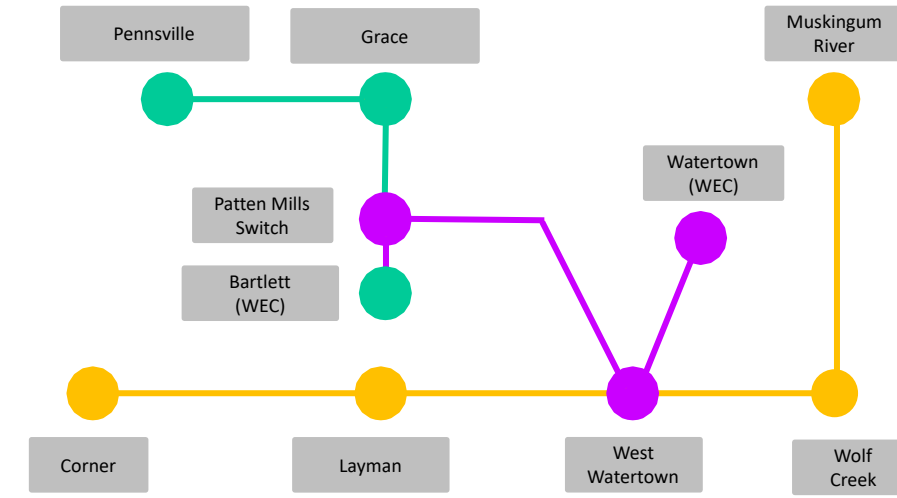
Proposed:

Bubble Diagram

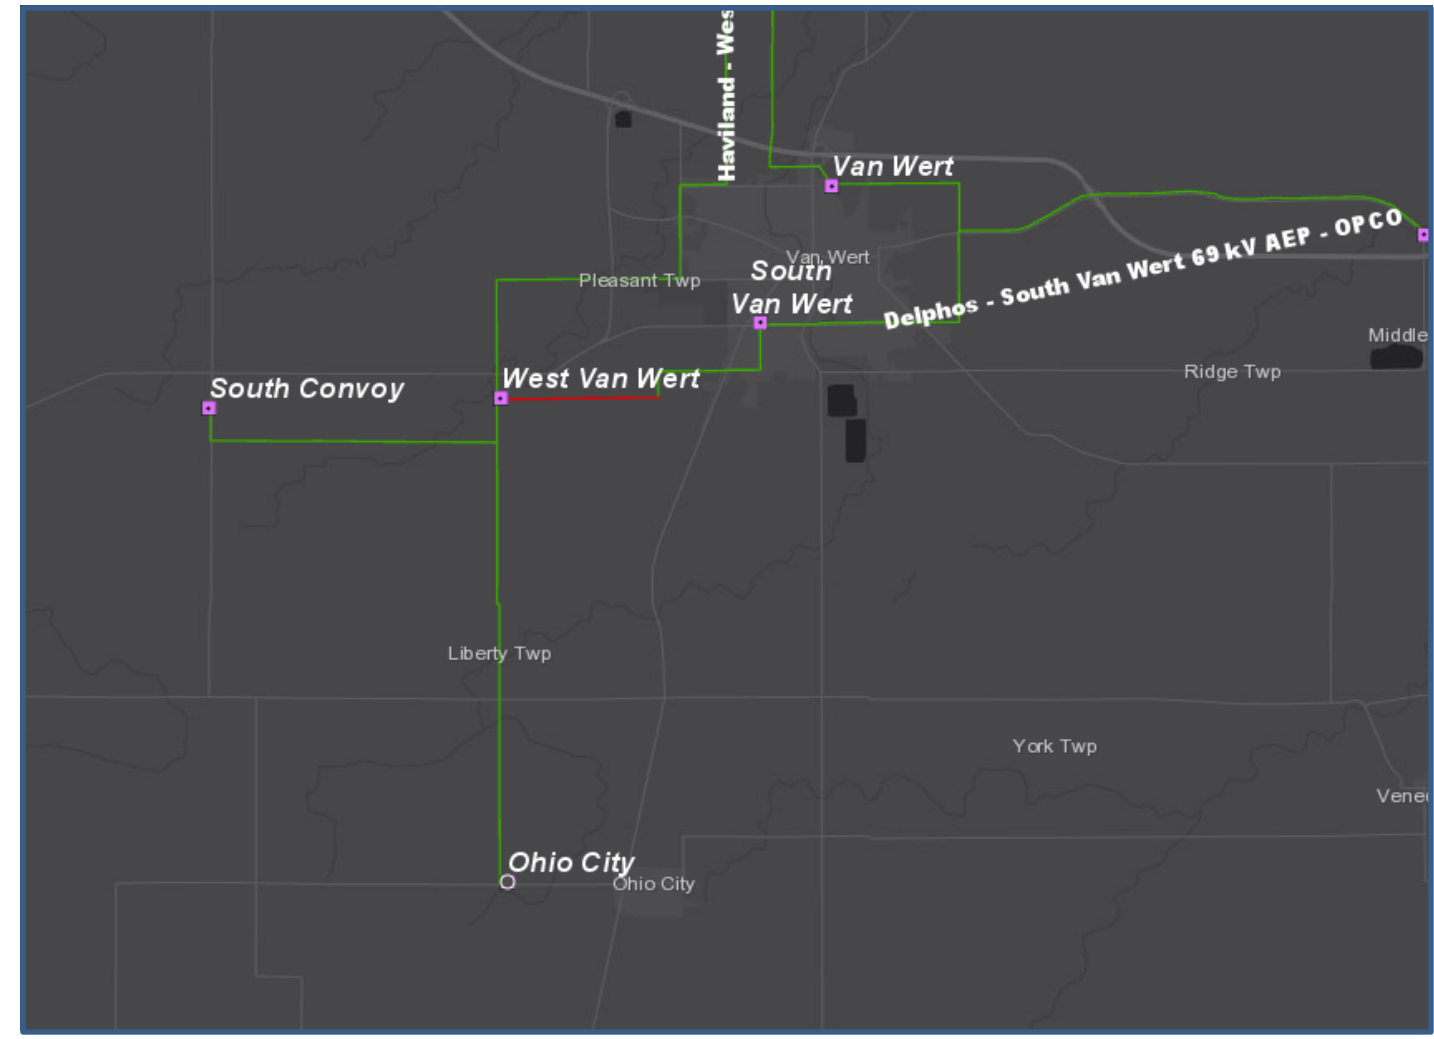
- **Original Install Date (Age):** 1963 (57 years)
- **Length of Line:** 8.90 miles
- **Total structure count:** 173
- **Original Line Construction Type:** Wood
 - 62% of structures replaced in 1994.
- **Conductor Type:** 1/0 Copper 7 (1939 Install), 4/0 ACSR 6/1 Penguin (1966 Install)

- Open conditions / defects / inspection failures include: missing/broken ground wires, woodpecker damage, broken guy wires
- Number of structures with defects/inspection failures: 24

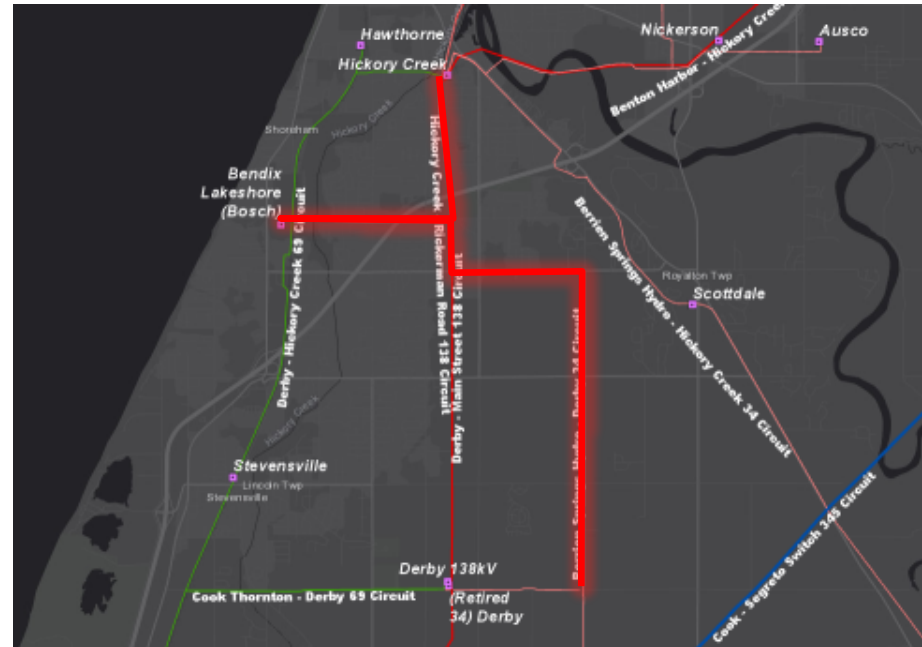
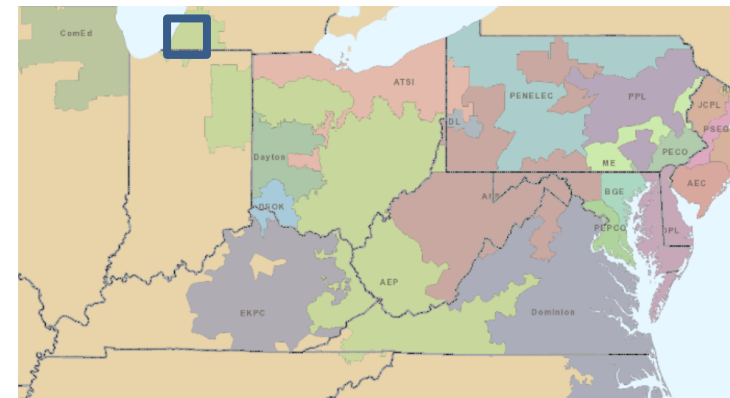
Bendix Lakeshore 34.5kV Tap (1.73 miles):

- Majority structures are 1952 wood pole crossarm style.
- Conductor is original 1952 4/0 ACSR
- Structures fail NESC Grade B, AEP Strength requirements, ASCE structural strength standards, Insulation standards minimum leakage distance and shielding angle.
- All structures were assessed by drone with 10 assessed by ground crew.
 - 25% of crossarms had decay
 - All structures had moderate levels of decay
 - Several crossarms had insect damage
- Currently there are 11 structures with open conditions on this segment including rot, cracked wood, and woodpecker damage.
- Line is a radial line which is difficult to maintain due to outage constraints.

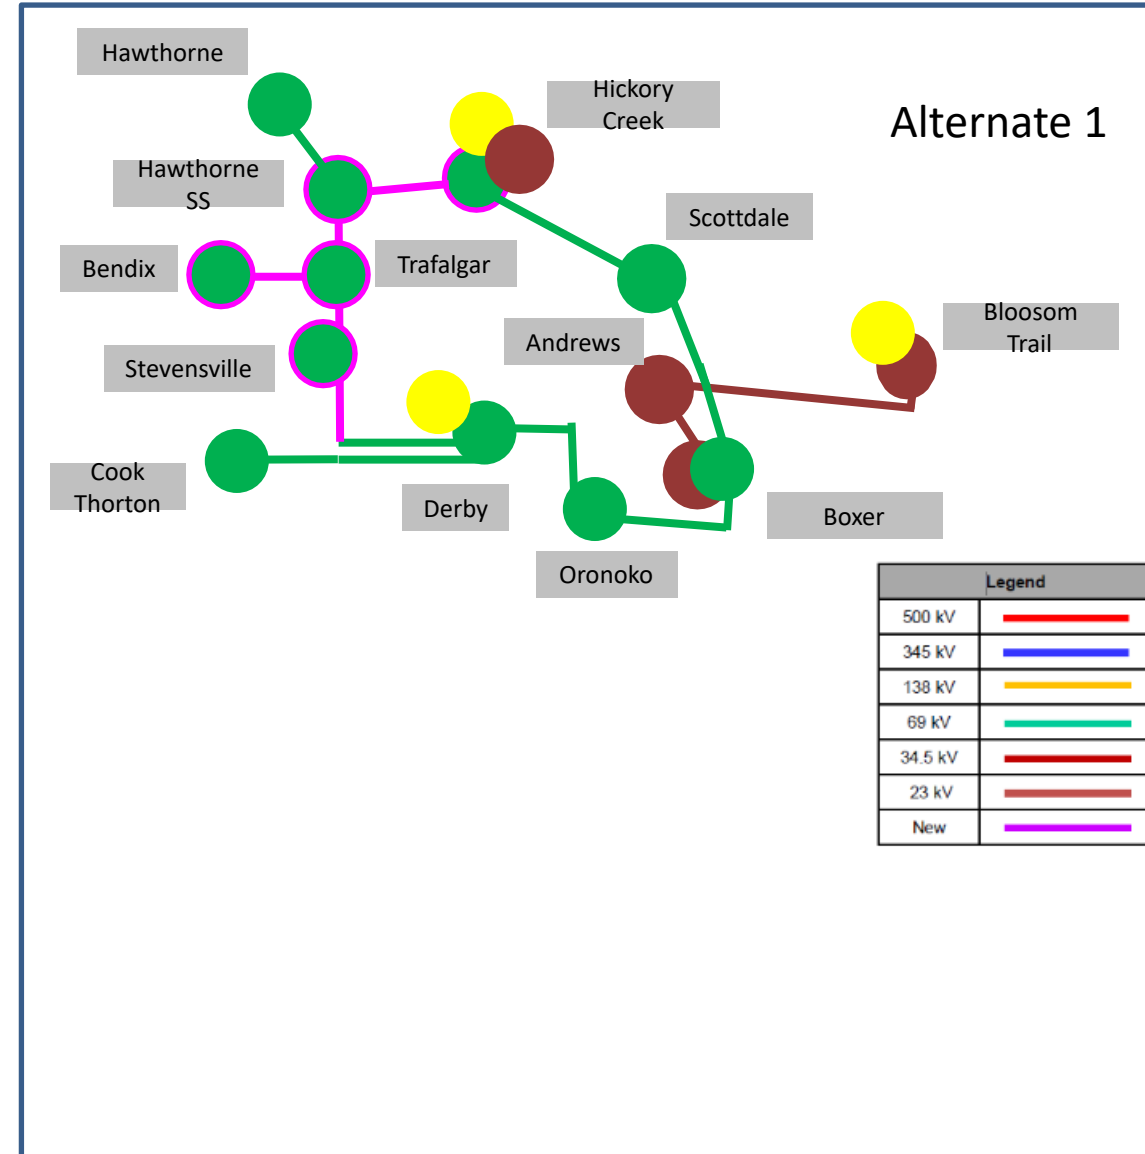
Instead of installing a 69/34.5kV XFR at Trafalgar and relocating a breaker there for the 34.5kV, upgrade Bendix Lakeshore to 69kV operation. This would cost roughly the same but would require additional work from the retail customer. AEP will continue to pursue this option based on the customer needs.

Estimated Cost: \$24.1M

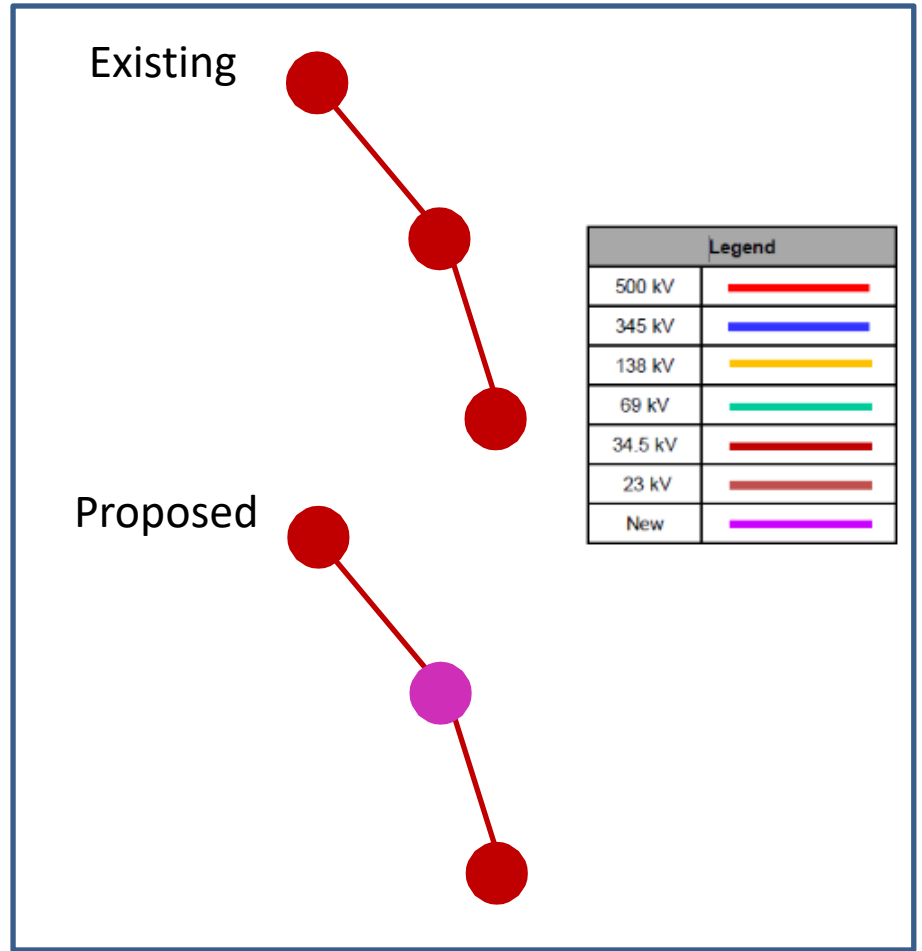
McGalliard Road replace 34.5 kV Moab switches “A” and “B” with 2000 A switches and install a 2000 A bus tie switch for operational and transformer maintenance flexibility.

Projected In-Service: 9/6/2024
