Sub Regional RTEP Committee: Western AEP Supplemental Projects

January 20, 2023

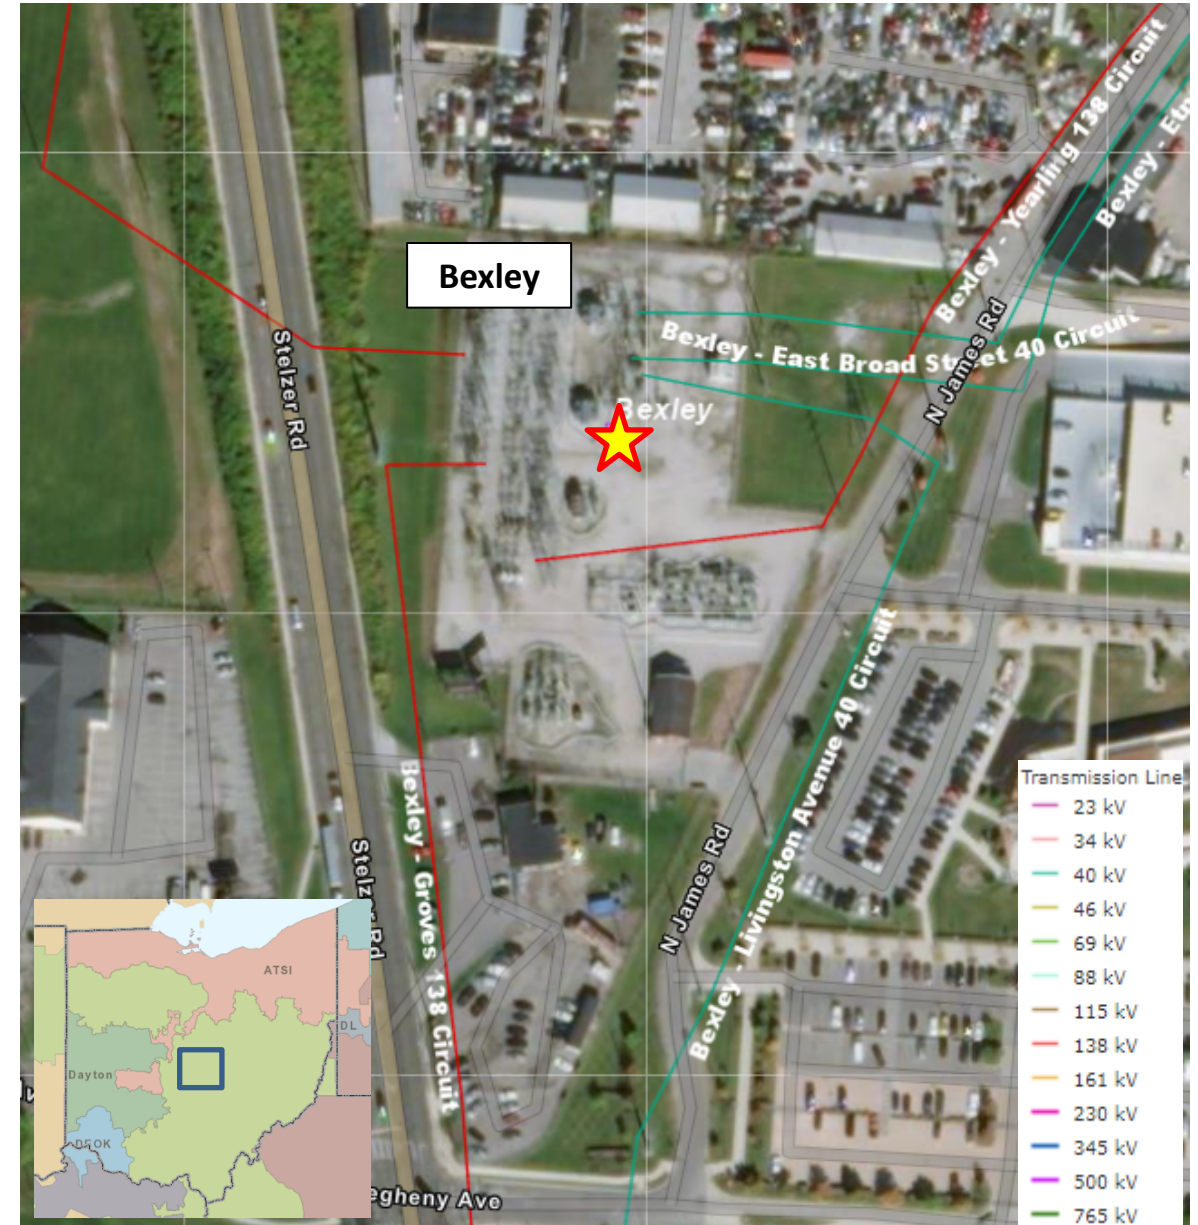
Bexley Station 138kV:

- TR 1 & 2 do not have arresters on the 40 kV or 13kV windings
 - Several small oil leaks and nitrogen leaks on TR1 and TR2
 - No oil containment on any of the transformers

- 5-40kV: (CBs 41, 42, 43, 44, & 47) 1960s & 1970s vintage GE & Westinghouse oil breakers.
 - 1-40kV: CB-42 has 14 Fault Operations (Manufacture recommended: 10)

- 1 – 40kV: (CB 45) is a SF6 type breaker has limited spare part availability, and poor historical reliability
- 1 – 40kV: CS-Bank 3 is an SF6 2030-69 model circuit switcher, which has been identified as needing replacement due lack of to spare part availability, historical reliability, and lack of vendor support.

- The 40kV system is an obsolete voltage class and as a result is difficult to obtain replacement parts.

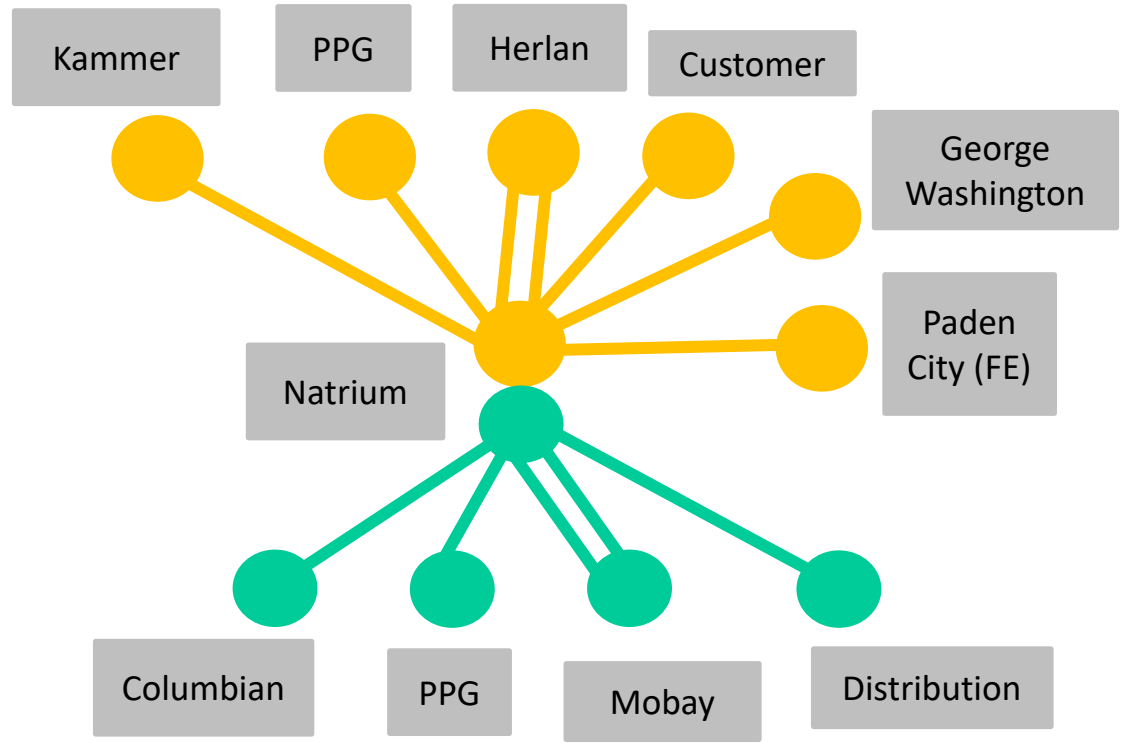
Existing:

AEP Transmission Zone M-3 Process Natrium Station Upgrade

Legend	
500 kV	
345 kV	
138 kV	
69 kV	
34.5 kV	
23 kV	
New

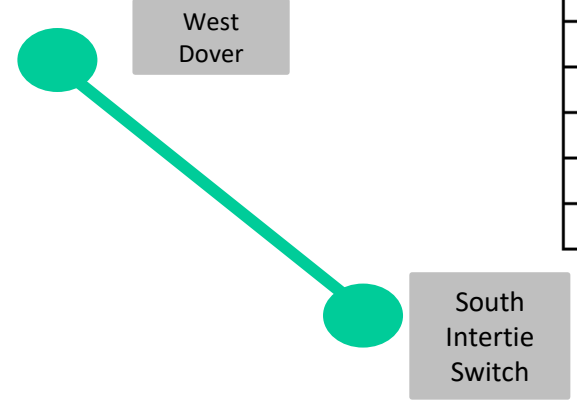
Existing:

AEP Transmission Zone M-3 Process West of Dover Customer Service
