Reliability Analysis Update

Transmission Expansion Advisory Committee November 9, 2017

2017 RTEP Reliability Analysis Update

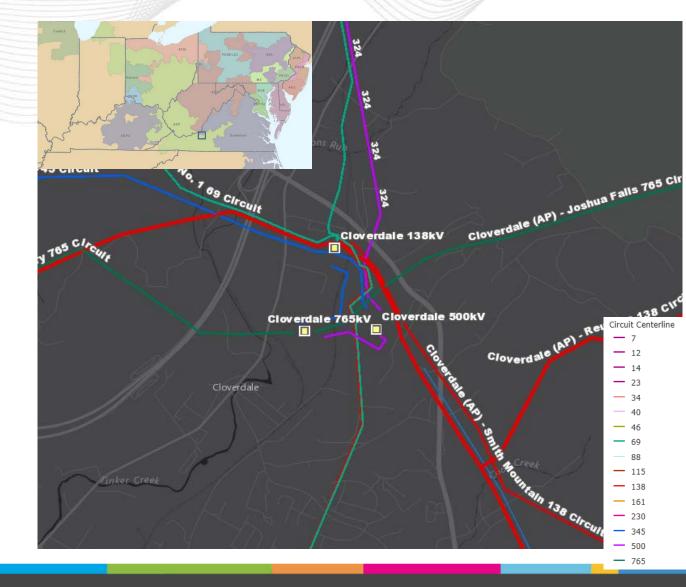
AEP Transmission Zone: Supplemental Cloverdale Breaker Replacement

At Cloverdale station, 345 kV circuit breakers "P" and "P2" are 63 kA GEC, PK-4C type Air Blast breakers . Air blast breakers are being replaced across the AEP system due to reliability concerns, intensive maintenance, and their tendency to catastrophically fail. During failures, sharps pieces of porcelain from their bushings are typically expelled, which, can be a potential safety hazard to field personnel. In addition, the ability to get spare parts for these breakers is becoming increasingly difficult. The Manufacturers recommended number of fault operations is 10. Breaker "P" has experienced 25 fault operations.

At Cloverdale station, replace 2- 345 kV PK type breakers ("P" & "P2") with new 345 kV, 5000 A, 63 kA breakers. Install new 345 kV 5000 A disconnect switches on both breakers. Install new 345 kV surge arresters on both 345 kV Busses (#1 & #2). Estimated Transmission Cost: \$4.7M

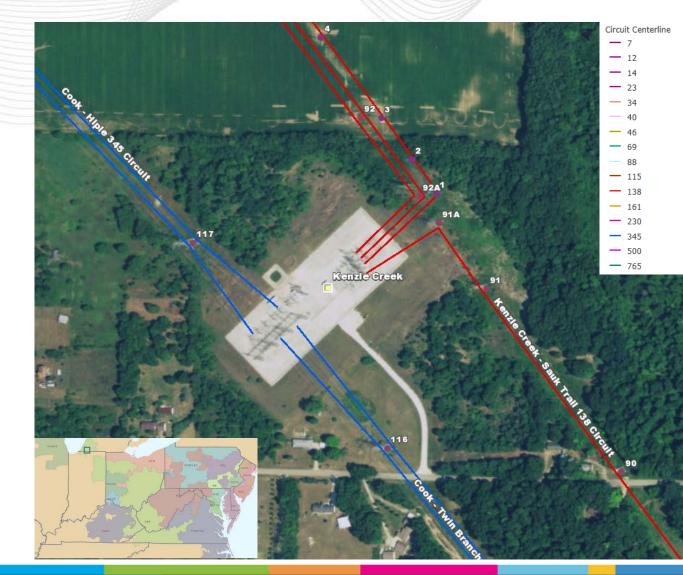
AEP Transmission Zone: Supplemental Kenzie Creek Breaker Addition

Motor Operated Air Break Switches (MOABs) have been utilized in the past as a less costly alternate to Circuit Breakers. MOABs at Extra High Voltage (EVH) unnecessarily subject expensive equipment, such as Transformers, to grid events in order to isolate a faulted section of the grid. This not only reduces the life of such expensive equipment, but also results in misoperations. It is AEP's practice to not install MOABs for fault sectionalizing at EHV. In addition, AEP is proactively replacing all EHV MOABs at existing stations with circuit breakers.

Estimated Transmission Cost: \$7.4M

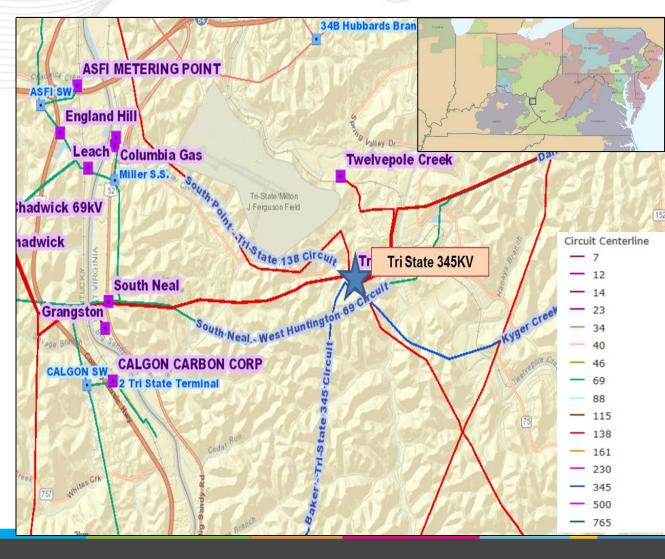
AEP Transmission Zone: Supplemental Tri-State Station Breaker Replacement

34B Hubbards Bra Equipment Material/Condition/Performance/Risk/Operational Flexibility: **ASFI METERING POINT** Breaker "H" at Tri-State is an Air Blast type breaker. Air blast breakers are being replaced across the AEP system due to reliability concerns, intensive

The 345/138 kV transformer #1 (1965 vintage) is also being replaced due to

At Tri State station, replace circuit breaker "H" with a 345 kV 63kA breaker. Install 4 new 345 kV 63kA breakers in a new breaker and a half string configuration. Replace transformers 1 & 2 with 345-138 450 MVA units. Estimated Transmission Cost \$9M

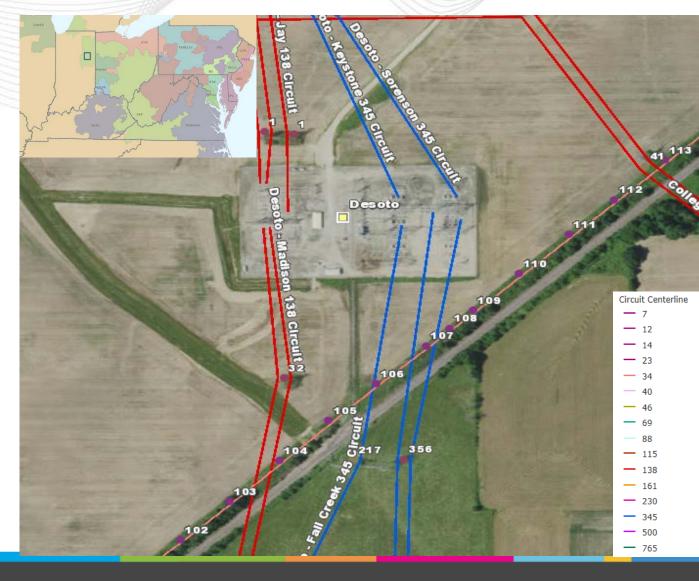
AEP Transmission Zone: Supplemental Desoto Breaker Replacement

At Desoto station, breaker C is an FX22A 3000A 50 kA Hydraulic breaker from 1985. Although only 32 years old, this breaker has experienced 124 fault operations which is significantly higher than the manufacturer recommendation of 3. In addition to this, there has been a rising trend of gas pressure on this breaker. Due to these identified issues, AEP recommends replacement of this breaker.

Replace 345kV breaker C with a GE Alstom 5000A 63kA 345kV breaker Estimated Transmission Cost: \$1.0M

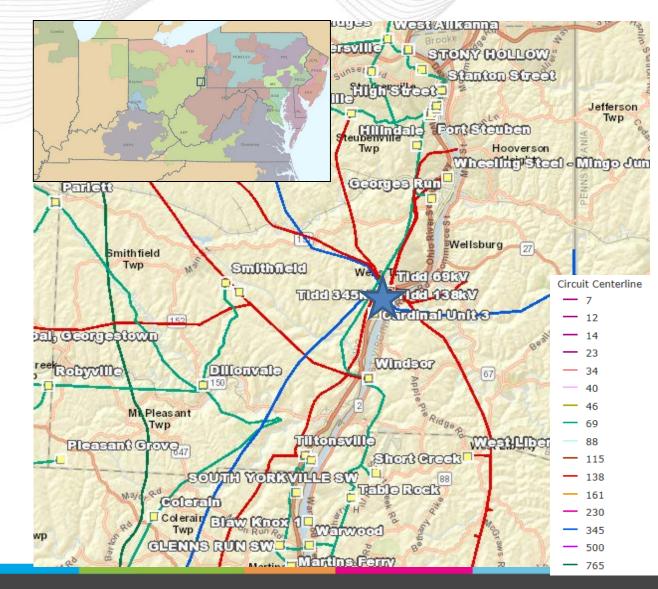
AEP Transmission Zone: Supplemental Tidd 345 – 138 kV Transformer B Replacement

The Tidd 345-138kV transformer has failed, due to extreme levels of combustible gases (ethylene, ethane, methane). Asset Health Data required this unit to be removed from service for safety concerns in March 2017. The unit was made in 1957 and is 150 MVA. In its place a 450 MVA transformer will be installed, for additional system support. To limit the fault duty in the 138kV yard, series reactors will be installed (2%) on the low side of the transformer. This setup will mirror the parallel Tidd 345-138kV transformer C (450 MVA XFMR with 2% series reactor). This upgrade will serve to benefit the area's heavily-networked 138kV system.

Currently the two Tidd 345-138kV transformers are tapped directly off of the 345kV buses without high-side protection. For a transformer fault, or for scheduled transformer maintenance, 4- 345kV breakers must be isolated, which is a concern for operations and field personnel. This also requires an overly complex protection scheme for the 345kV buses and transformers. In addition, for a bus fault or scheduled bus maintenance, either transformer B or C is automatically taken out of service today. To resolve this reliability concern, a 345kV 3-breaker string will be installed on the high side of the two 345-138kV transformers.

At Tidd station, replace the failed 150 MVA 345-138kV transformer with a 450 MVA unit; install a 138kV series reactor on the low-side of the transformer, to control fault currents in the 138kV yard; install a 345kV 3-breaker string on the high side of the transformers, along with new relay panels and SCADA functionality. Reconductor tie-line from 345kV yard to 138kV yard at Tidd, on the low-side of transformer B, due to increased capacity of the transformer.

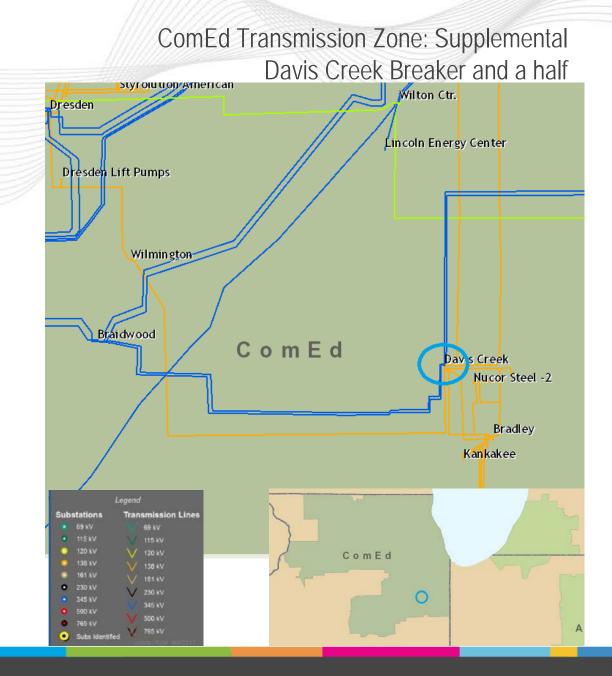
Davis Creek 345kV substation bus configure does not comply with current design standards Single 345kV breaker failure will trip 63 miles of 345kV transmission and one to two 345-138kV auto-transformer(s)

Install line breakers and transformer high side breaker. Station configuration will still be a straight bus, and single 345kV breaker failure will trip 63 miles of 345kV transmission and one to two 345-138kV auto-transformer(s)

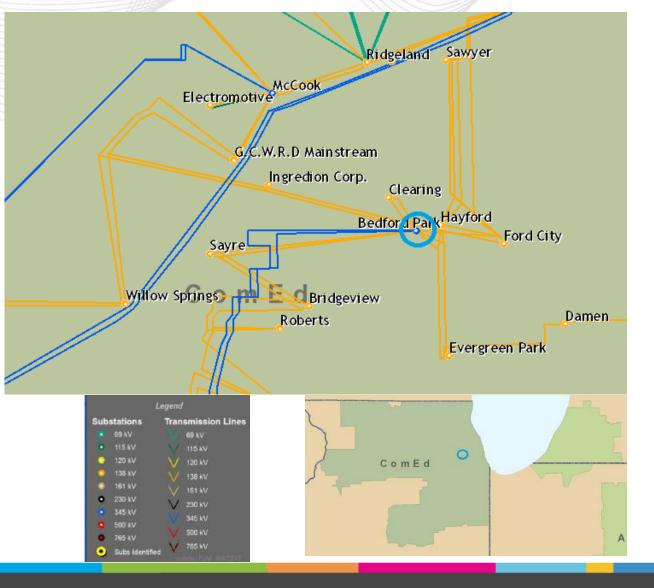
ComEd Transmission Zone: Supplemental Northbrook

Replace Bedford Park open air 345kV bus with indoor GIS

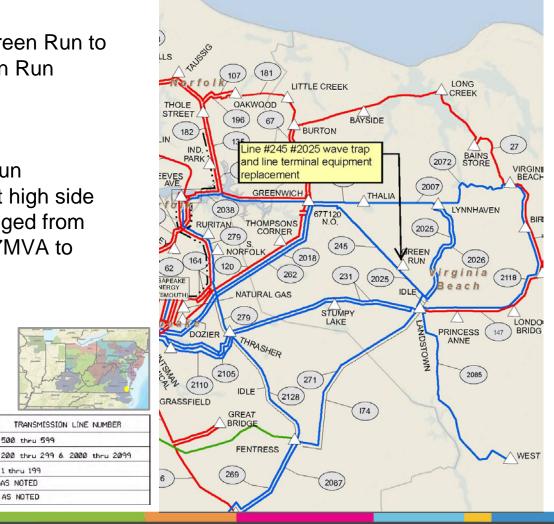
Dominion Transmission Zone: Supplemental Green Run Substation - Line #245 & #2025 Wave Trap & Line Terminal Equipment Replacement

230kV Line #245(Green Run to Greenwich) and 230kV Line #2025 (Green Run to Lynnhaven) wave traps and associated line terminal equipment at Green Run substation need to be replaced due to age.

Replace existing Line #245 & Line #2025 1600A wave traps at Green Run substation with 3000A wave traps. Replace high side circuit switchers at high side of TX#1 and TX#2. Summer emergency rating of Line #245 will be changed from 637MVA to 898MVA. The rating of Line #2025 will be changed from 637MVA to 722MVA.

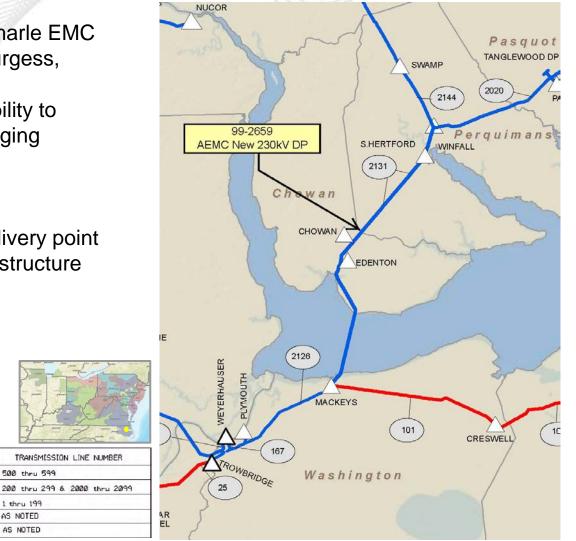
Dominion Transmission Zone: Supplemental New 230kV DP for Albemarle EMC

- NCEMC has requested a new 230kV delivery point on behalf of Albemarle EMC to replace three existing AEMC distribution served delivery points: Burgess, Cisco and Edenton DP's.
- The main drivers for the new 230kV delivery point are AEMC's 1) inability to serve future load from the existing distribution delivery points and 2) aging facilities.

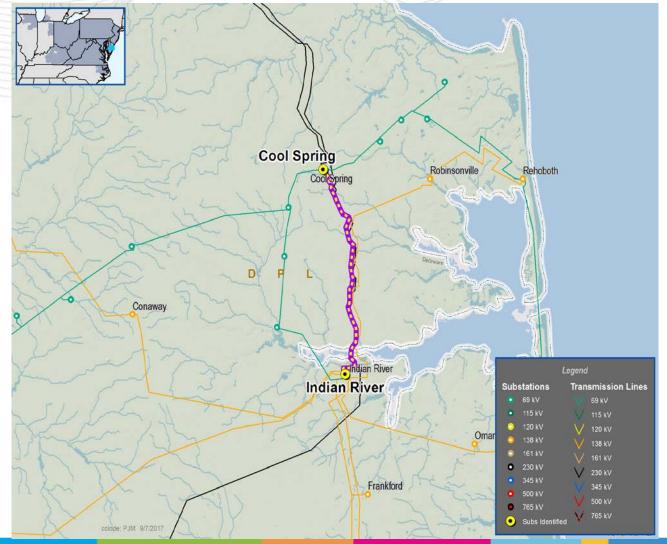
- Rebuild line 23070 between Cool Spring and Indian River substations. All structures, conductor, and static wire will be replaced with new steel poles, conductor, and OPGW. (Estimated cost: approximately \$17.8M)
- Obtain new ROW to install a new line
