Reliability Analysis Update

Transmission Expansion Advisory
Committee

March 07, 2019

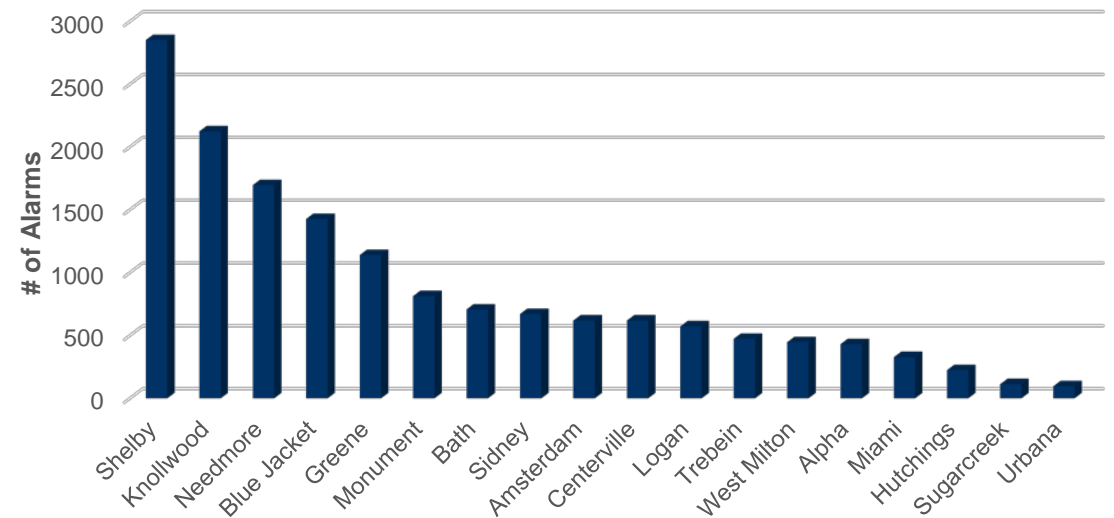
Alarms by 138kV Substation 1/2017 -12/2018

- **Excessive Amount of High Voltage Alarms for Dayton**
 - Approximately 19,000 operational alarms logged in 2017-2018 (including 327 alarms at 345kV buses).

- After exhausting all typical operating procedures, Dayton is frequently forced to switch out equipment to avoid long-term damage from high voltage exposure. This practice of switching out equipment is not a sustainable operating practice and does not effectively solve the high voltage issues.

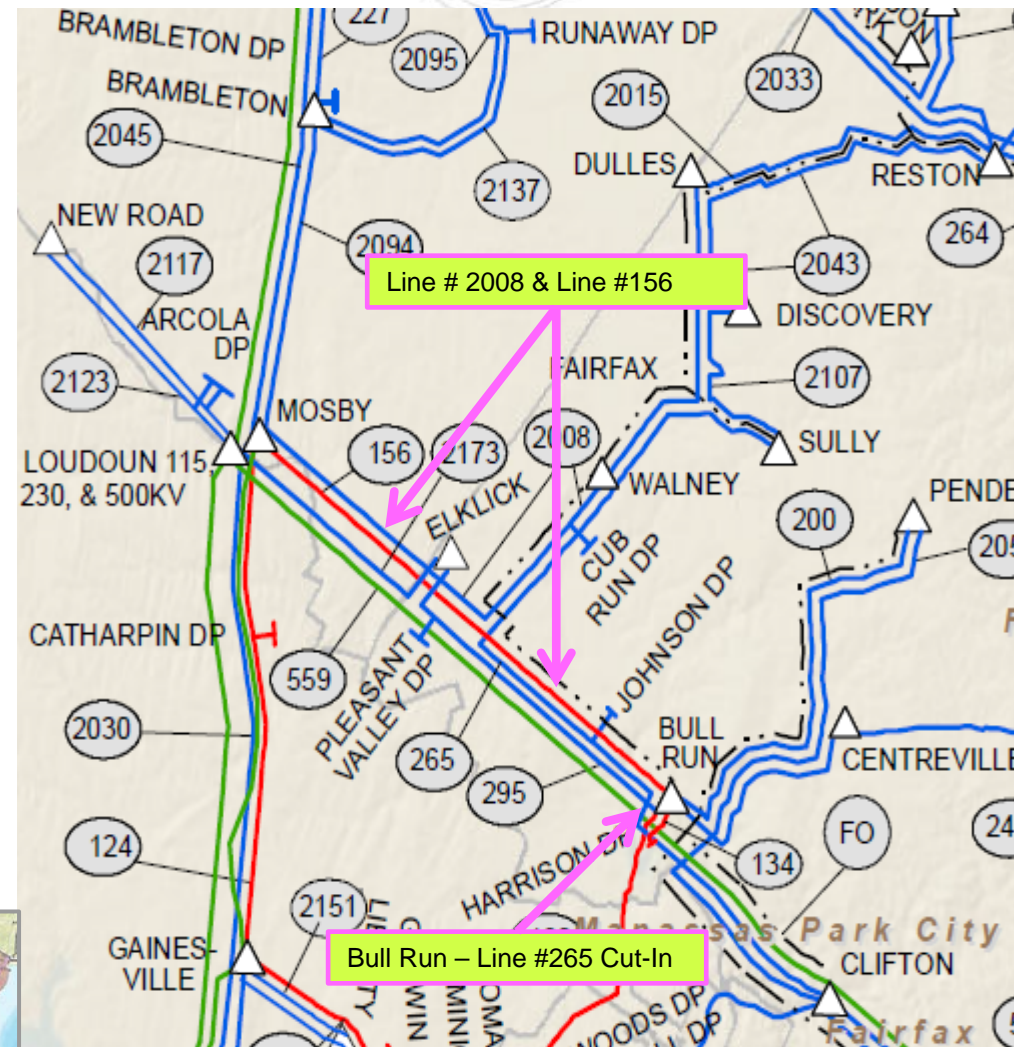
Dominion Transmission Zone: Baseline Line #2008 Partial Rebuild, Line #265 Cut-In & Line #156 Retirement

A 4.4 mile long section of 230kV Line #2008 between Loudoun to Dulles Junction was constructed on Cor-ten lattice-type double circuit towers. A 4.4 mile long section of 115kV Line #156 between Loudoun to Dulles Junction is on the same structures as Line #2008. These towers have been shown to have inherent corrosion problems that continuously deteriorate the steel members. These lines have been identified to be rebuilt or retired as part of Dominion’s End of Life criteria.

Rebuild Line #2008 between Loudoun to Dulles Junction using single circuit conductor at current 230kV northern Virginia standards with minimum summer ratings of 1200 MVA.
