# Submission of Supplemental Projects for Inclusion in the Local Plan

**Need Number:** Dayton-2019-009

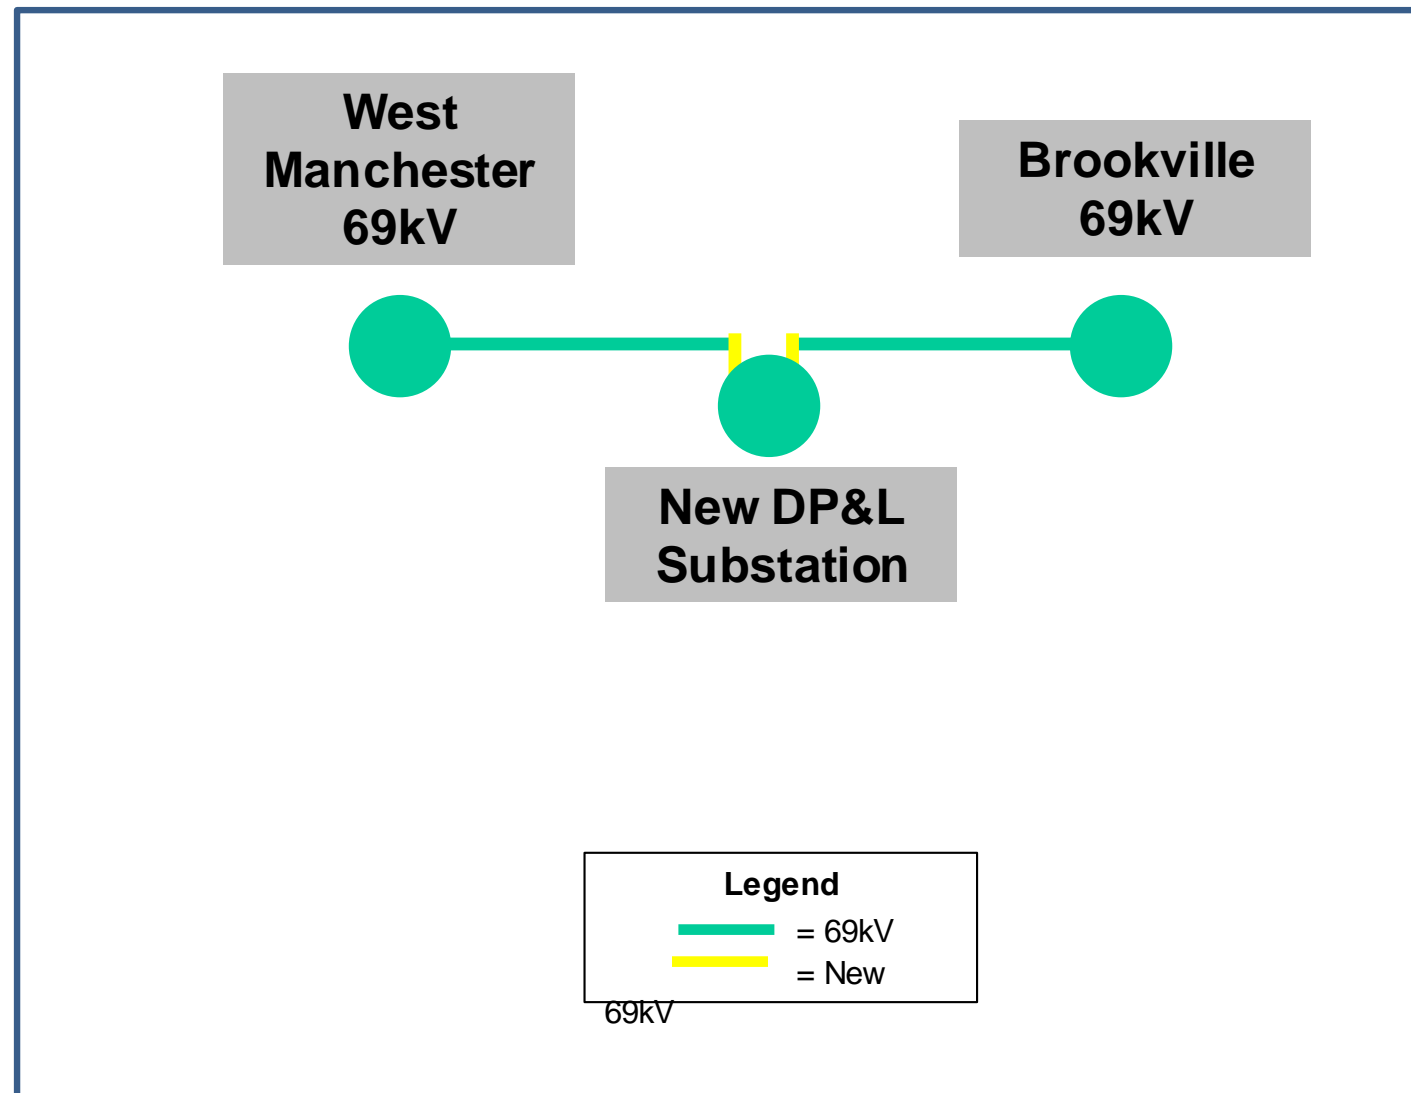
Dayton has developed a comprehensive distribution and transmission solution to meet both the short-term and long term needs identified in problem statement. Dayton plans to install distribution level service to provide service to the first 500kW and 5MW loads. The transmission project to serve the initial 11MVA of load will entail tapping the existing Brookville-West Manchester 69 kV line (6639). This new transmission tap, constructed with 477 ACSR conductor, will loop in and out of a new three breaker 69kV ring bus substation where one 69/12kV 30MVA transformer will be installed. Fiber will be added from Brookville Substation to the new sub, so remote end relay changes will be needed at Brookville Substation. Remote end relay setting updates will be required at West Manchester Substation.

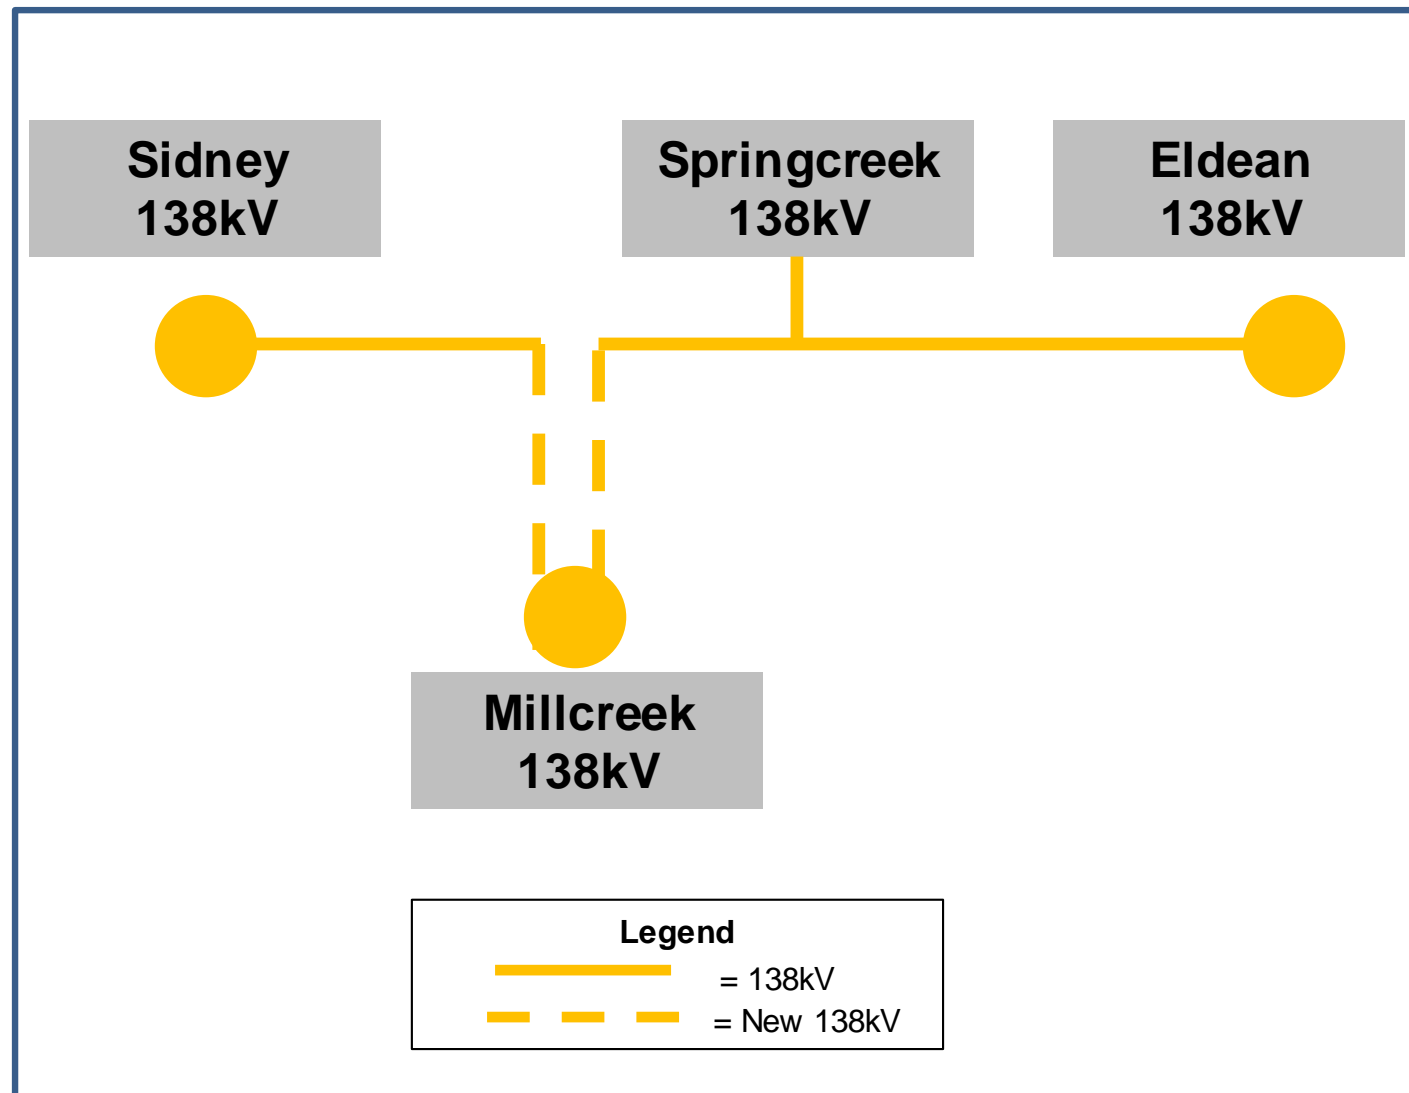
Millcreek Substation is currently tapped off the existing 138kV line from Sidney Substation to Eldean Substation. With this solution, the 138kV line will be extended approximately 0.2 miles, using the same 636 ACSR conductor as the existing line, to loop in and out of a new four breaker ring bus at Millcreek Substation, where a second 138/12kV 30MVA transformer will also be added. The second transformer will allow load to be transferred from the Sidney Substation to Millcreek Substation and will provide the needed capacity at Millcreek to be able to serve the new 10MVA of load. This solution will also provide switching capability between Sidney and Millcreek substations. (**S2210**)

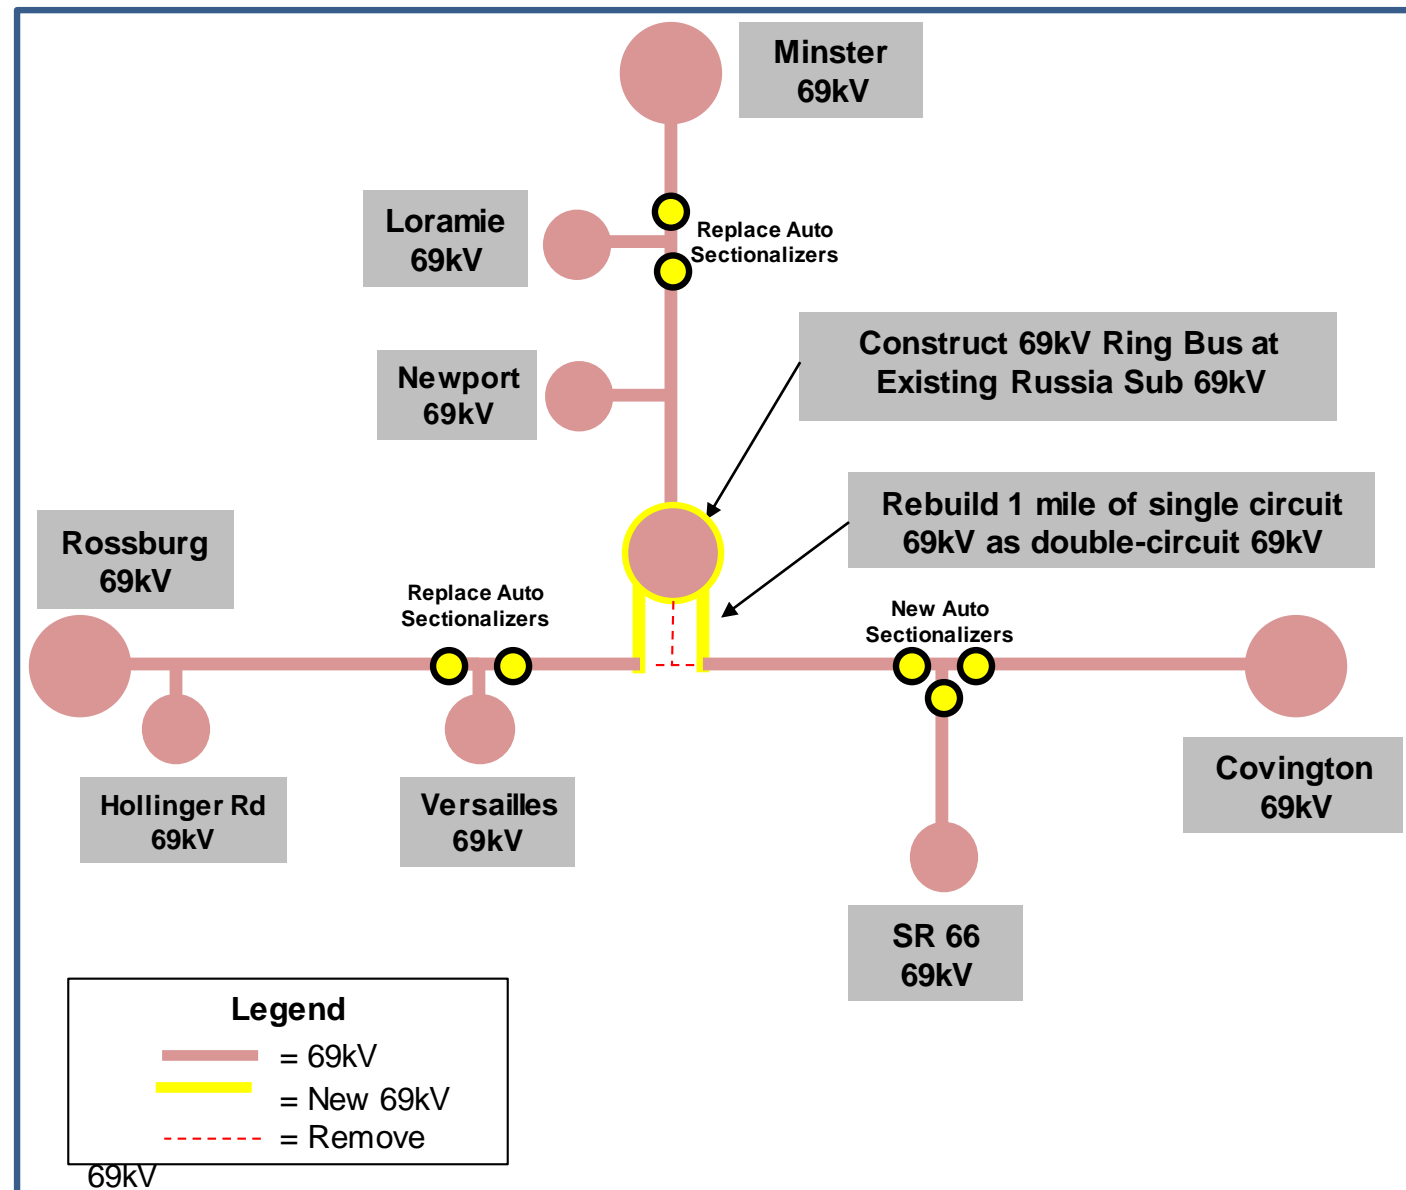
Convert the existing Russia Substation from a tapped substation to a ring bus arrangement and complete 69kV transmission line work to loop lines in and out of the substation.

- This reconfiguration will require the installation of four new 69kV circuit breakers and will involve approximately 1 mile of double circuit 69kV transmission line construction.
- The solution will effectively eliminate the current three-terminal line configuration and will reduce exposure from 42 miles down to approximately 14 miles for each new section of the line.
- This will lead to fewer outages and quicker restoration times for the six substations that currently receive service from the existing line.

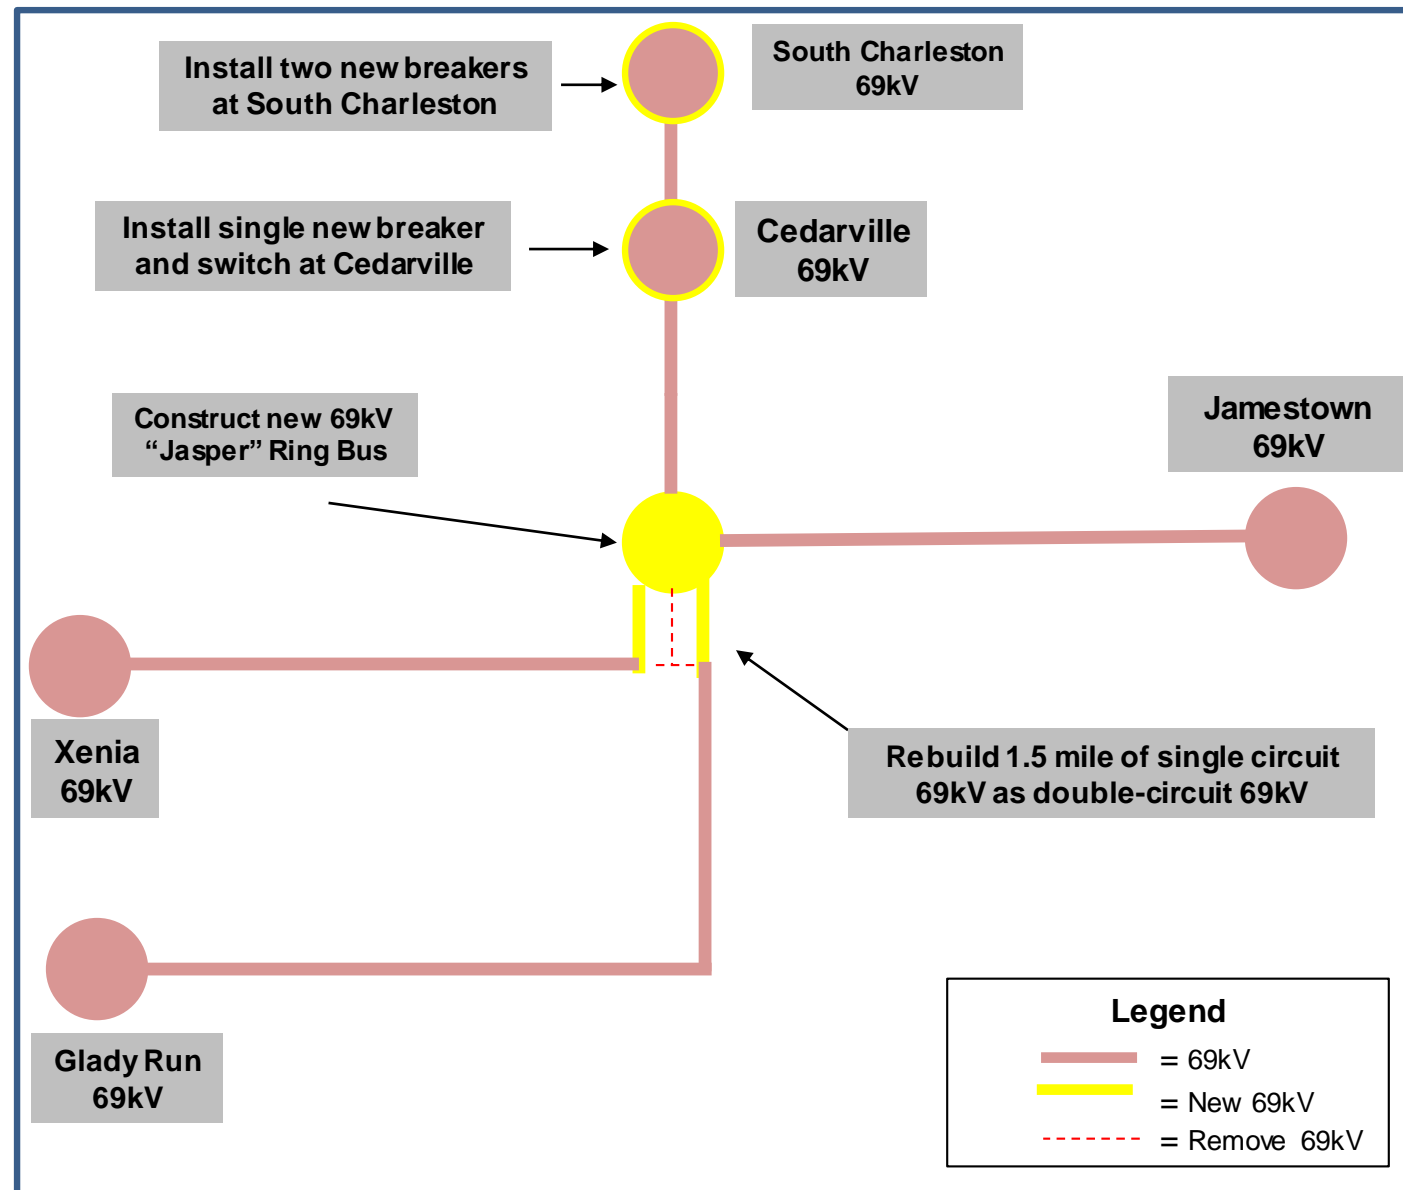
Construct a new four breaker ring bus substation called "Jasper" and build a new 1.5 mile transmission line extension from the existing 63611 switch to the new Jasper Substation for separate 69kV feeds from Xenia Substation and Glady Run Substation. **(\$2255.1) Estimated Cost: \$5.7M**

- The line exposure on the feeds to Cedarville and South Charleston exposure will be reduced from ~17 miles to ~6 miles for the section to Cedarville and ~11 miles for the section between Cedarville and South Charleston.
- Circuit breakers will help ensure reliability and enhance performance to customers served at Cedarville and South Charleston by ensuring an outage on the ~17 mile portion of that line does not take out all 3 distribution transformers and ~25MW of load.
